# **2.7L Nano Intake Valve Failures**

## **U725 Warranty Claims and ERA proposal**

<b>Issue Title:</b>	Intake Valve Failures at 3 <sup>rd</sup> keeper groove on 20-21MY 2.7L / 3.0L Engines.			<b>Champion:</b>	Dave Simon / Jeff Bautz	
<b>Source:</b>	PT Current Model Quality Engine Exchange List.			<b>Team:</b>	B. Rhude, P. Adam, J. Kolodziejczyk, G. Pearson, Z. Ward T. Knott, M. Hewlett, T. Strand	
<b>Issue Description:</b>	2020 - 21MY 2.7/3.0L Nano engine failures due to 3 <sup>rd</sup> keeper groove fracture on left bank intake valves occurring at low time in service.					
<b>Containment:</b>	Implement micro indent core hardness checks, increase frequency of coolant flow and position checks at grinding operation, Increased visual inspection.					
<b>Root Cause:</b>	Side loading of the valve tip from rocker arm tipping as a result of valvetrain dynamics caused by increased lash in the system.					
<b>Corrective Action:</b>	Implement following ERA's: Increase frequency core micro hardness checks and control plan update. Including batch and hold Change valve material to Silchrome 1 for improved robustness to side loading and significantly higher high temperature fatigue strength pr

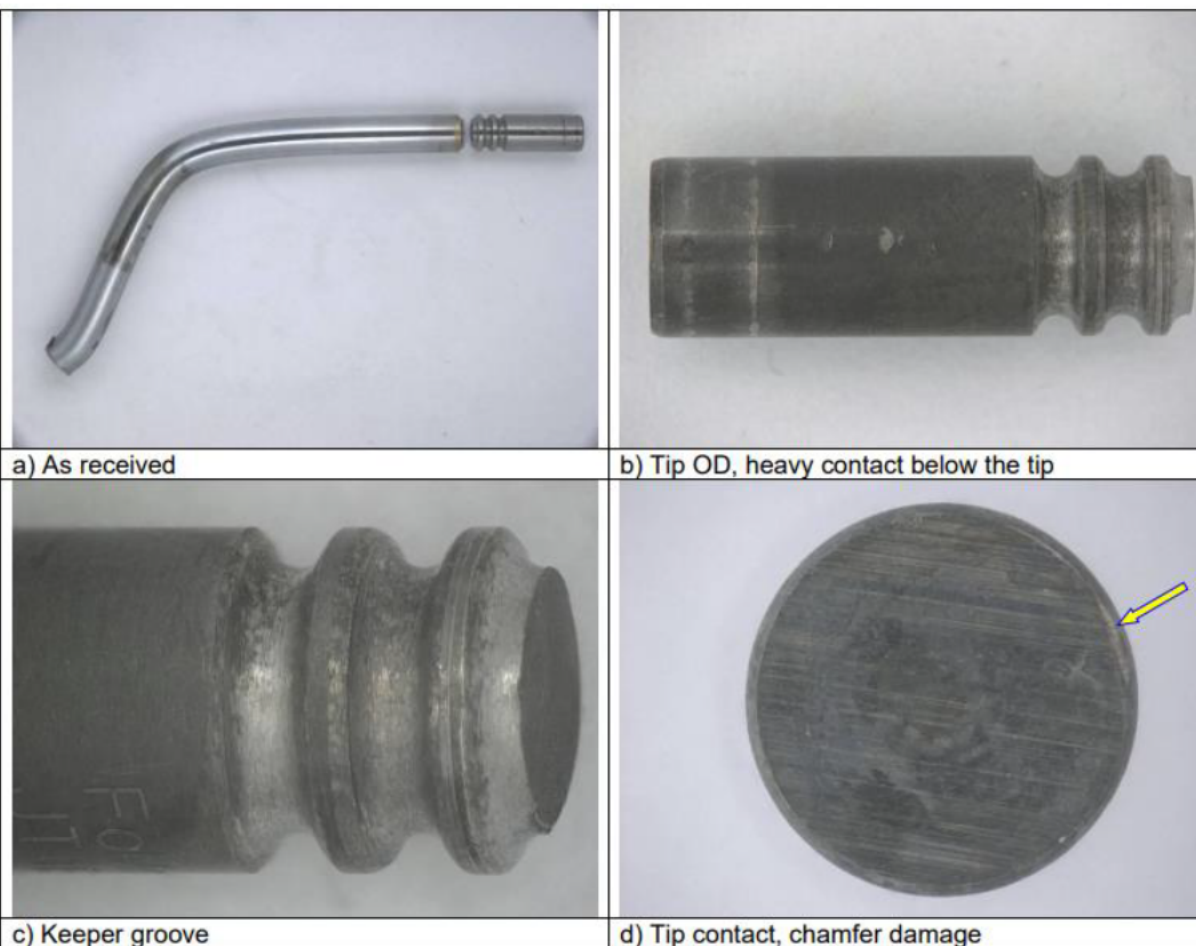
37 total Nano 2.7L & 3.0L engine exchanges in 2020 - 2021MY due to 3<sup>rd</sup> keeper groove fracture on left bank intake valves occurring at low time in service. Fractured valves show evidence of side loading.

- All returned valves show evidence of side loading / impact.
- Witness marks of RFF side wall contact & RFF tipping. Significant wear depth at witness marks.
- Chamfer impact damage aligning with crack initiation point on fractured surface.
- RFF side wall broken or damaged in some cases.
- Parts within specification. Hardness 50-57 HRC

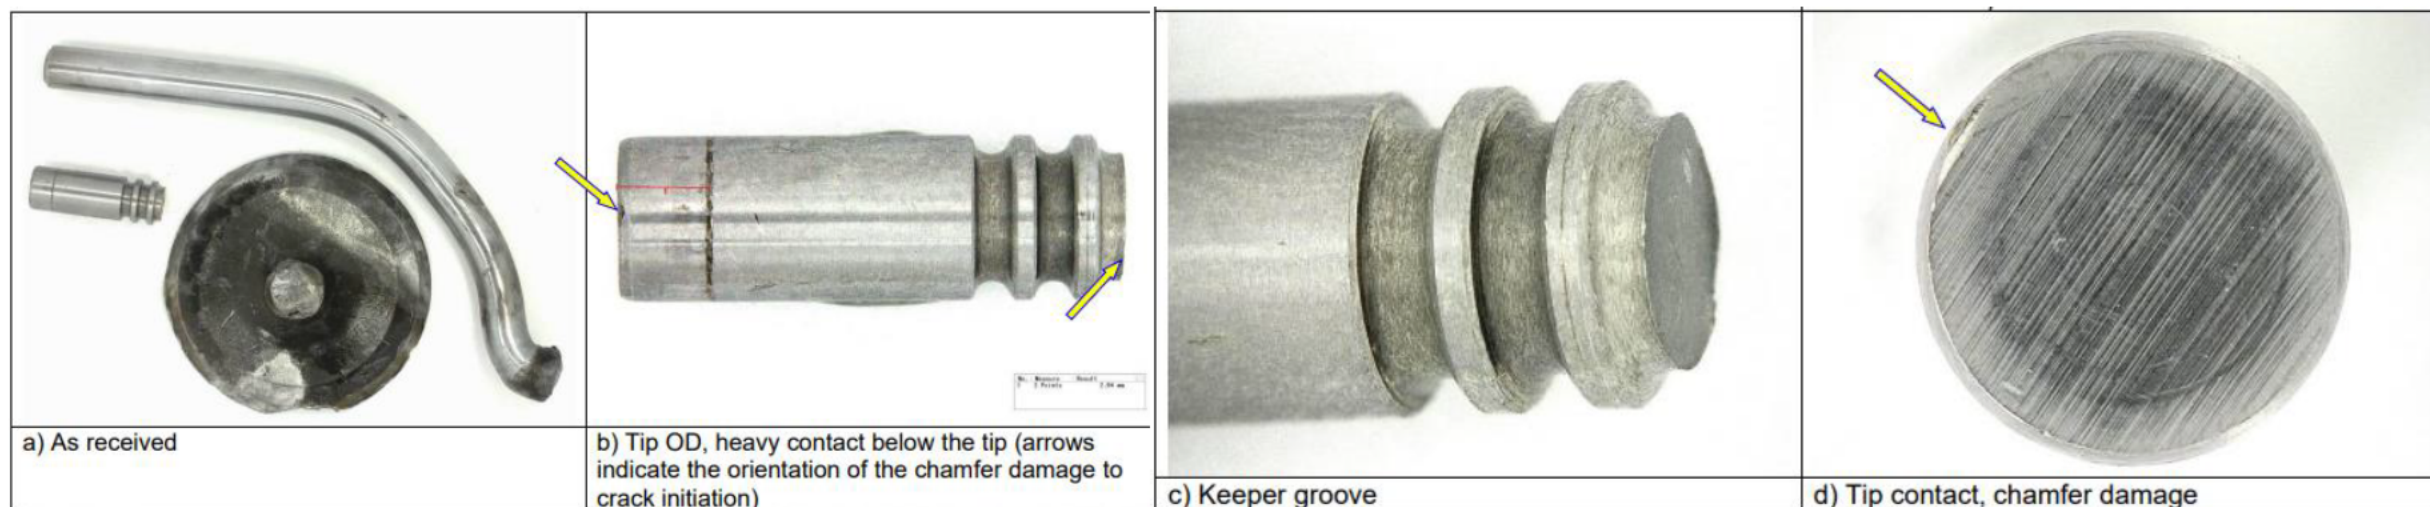
#### U725 Valve Failure Teardown Observations: (Grand Rapids Vehicle VIN 6408)

- #6 Secondary intake valve 3<sup>rd</sup> keeper groove failure
- Signs of RFF tipping in other locations. #4 primary Intake & 5 secondary intake.
- RFF side walls show edge break and polishing.
- #4 primary shows valve tip chamfer damage and other marks indicting side loading.
- Failure consistent with previous warranty claims.

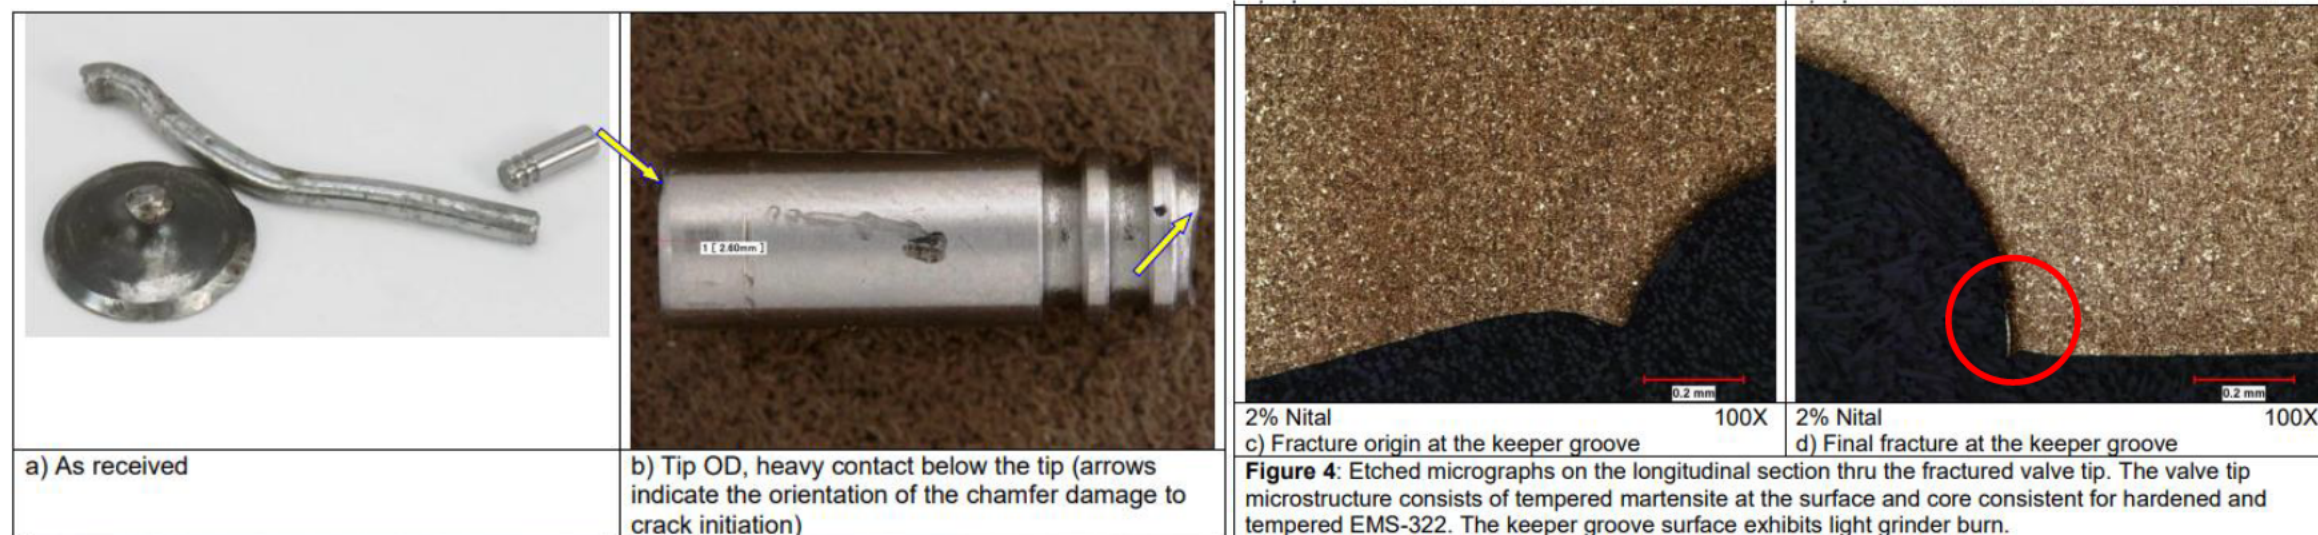
## U725 Valve Failure Teardown Observations: (Bommarito Ford Vin: 1500)

- #5 Primary intake valve 3<sup>rd</sup> keeper groove failure
- Failure consistent with previous warranty claims.

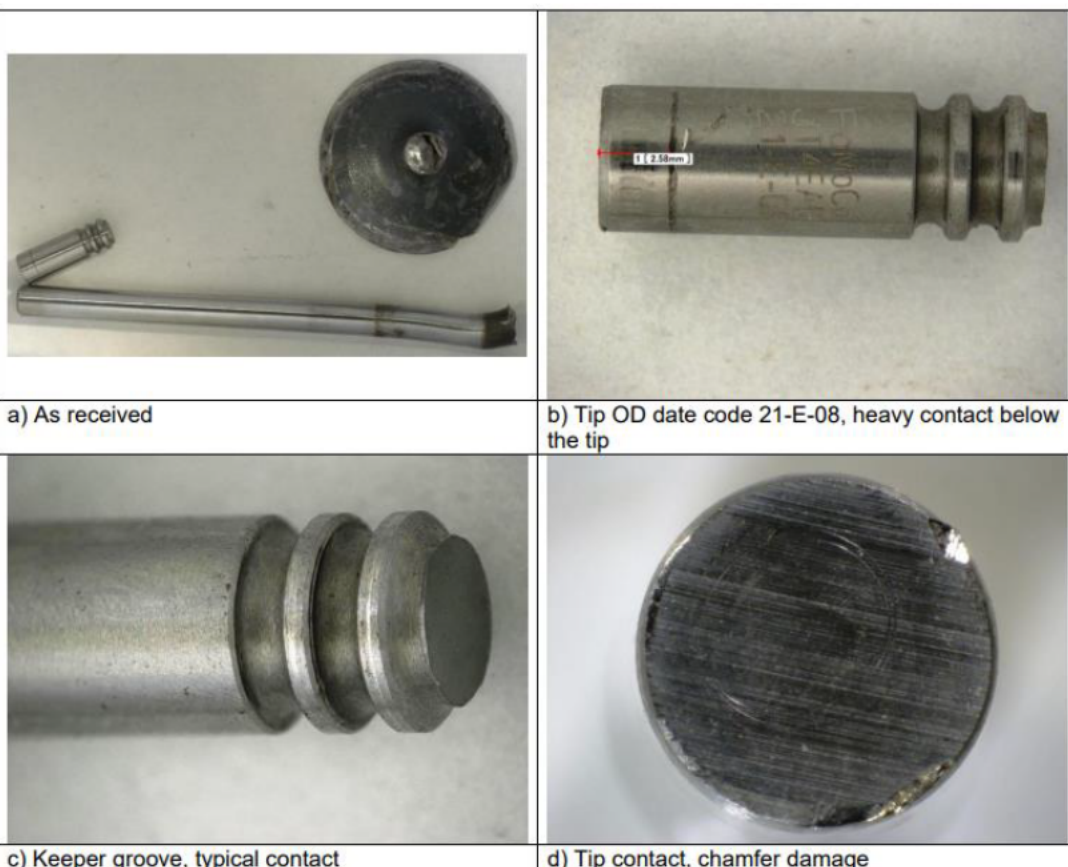
### U725 Valve Failure Teardown Observations: (Autonation Ford Frisco Vin: 2960)

- #6 Primary intake valve 3<sup>rd</sup> keeper groove failure
- Failure consistent with previous warranty claims.

**Table 1:** Microhardness measurements on the left and right keeper groove cross-sections measured HV0.5 and converted to HRC. The left and right keeper grooves exhibit typical hardness values.

Left Side	Right Side
KG 1		59.2	58.9
KG 2		59.3	59.2
KG 3		59.1	58.4

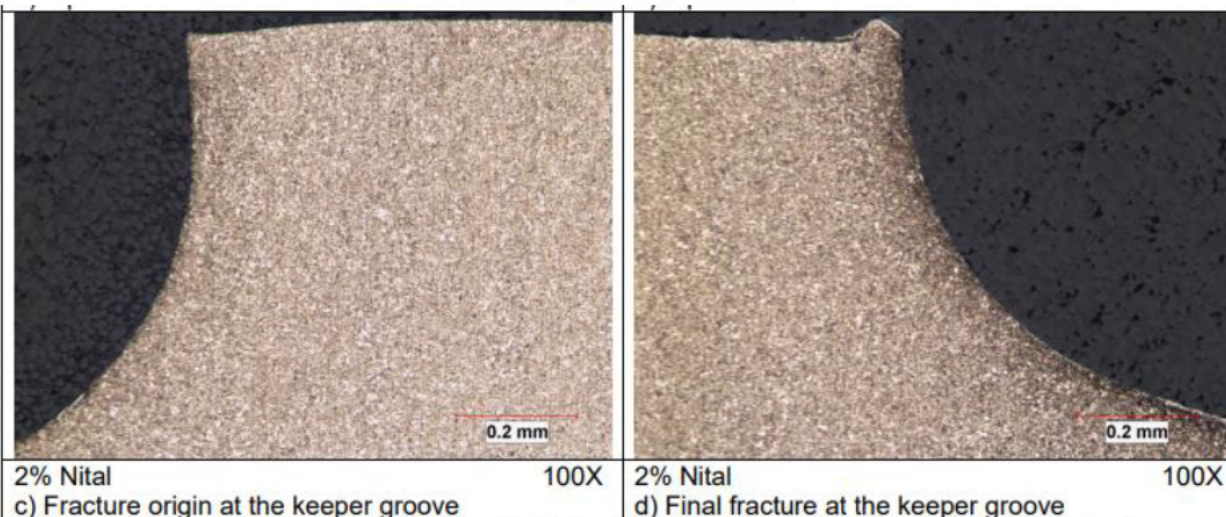
**Figure 4:** Etched micrographs on the longitudinal section thru the fractured valve tip. The valve tip microstructure consists of tempered martensite at the surface and core consistent for hardened and tempered EMS-322. The keeper groove surface shows no evidence of grinder burn at the fracture.

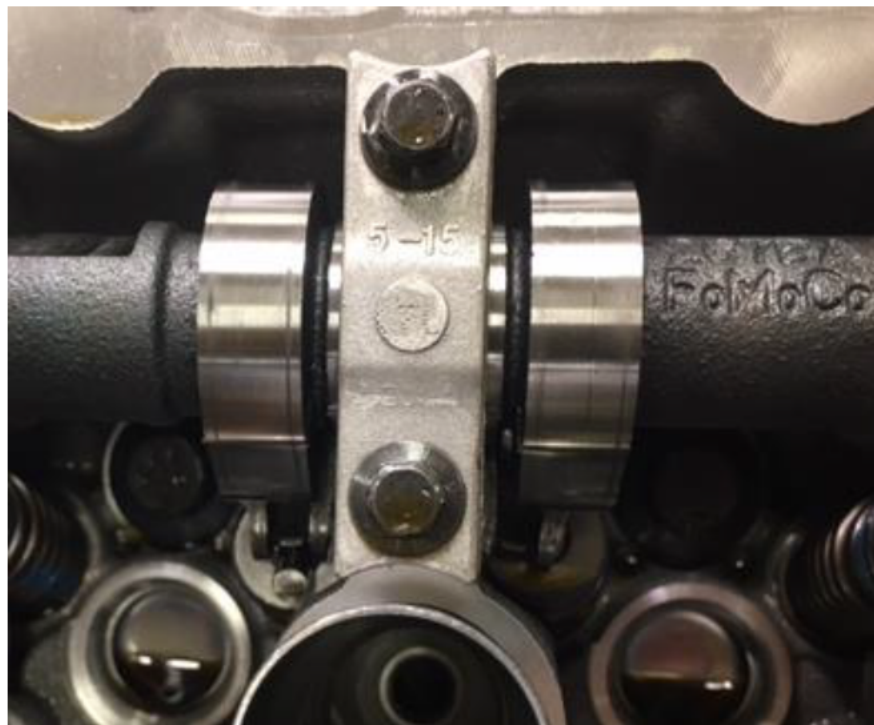
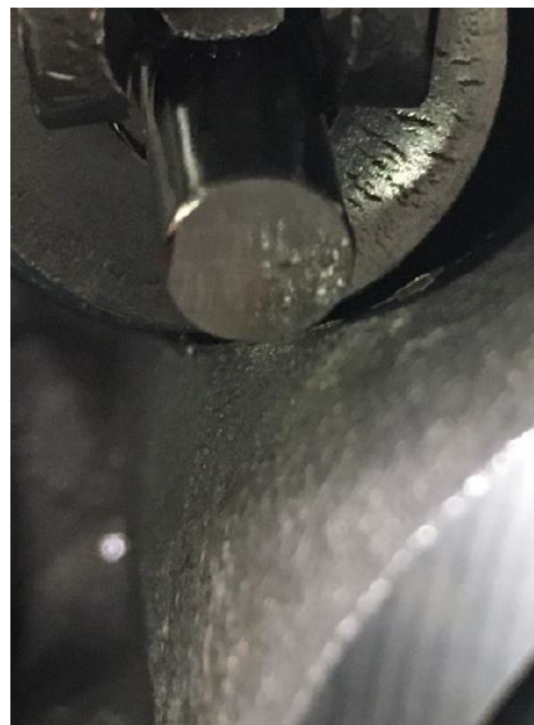
5P Intake

- #5 Primary intake valve 3<sup>rd</sup> keeper groove failure. Tip remained in retainer.
- #5 Secondary broken RFF side wall. May be secondary.
- Parts being shipped to supplier 8/6/21

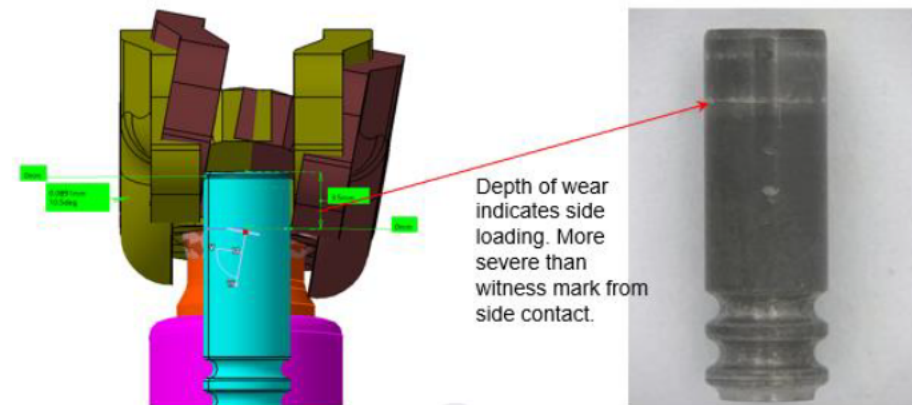
Slow motion video with lash in the system show tipping and side loading of valve tip.

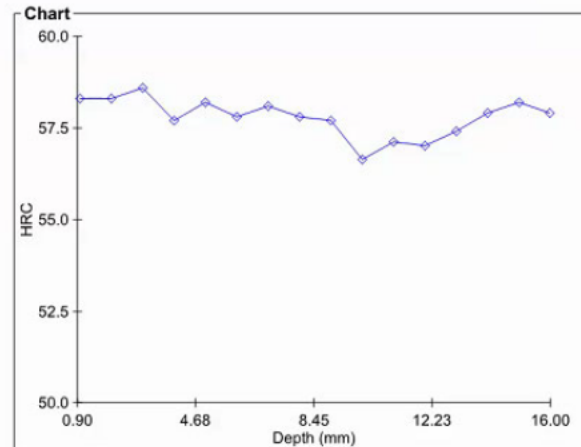
#### Stem Tip Core

- Failed valve tip core hardness above 50 – 57 HRC spec.
- ERA 1 – Increase core microhardness check from 1 to 3 times per shift. (beginning, middle, end of shift)
- Add operator tip hardness check 1 / hour (was 3/shift).

Minimum: 56.6 HRC ( 626 HV )  
 Maximum: 58.6 HRC ( 666 HV )  
 Mean: 57.8 HRC ( 649 HV )  
 Std Deviation: 0.5 HRC ( 11 HV )  
 Count: 16 of 16

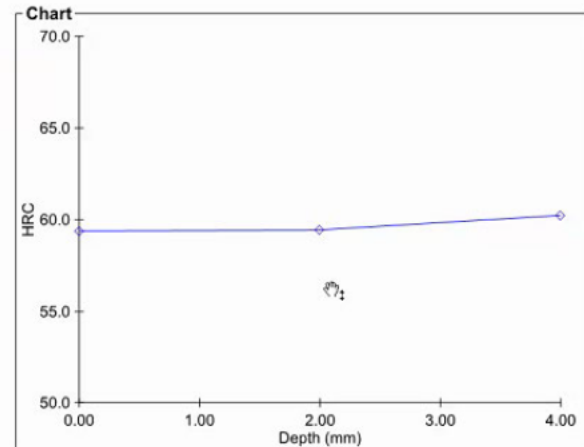
#### KG Left

Minimum: 59.4 HRC ( 682 HV )  
 Maximum: 60.2 HRC ( 702 HV )  
 Mean: 59.7 HRC ( 690 HV )  
 Std Deviation: 0.5 HRC ( 11 HV )  
 Count: 3 of 3

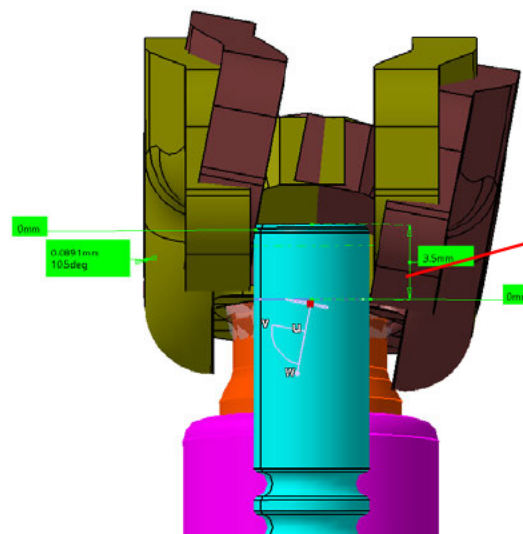
Slow motion video with lash in the system shows RFF tipping and side loading of valve tip.

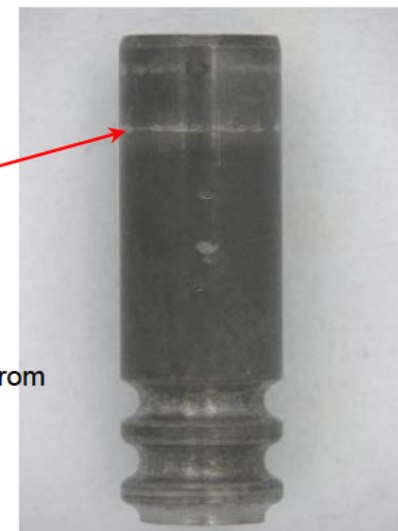
Depth of wear indicates side loading. More severe than witness mark from side contact.
