Eaton Corporation
4200 HWY 30 East
Kearney NE

8D Report

Title: JT4E-6507-AB Keeper Groove Burn	Date Opened: 10/18/21	Last Updated: 11/1/21
Product/Process Information: P/N JT4E-6507-AB (Eaton 372237) Nano Intake Valve	Organization Information: Ford-Lima	Ref. No.: Ford Concern Number: QR# UF50198
D0 Symptoms At Ford: Keeper groove found burned (rehardened) or tempered back.		
D1 Team (Name, Dept., Tel) Champion: Jonn Nebbe – Quality Supervisor (308-233-5447) Ken Bentley – Metallurgical Technician Lynette Buss – Metallurgical Technician

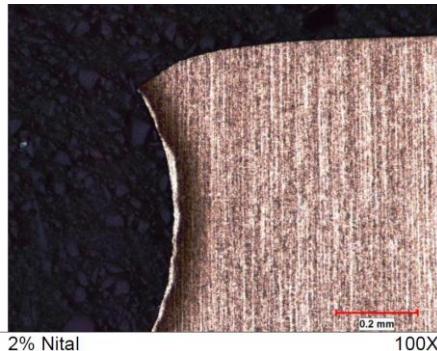
DESCRIBE THE PROBLEM: At Ford: Rehardened and tempered back area of the keeper groove identified in a keeper groove field failure.
<i>Before trying to define the root cause or jump to solutions – stop and take time to describe the problem, using as much data and facts as you can gather. Use the questions below to guide you.</i>

Figure 1: Rehardened Material (white) in Keeper Groove (Dewey Moore)

Cause #	Root Cause
1	No metallographic inspection at keeper groove set-up.
2	Grinding was too aggressive on the keeper grooves causing rehardened material.

Countermeasures: <i>(Long term corrective actions to prevent reoccurrence of problem)</i>	Who?	Start Date	Status	Breakpoint/Due Date
Added keeper groove metallographic check at keeper groove grind at set-up and once/shift.	Jonn Nebbe	7/30/21	OK	8/24/21
