8D Report

Title: JT4E-6507-AB High Tip End Hardness	Date Opened: 10/18/21	Last Updated: 10/20/21
Product/Process Information: P/N JT4E-6507-AB (Eaton 372237) Nano Intake Valve	Organization Information: Ford-Lima	Ref. No.: Ford Concern Number: QR# UF50198
D0 Symptoms At Ford: Hardness found above the maximum specification adjacent to keeper grooves.		
D1 Team (Name, Dept., Tel) Champion: Jonn Nebbe – Quality Supervisor (308-233-5447) Ken Bentley – Metallurgical Technician Lynette Buss – Metallurgical Technician

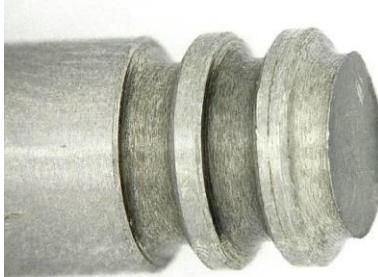
DESCRIBE THE PROBLEM: At Ford: Parts found to have hardness > 58 – 60 HRC in the keeper groove region of valves that allow for a maximum hardness of 57 HRC. These valves were field failures in the 3 rd keeper groove. <i>Before trying to define the root cause or jump to solutions – stop and take time to describe the problem, using as much data and facts as you can gather. Use the questions below to guide you.</i>
--

Figure 1: Tip Fracture in 3rd Keeper Groove

(Long term corrective actions to prevent reoccurrence of problem)	Who?	When?	Status	Results
Added microhardness profile check at set-up and in-process.	Jonn Nebbe	7/30/21	OK	Improved hardness data
Increased hardness testing frequency.	Jonn Nebbe	7/30/21	OK	Increased hardness data

Countermeasures: (Long term corrective actions to prevent reoccurrence of problem)	Who?	Start Date	Status	Breakpoint/Due Date
Added microhardness profile check at set-up and in-process.	Jonn Nebbe	7/30/21	OK	8/24/21
Added keeper groove hardness check at keeper groove grind.	Jonn Nebbe	7/30/21	OK	8/24/21

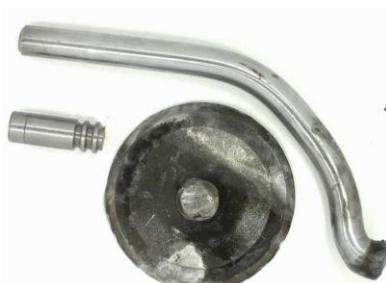
Figure 2: As-received Failed Valve from Ford

Left Side	Right Side
KG 1	59.4	59.0
KG 2	59.5	59.0
KG 3	60.2	59.7

Figure 3: Hardness Measurements in the Keeper Groove Region
