# Central Laboratory Request System (CLRS – NA)

## 3252-2021 Nano Engine Valve Fracture

**Subject:** 2021 Nano Engine Valve Fracture

GPID: QLT14  
Part Number: JT4E-6507-AB  
Specification: SAE J775 K14072  
Supplier: Eaton

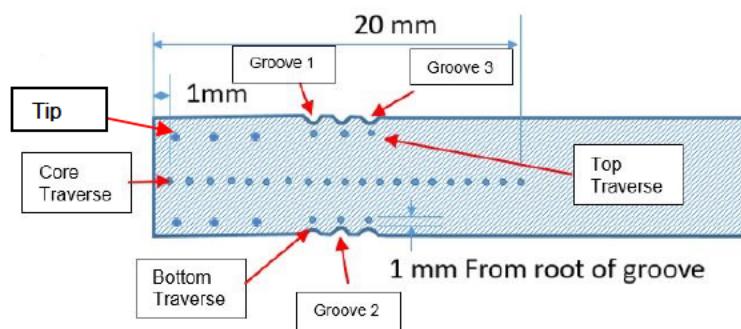
Illustration A: Hardness measurement locations.

Microindentation hardness readings were made on the polished metallographic cross-section of Intake Valve 10 in the area shown in Illustration A. Microindentation hardness was performed with a Vickers pyramidal indenter using a 500 gf load in accordance with ASTM E384. Vickers values were converted to Rockwell C in accordance with ASTM E140. The core traverse was performed from the tip of the valve stem at 1 mm intervals. Hardness measurements were also taken 1 mm below each of the keeper grooves and along the tip, on the top and bottom sides as detailed in Illustration A. The hardness in several locations near the grooves and core traverse exceeded the hardness specification per Ford Drawing JT4E-6507-AB. The drawing specifies a hardness of 50 – 57 HRC past the keeper grooves, 17.3 – 21.3 mm deep from the tip which applies to all of the areas tested in this report, and 40 – 50 HRC for the remaining valve body. The hardness results are shown in Tables 1 – 2.

Sample	Location	Hardness, HRC <sub>VICKERS</sub>	
		Top	Bottom
Intake Valve 10	Groove 1	59 <sub>664</sub> *	59 <sub>664</sub> *
	Groove 2	58 <sub>659</sub> *	58 <sub>643</sub> *
	Groove 3	59 <sub>664</sub> *	57 <sub>630</sub>
	Tip 1	60 <sub>689</sub> *	59 <sub>675</sub> *
	Tip 2	58 <sub>653</sub> *	59 <sub>678</sub> *
	Tip 3	58 <sub>661</sub> *	58 <sub>659</sub> *
Specification		50 - 57

Table 1: Keeper groove and tip hardness, HRC<sub>VICKERS</sub>.

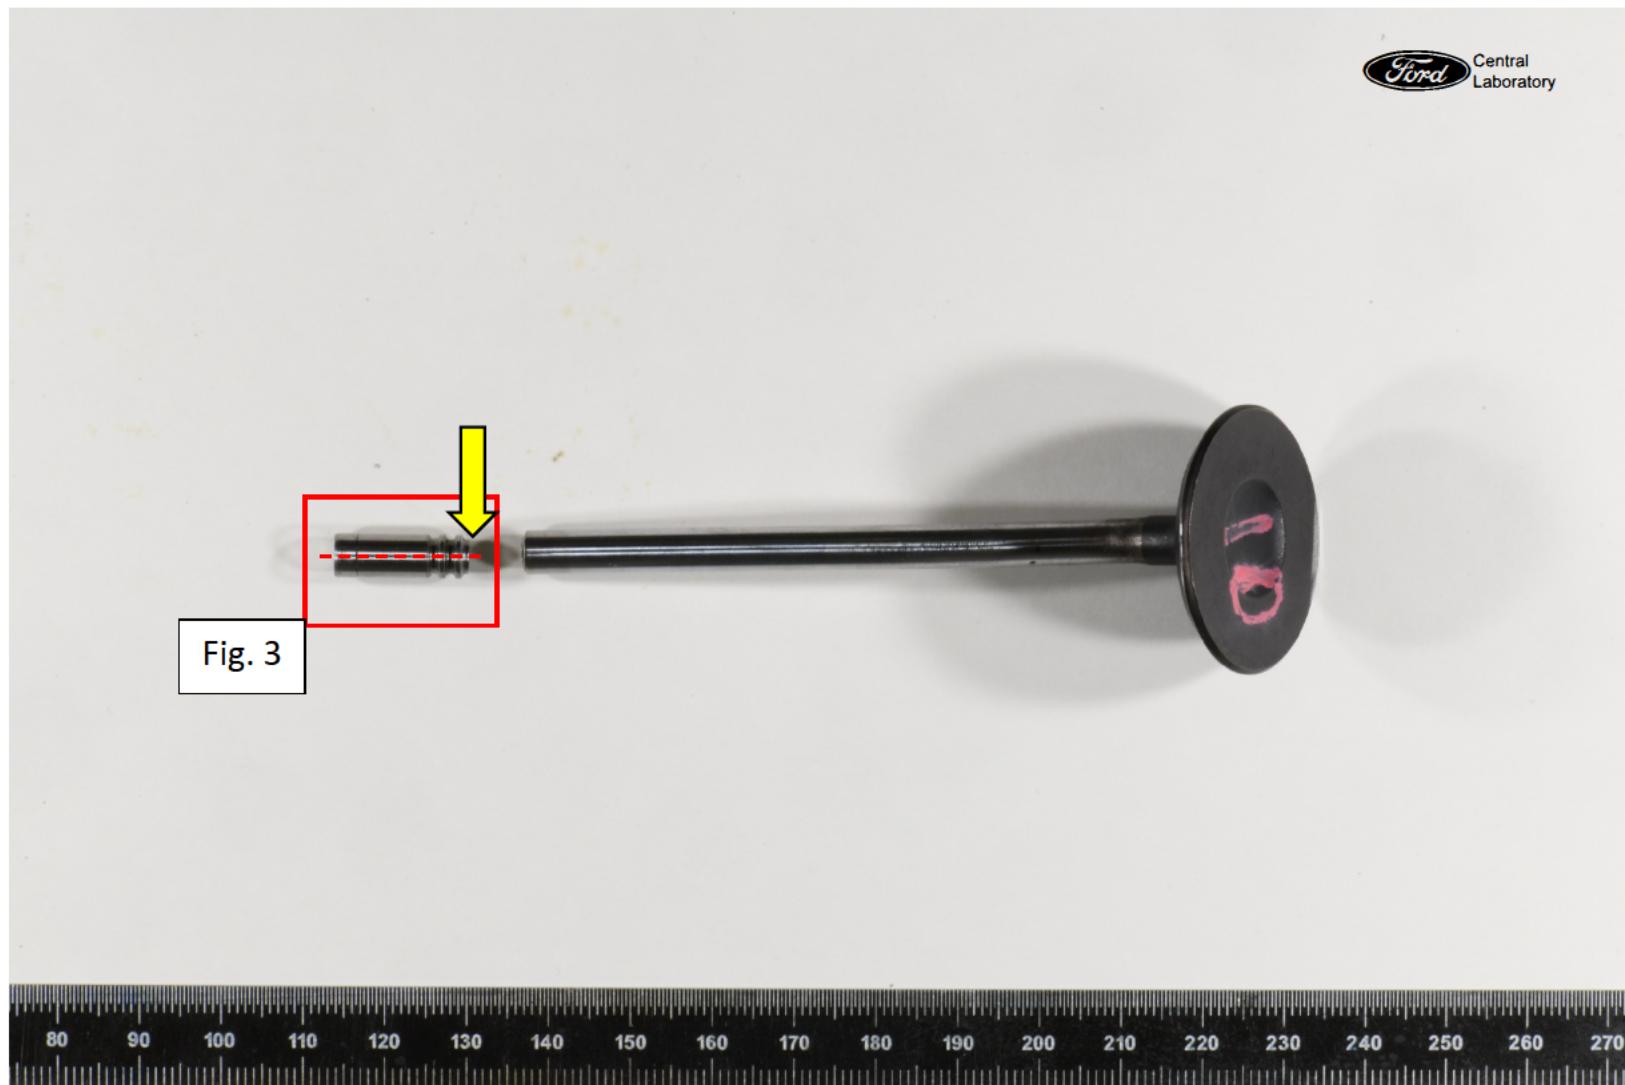
The fractured intake valves were photographed upon being received showing the fracture at the third keeper groove from the tip at the root (Figures 1 – 4). Both fractures exhibit a point containing one or more ratchet marks which beach marks radiate from, characteristic of bending fatigue. This region propagated approximately 80% of the cross-section where the fracture transitions to a rougher textured region, suggestive of an overload final fracture (Figures 5 – 6). The fracture propagation of Intake Valve 10 arrested at about a third of the cross-section and then continues to propagate at a different angle, suggesting that the loading of the valve tip changed at this point. The fracture surface was further examined using a scanning electron microscope (SEM). Fatigue striations were observed at the initiation and in all the regions of beach marks, confirming a fatigue fracture mode initiation for both intake valves (Figures 7, 9,10). Micro-void coalescence (ductile dimples) was observed within the rougher textured final fracture region on both samples, confirming a ductile overload final fracture (Figures 8, 11). No evidence identifying the presence of a preexisting crack at the initiation was observed.

**Figure 1: Intake Valve – 10 – Overall view of the fractured intake valve. The fracture occurred at the third keeper groove from the tip as indicated by the yellow arrow. The red dotted line denotes the cross section location through the centerline.**

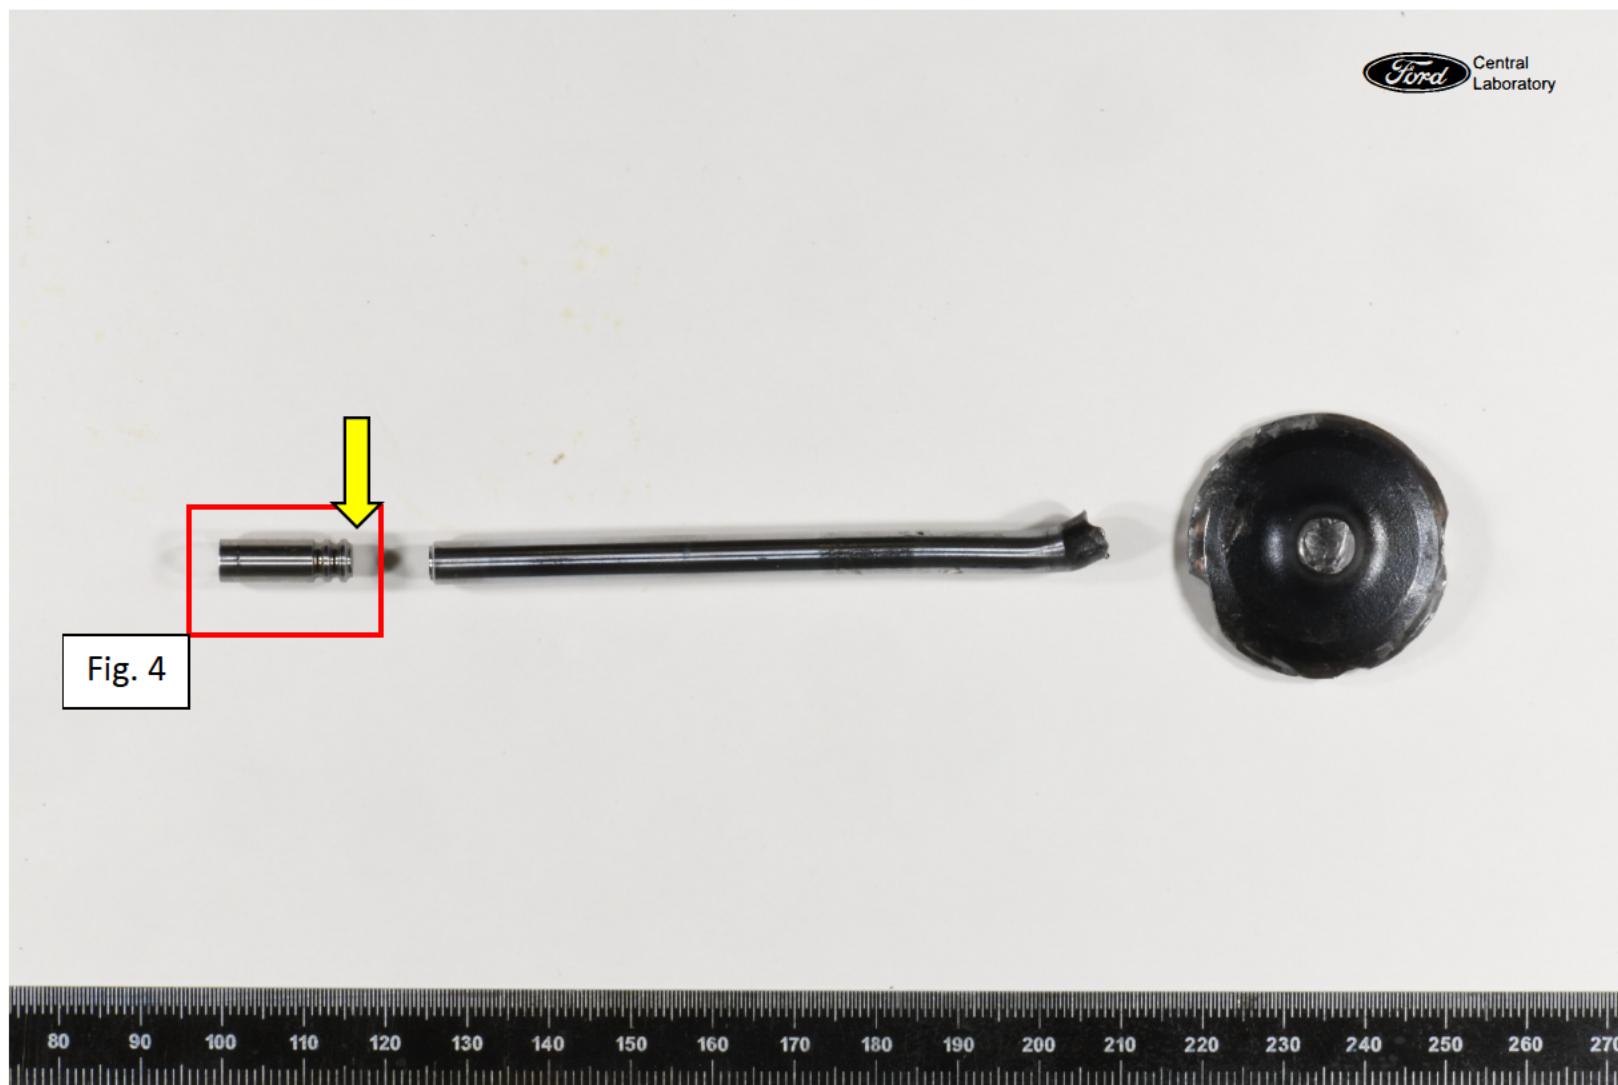
**Figure 2: Intake Valve – 12 – Overall view of the fractured intake valve. The fracture occurred at the third keeper groove from the tip as indicated by the yellow arrow.**

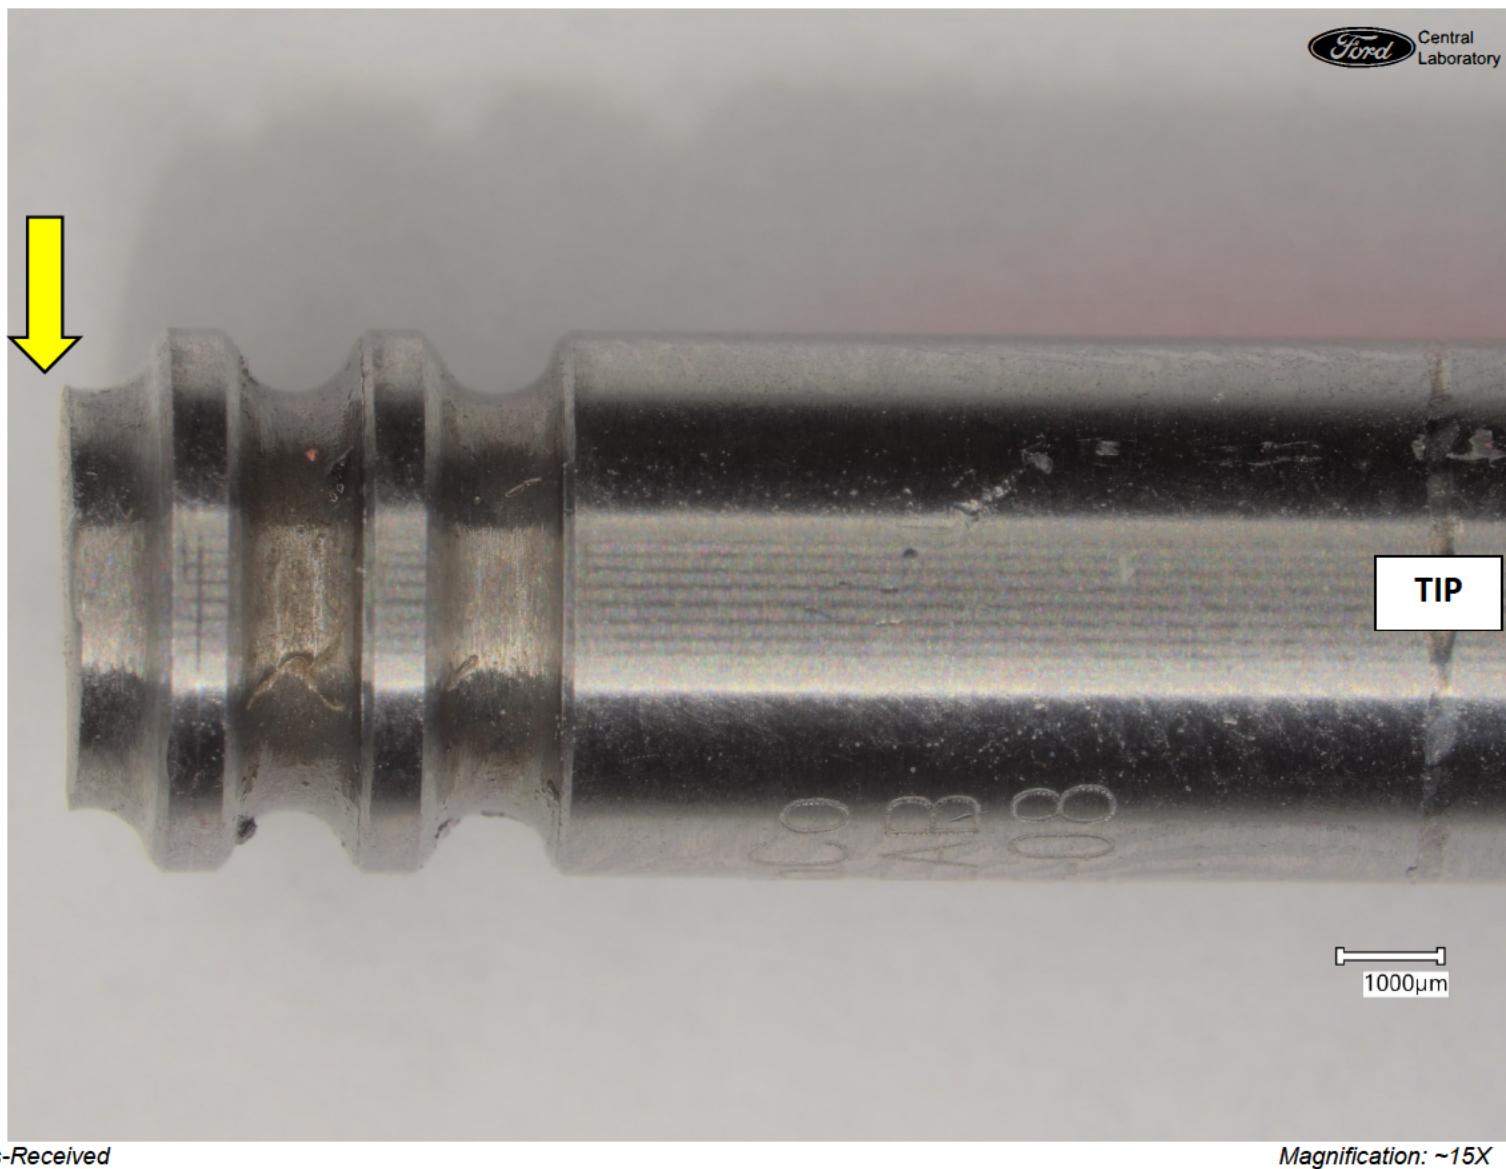
Figure 3: Intake Valve – 10 – Magnified view of Figure 1 showing the fracture at the third keeper groove from the tip, indicated by the yellow arrow.

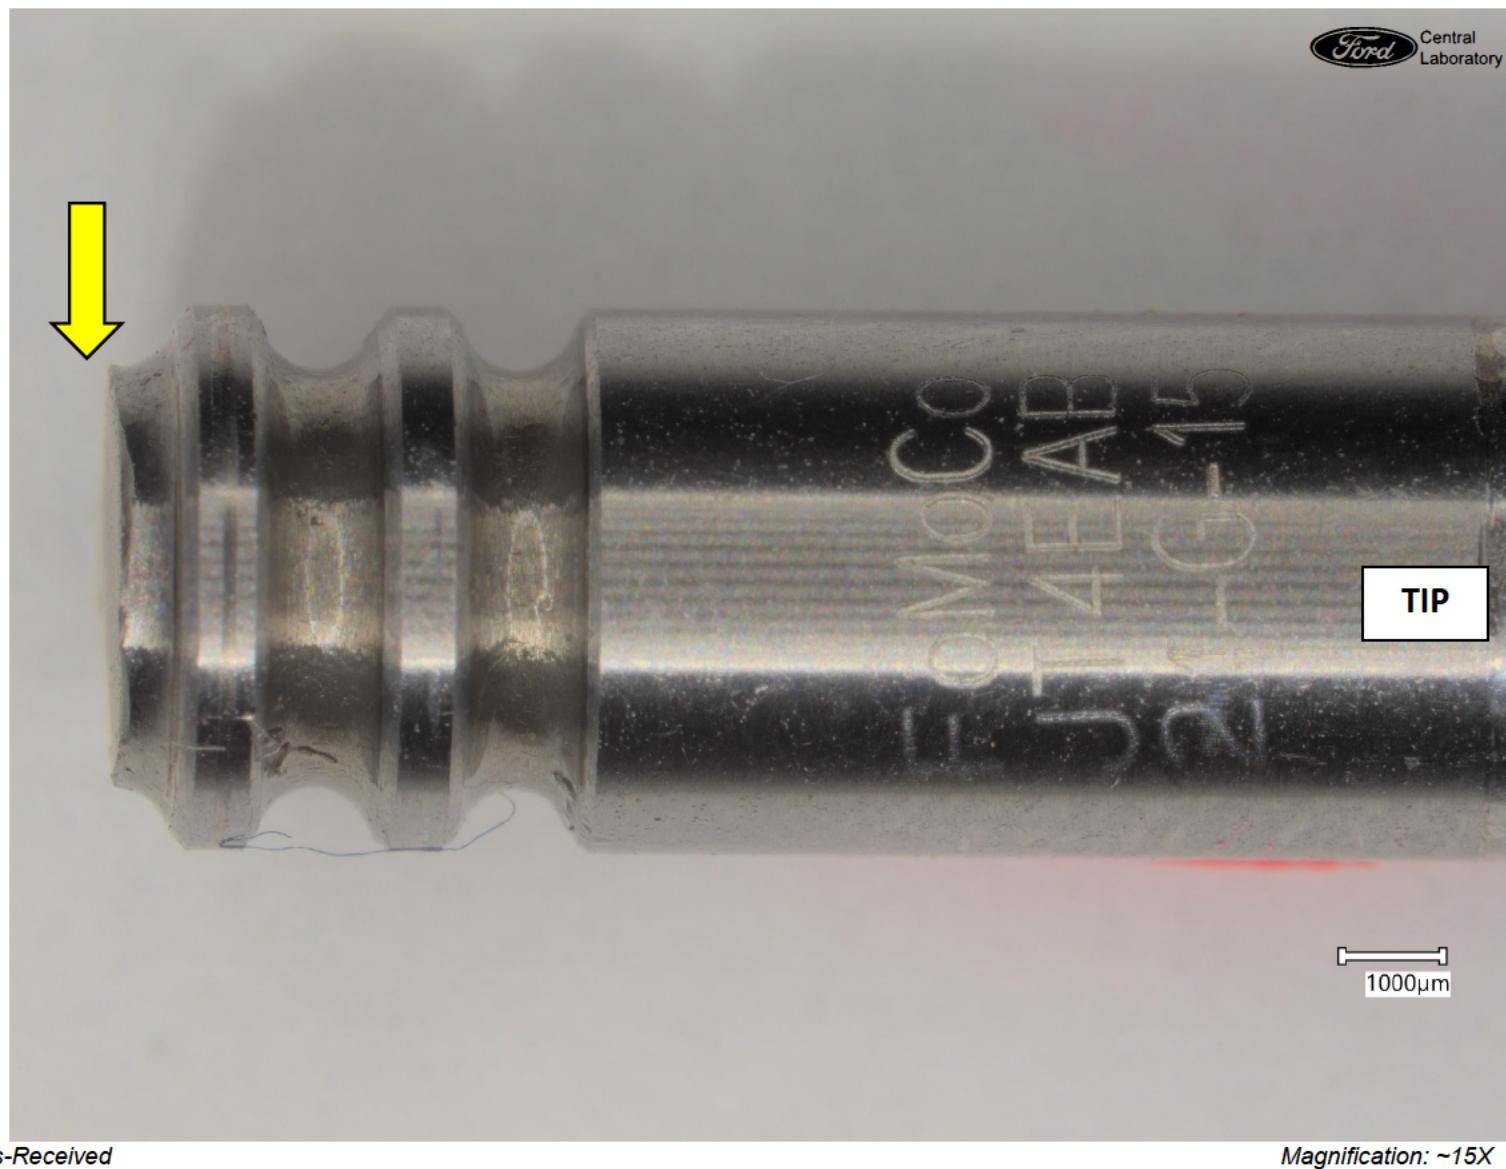
Figure 4: Intake Valve – 12 – Magnified view of Figure 2 showing the fracture at the third keeper groove from the tip, indicated by the yellow arrow.

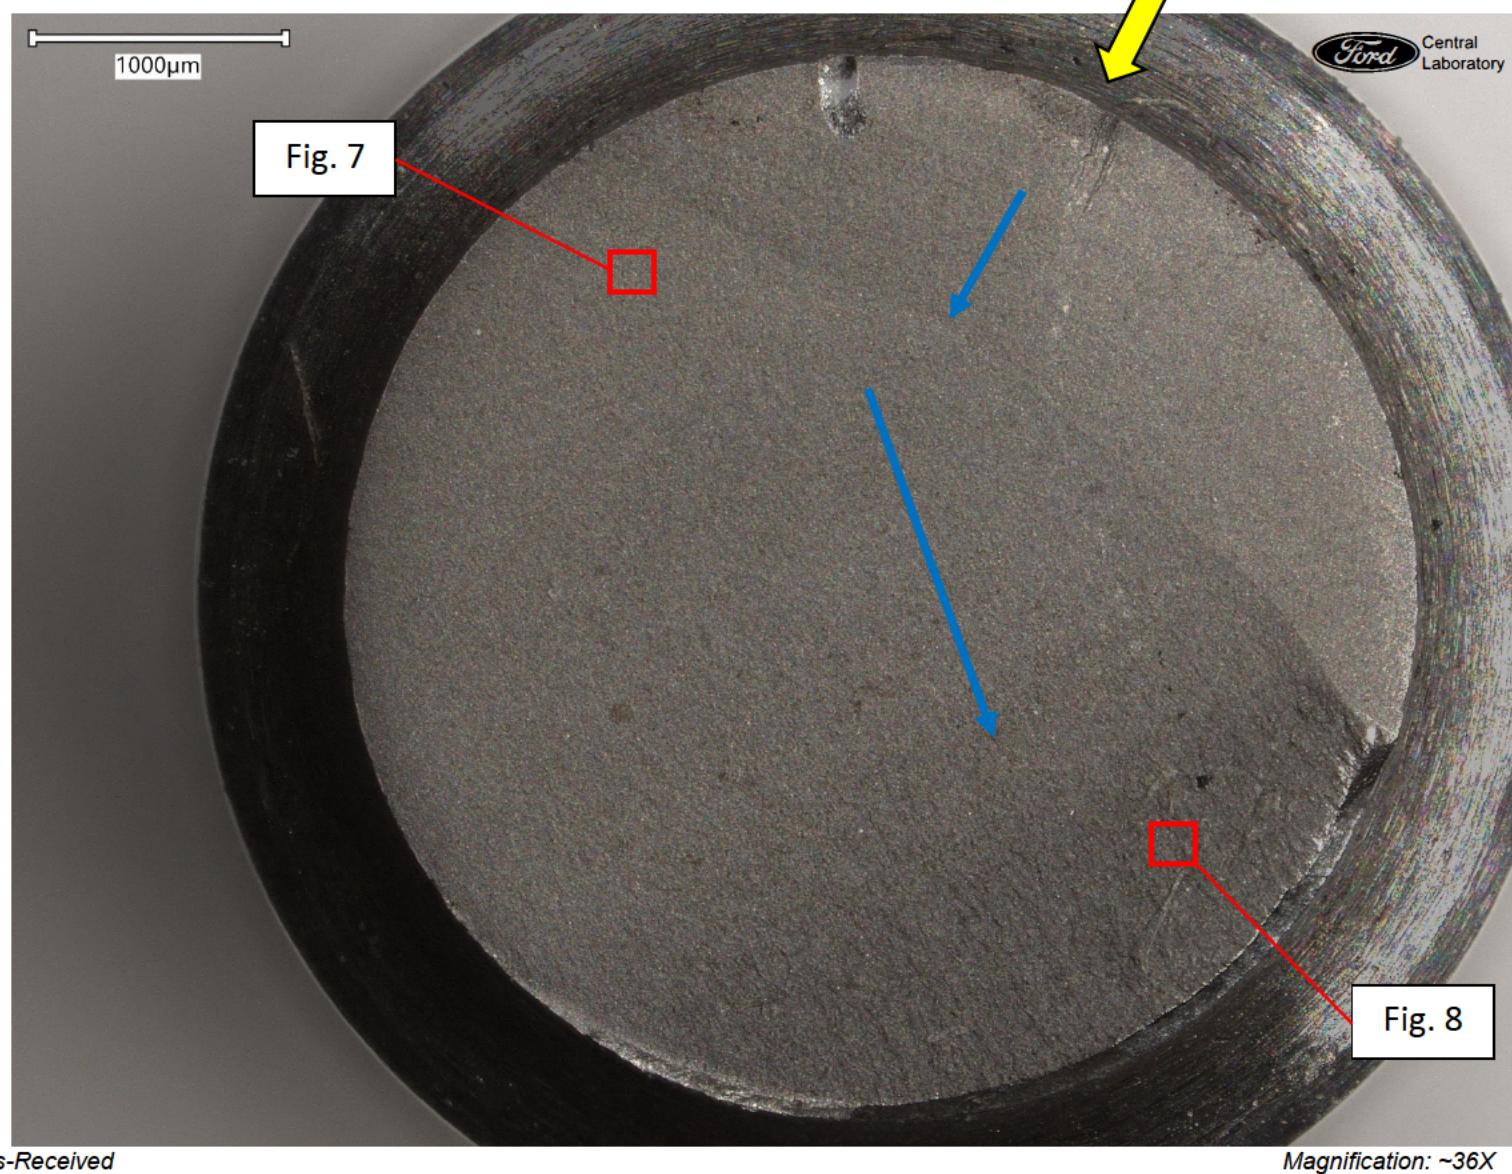
**Figure 5: Intake Valve – 10 – View of the fracture surface. The yellow arrow indicates the likely fracture initiation site. The blue arrows denote the fatigue propagation direction which suggests that the loading of the valve tip changed after propagating about a third of the cross-section.**

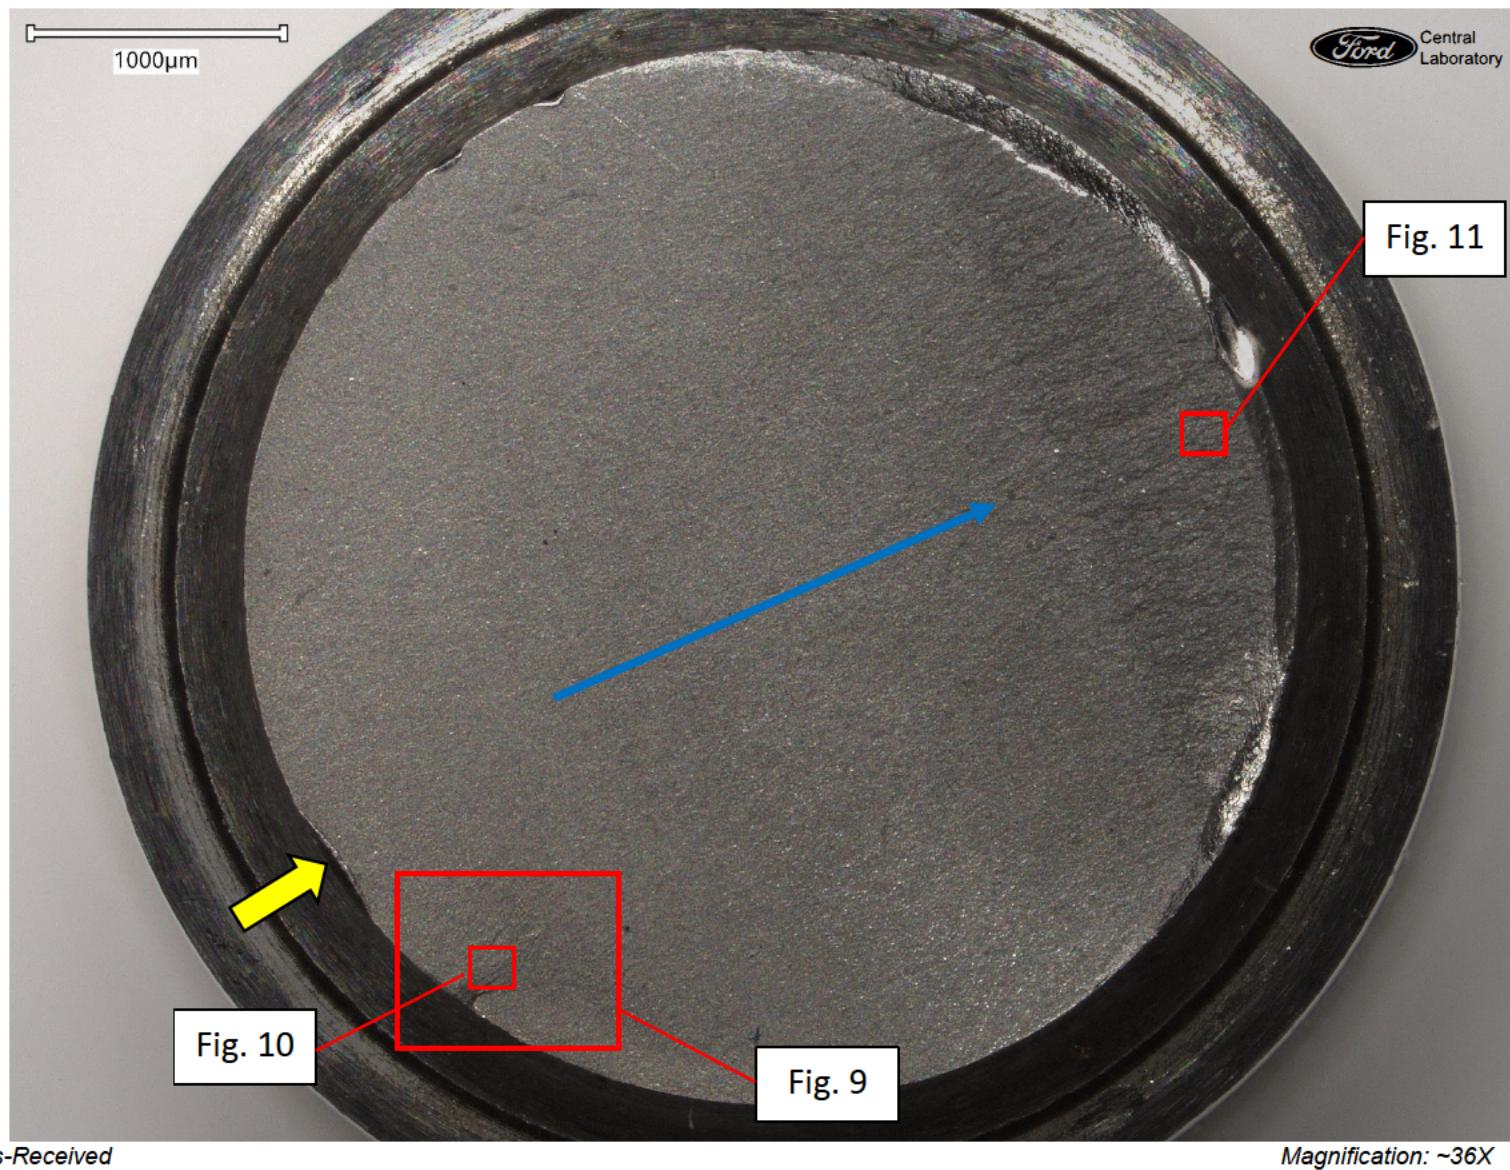
**Figure 6: Intake Valve – 12 – View of the fracture surface. The yellow arrow indicates the likely fracture initiation site. The blue arrow denotes the fatigue propagation direction.**

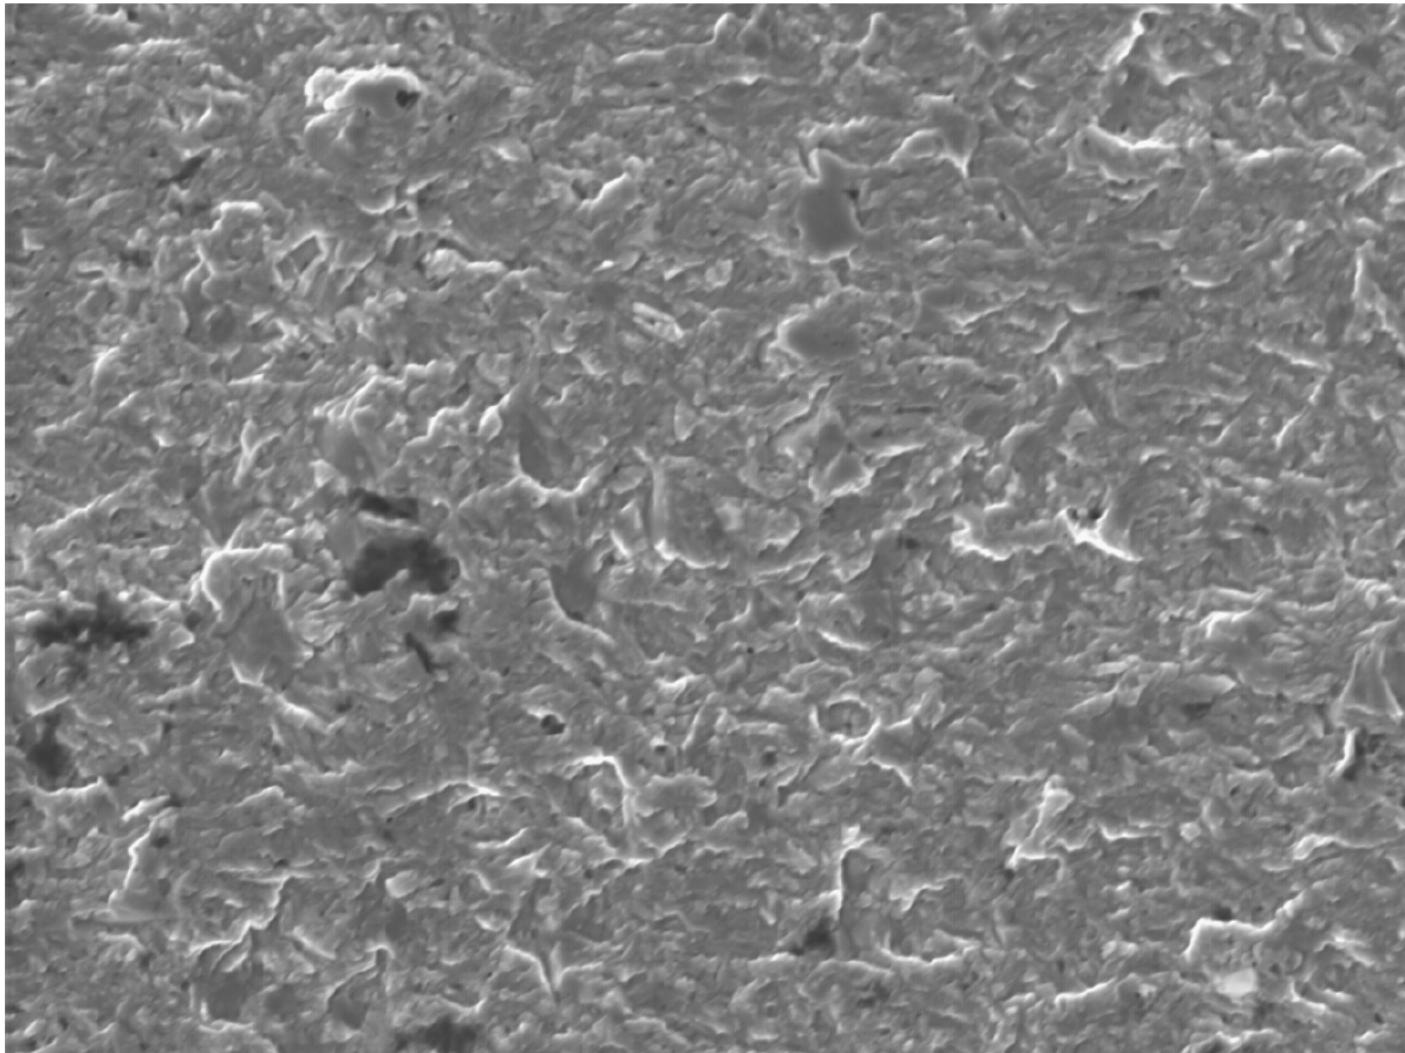
Figure 7: Intake Valve – 10 – Magnified SEM view of Figure 5 showing fatigue striations.

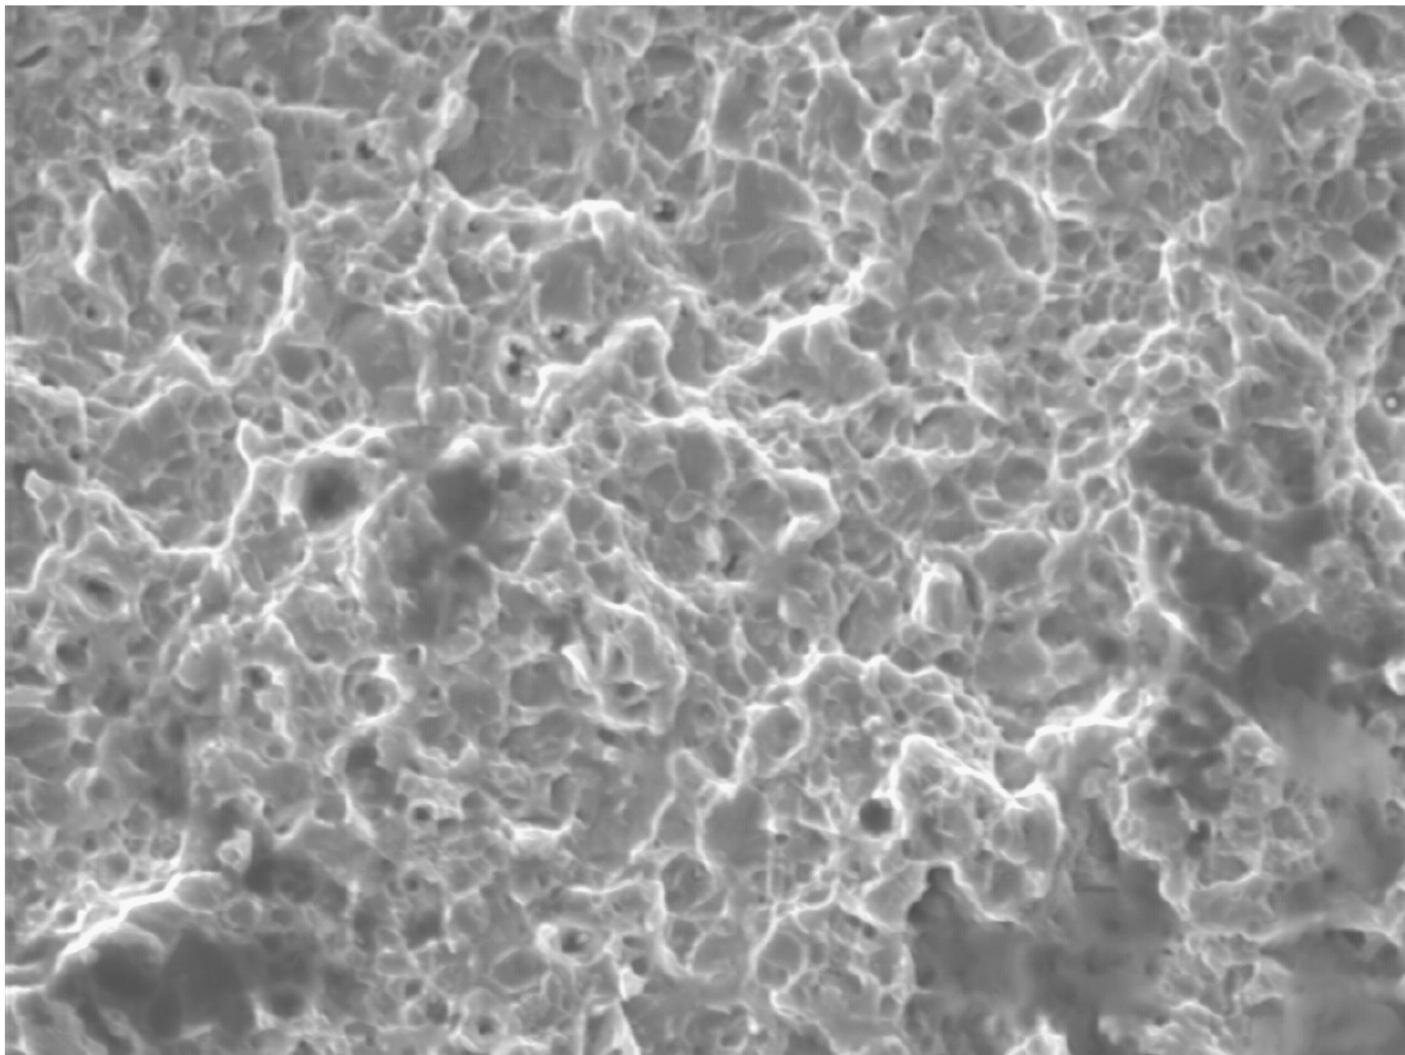
Figure 8: Intake Valve – 10 – Magnified SEM view of Figure 5 showing Micro-void coalescence (ductile dimples) in the final fracture region.

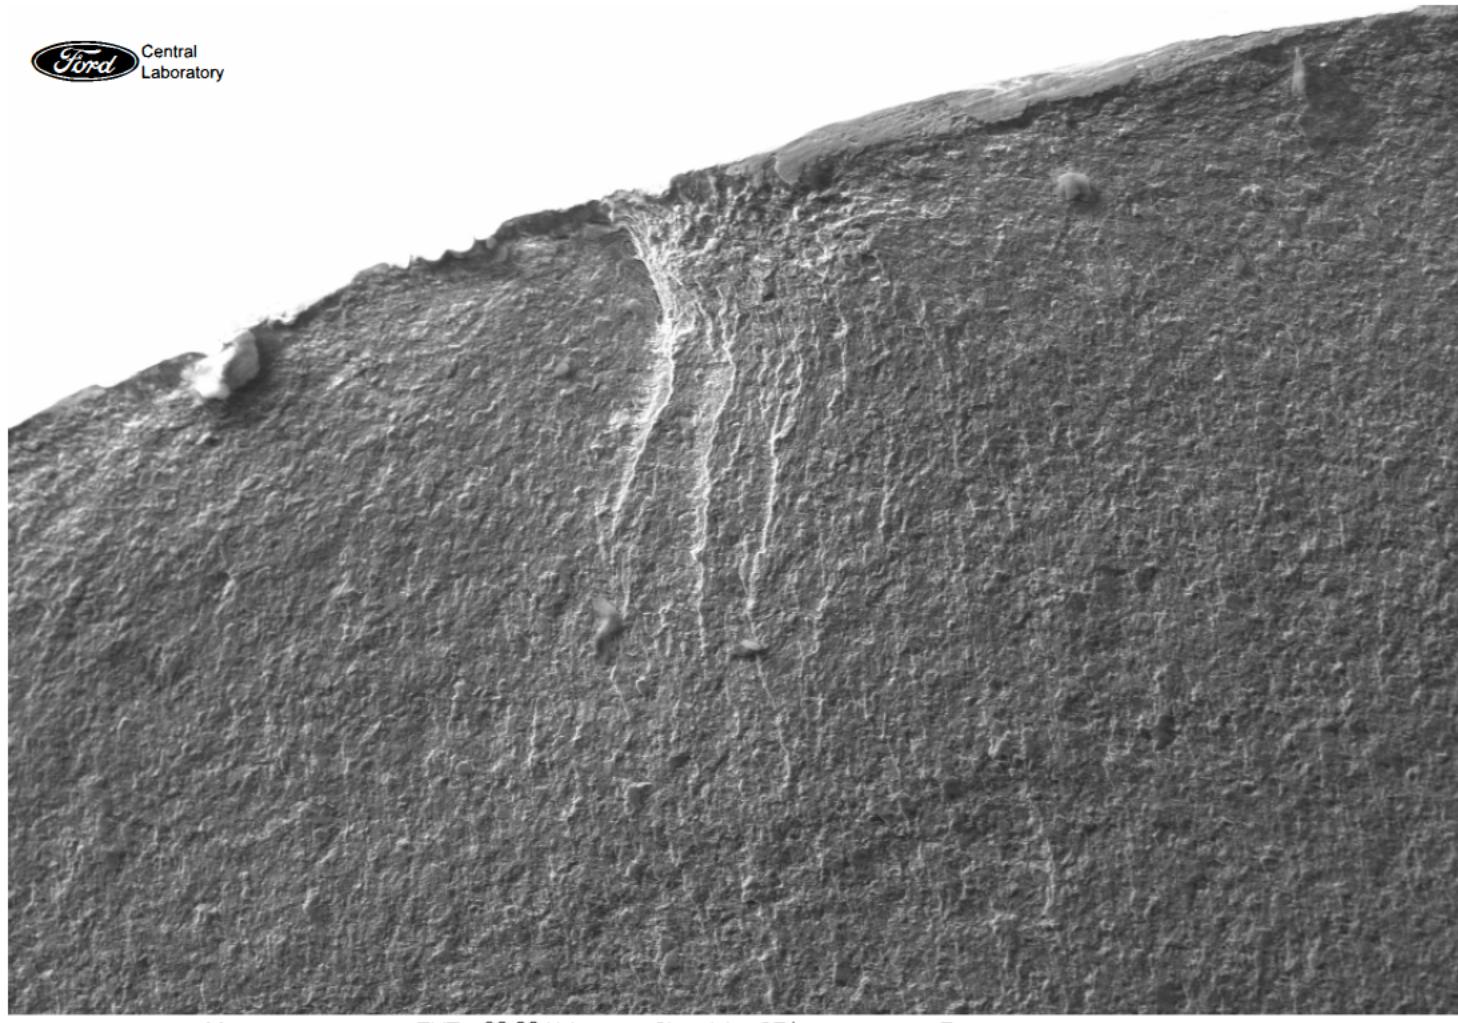
Figure 9: Intake Valve - 12 - Magnified SEM view of Figure 6 showing the initiation region.

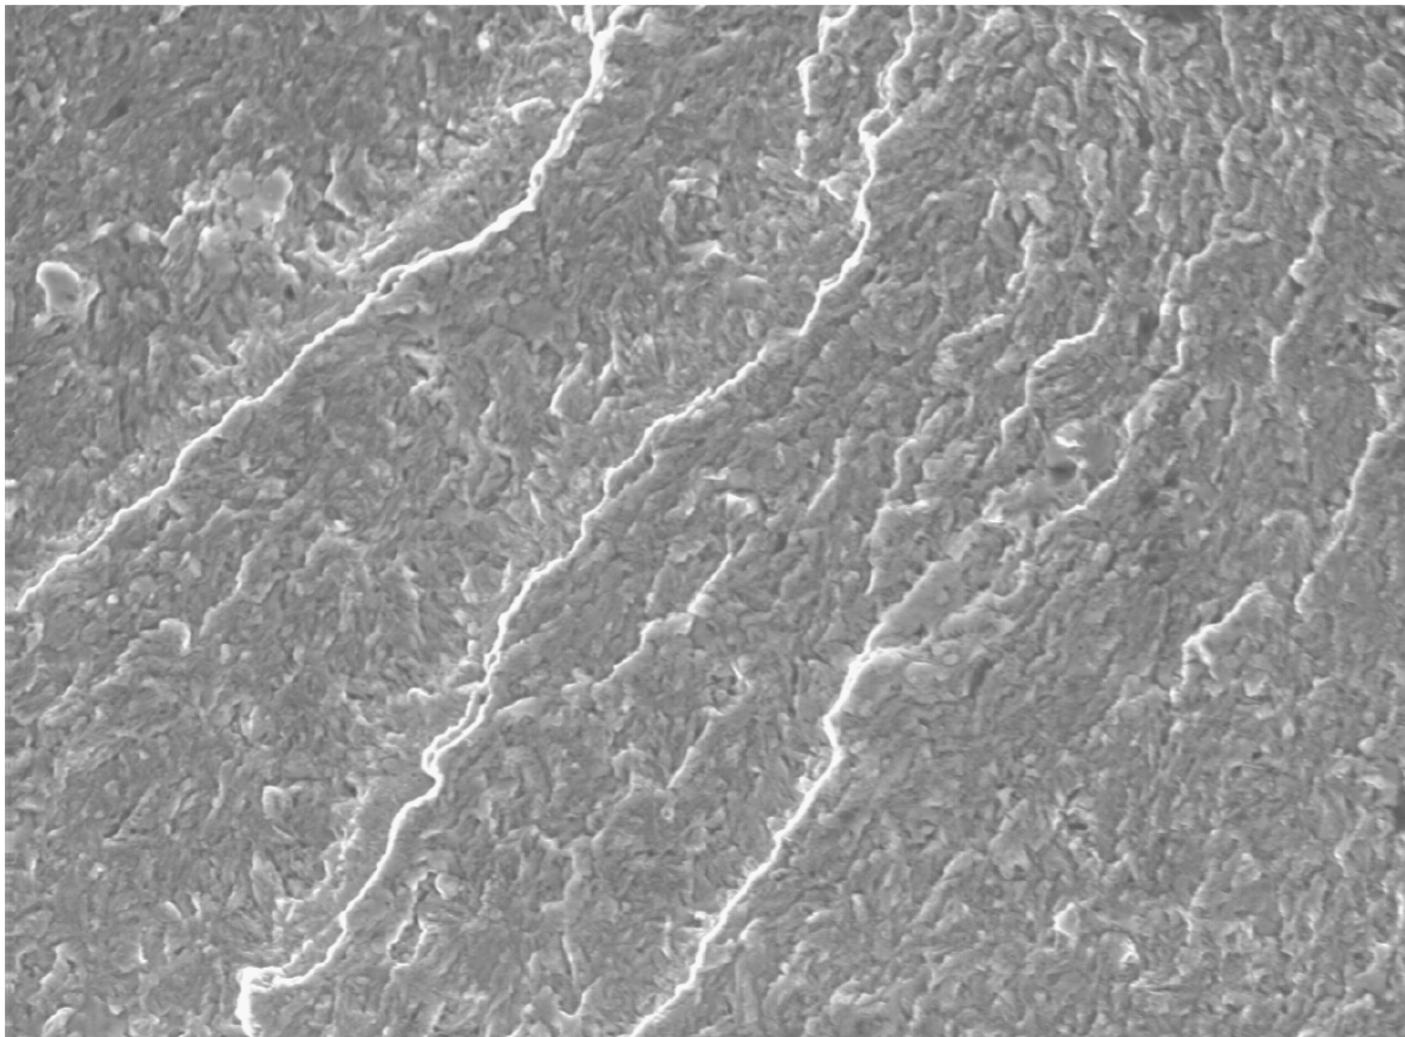
Figure 10: Intake Valve – 12 – Magnified SEM view of Figure 6 showing fatigue striations.

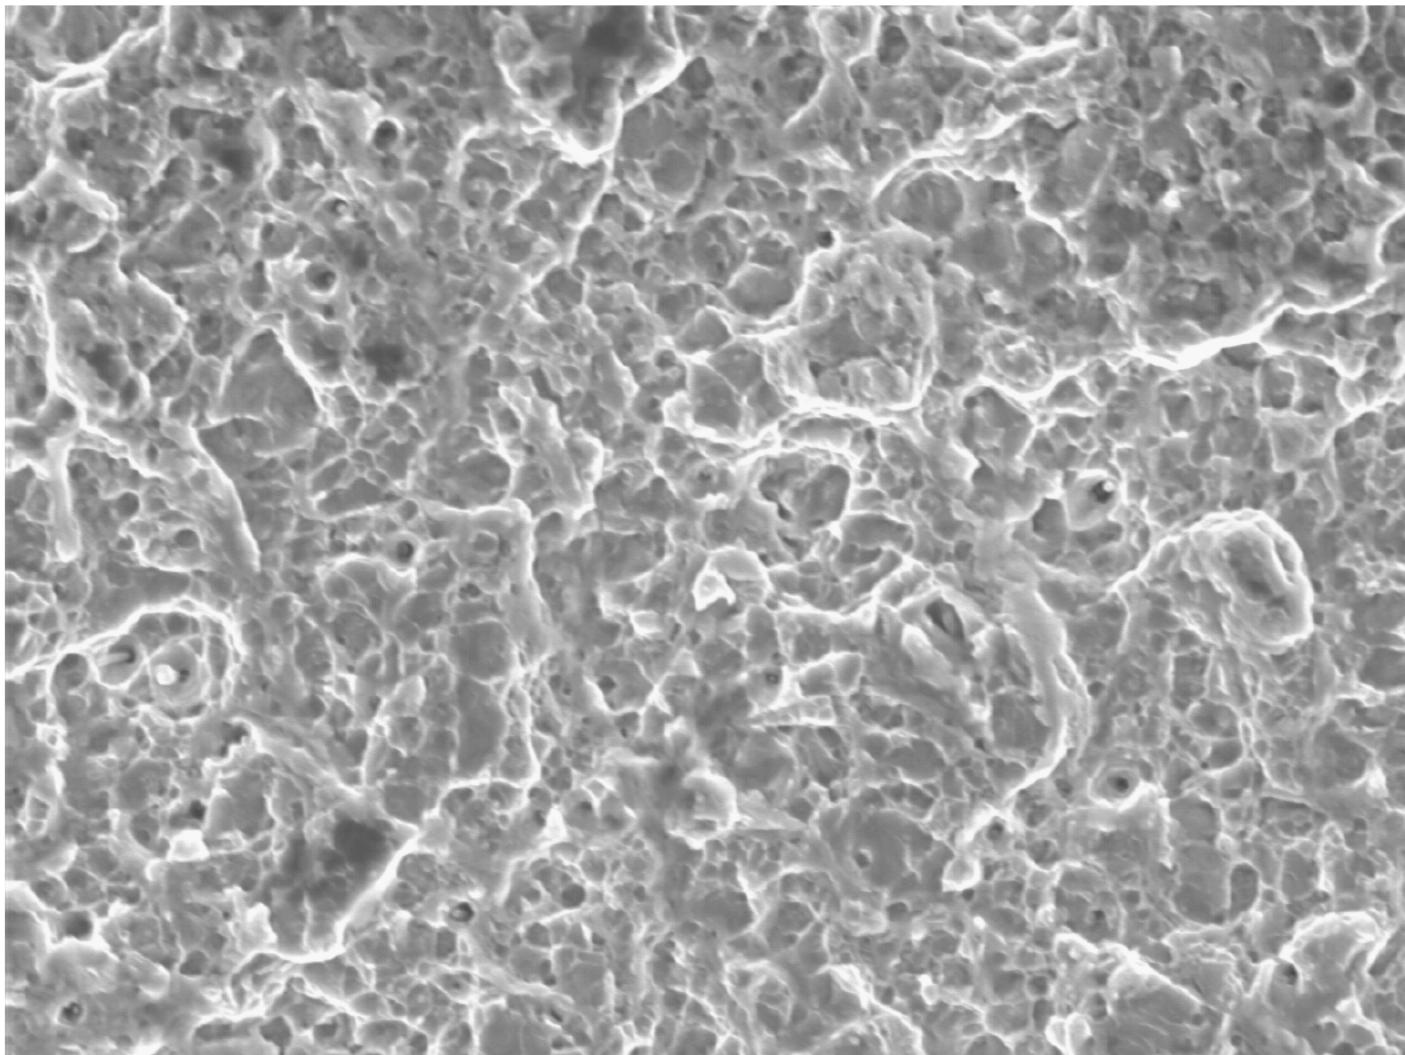
**Figure 11: Intake Valve – 12 – Magnified SEM view of Figure 6 showing Micro-void coalescence (ductile dimples) in the final fracture region.**

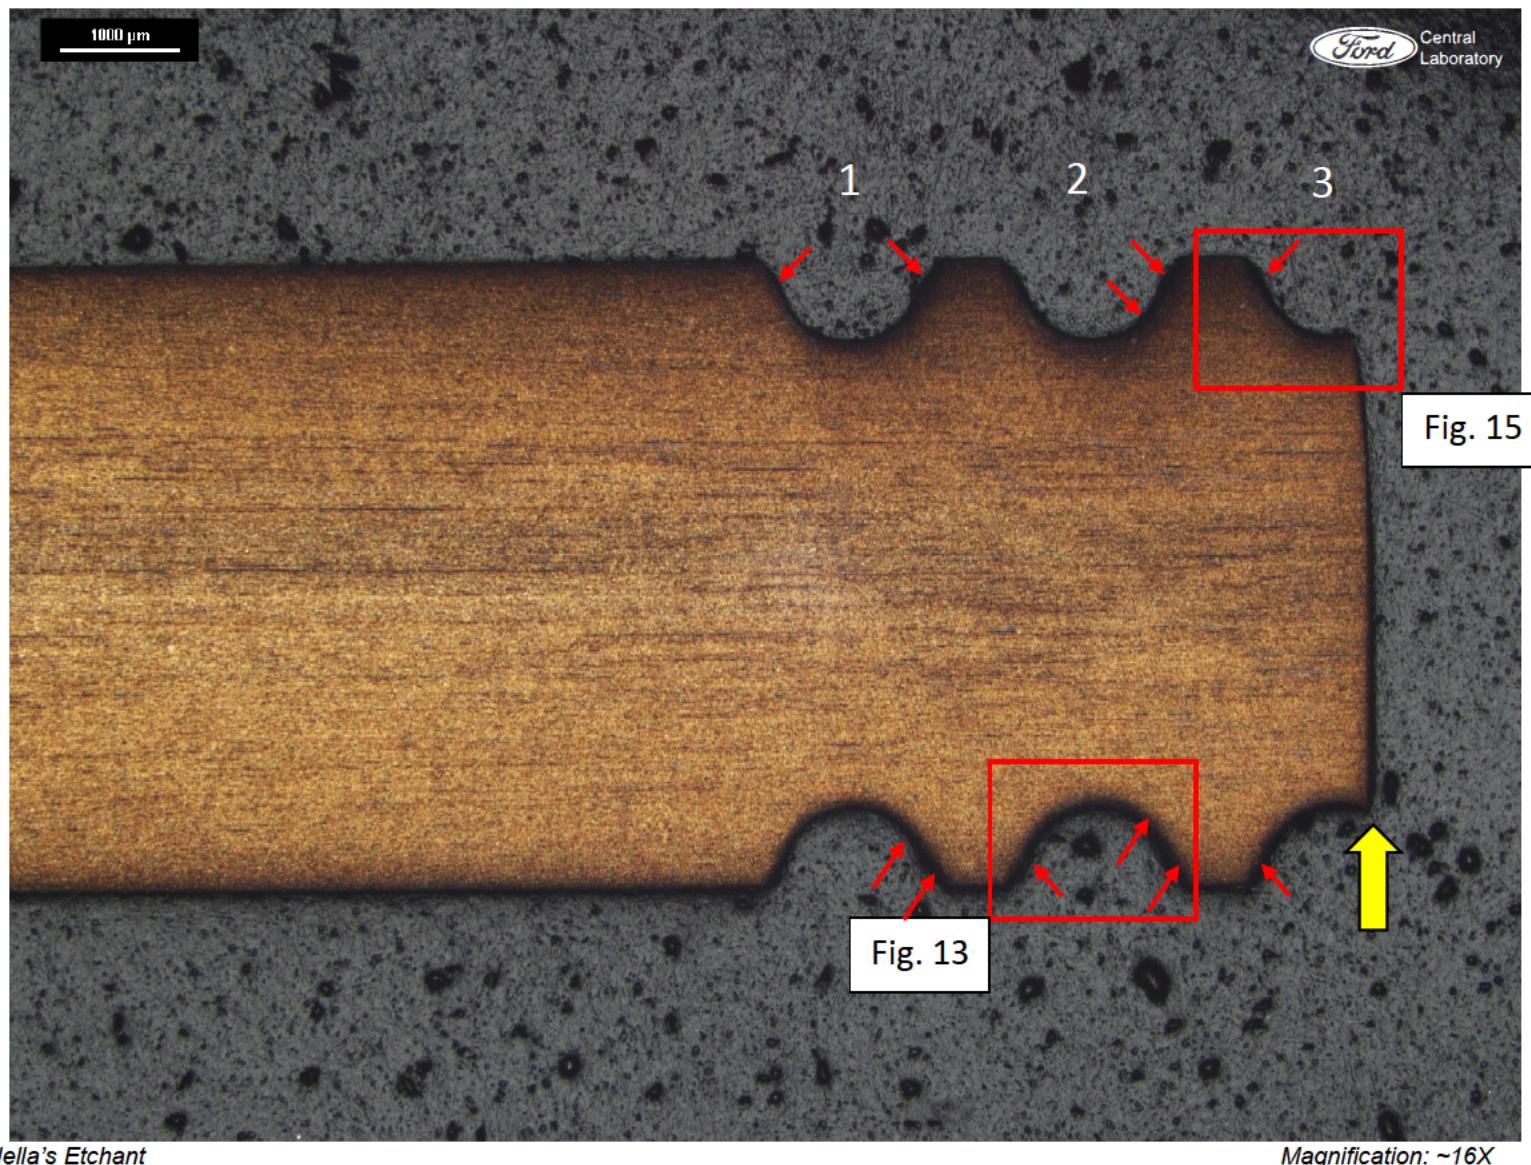
Valve 10 was selected for metallographic analysis due to the similarities in the fractures. The tip of Intake Valve 10 was longitudinally sectioned through the apparent fracture initiation site. The section was prepared for metallographic analysis in accordance with ASTM E3. The cross-section was etched with Vilella's etchant to reveal the microstructure in accordance with ASTM E407. Over tempering and retransformation products were observed in multiple locations along the keeper grooves as indicated in Figure 12. Retransformation products were observed near the root of the first and second keeper grooves from the tip (Figures 13 – 14). Representative micrographs of retransformation products present within the keeper groove at the corner near the major diameter are shown in Figures 15 – 16. The overall microstructure appears to be predominately tempered martensite (Figure 17).

**Figure 12: Intake Valve – 10 – Overall cross-sectional view of the fractured valve head showing areas of interest. The red arrows denote the locations where retransformation products were observed. The yellow arrow indicates the fracture initiation site.**
