# Central Laboratory Request System (CLRS – NA)

## 3252-2021 Nano Engine Valve Fracture

**Subject:** 2021 Nano Engine Valve Fracture

GPID: QLT14  
Part Number: JT4E-6507-AB  
Specification: SAE J775 K14072  
Supplier: Eaton

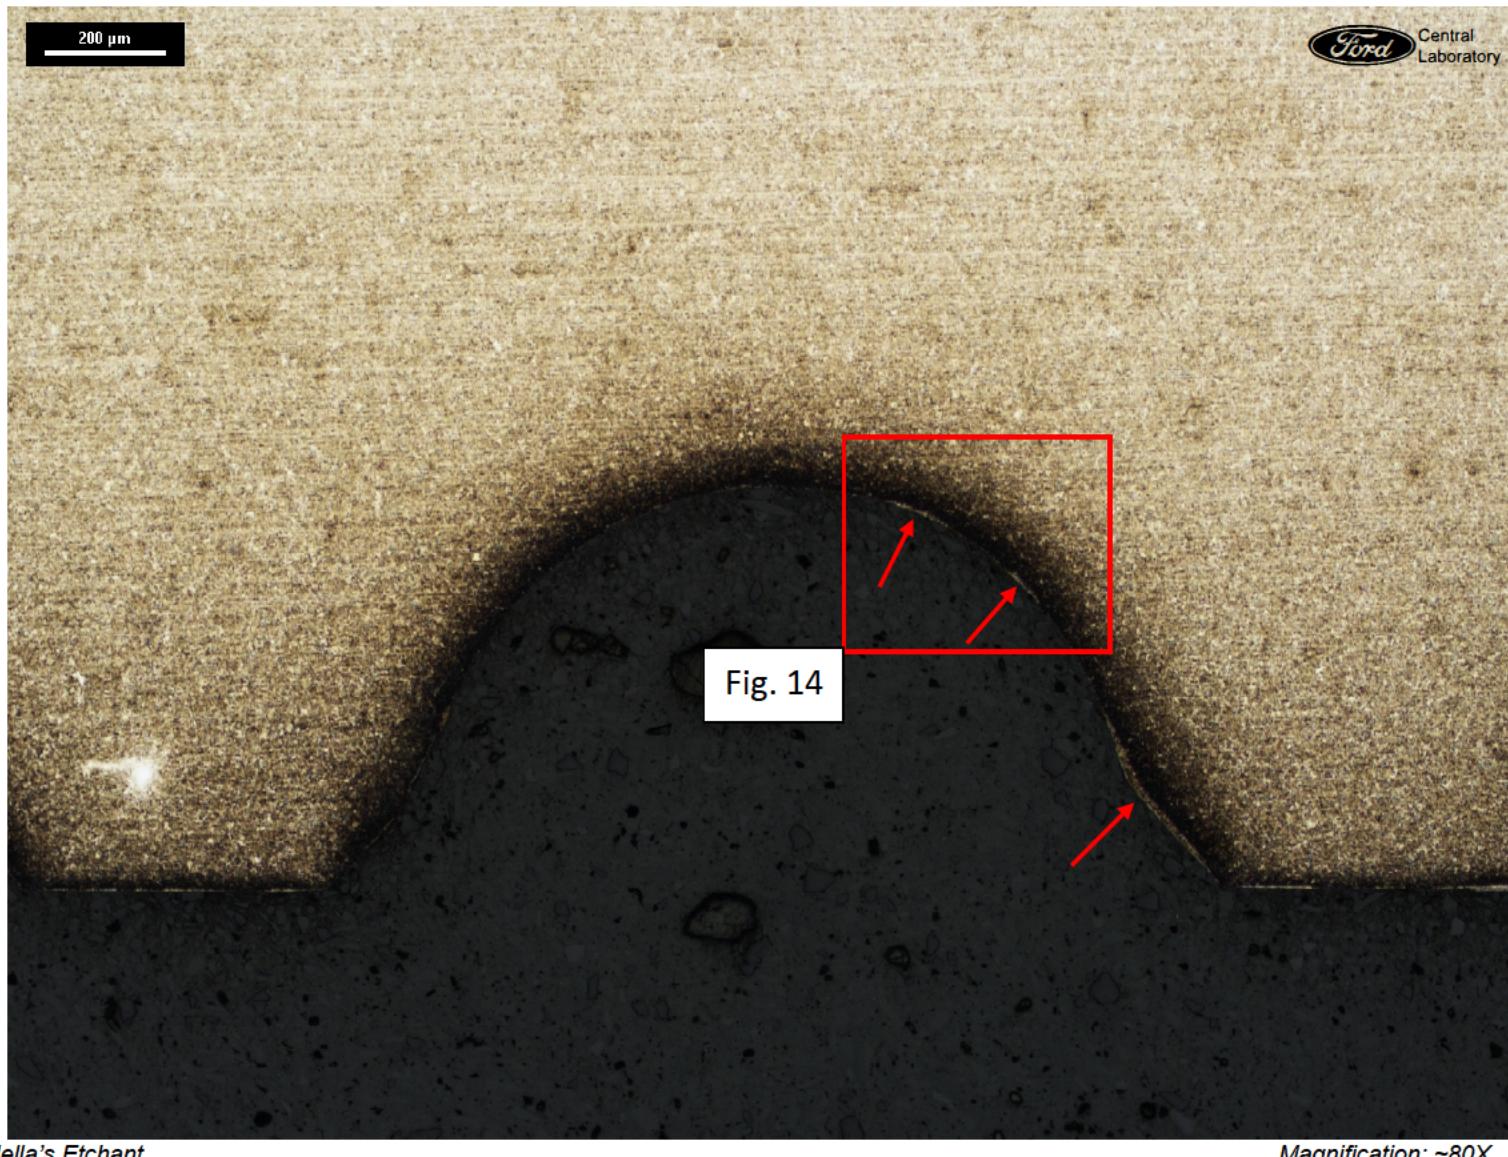
**Figure 13: Intake Valve – 10 – Magnified cross-sectional view of Figure 12 showing over tempering (dark phase) and retransformation products (white phase) indicated by the red arrows.**

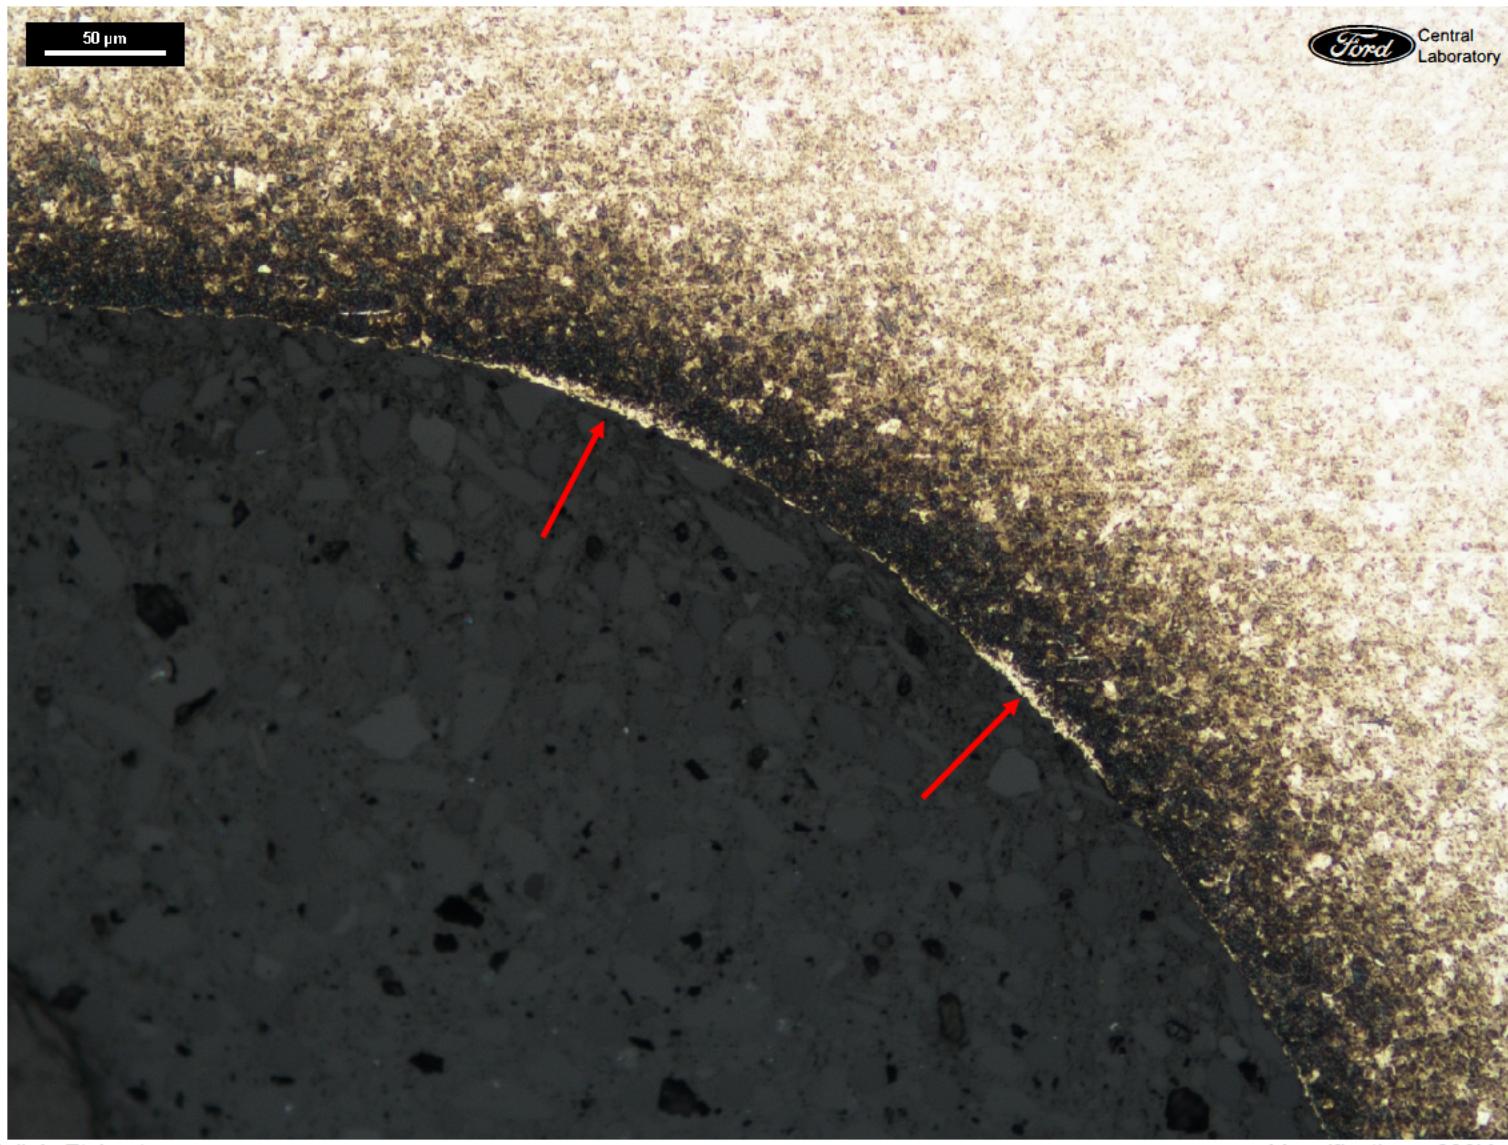
**Figure 14: Intake Valve – 10 – Magnified cross-sectional view of Figure 12 showing retransformation products (white phase) within the keeper groove, indicated by the red arrows.**

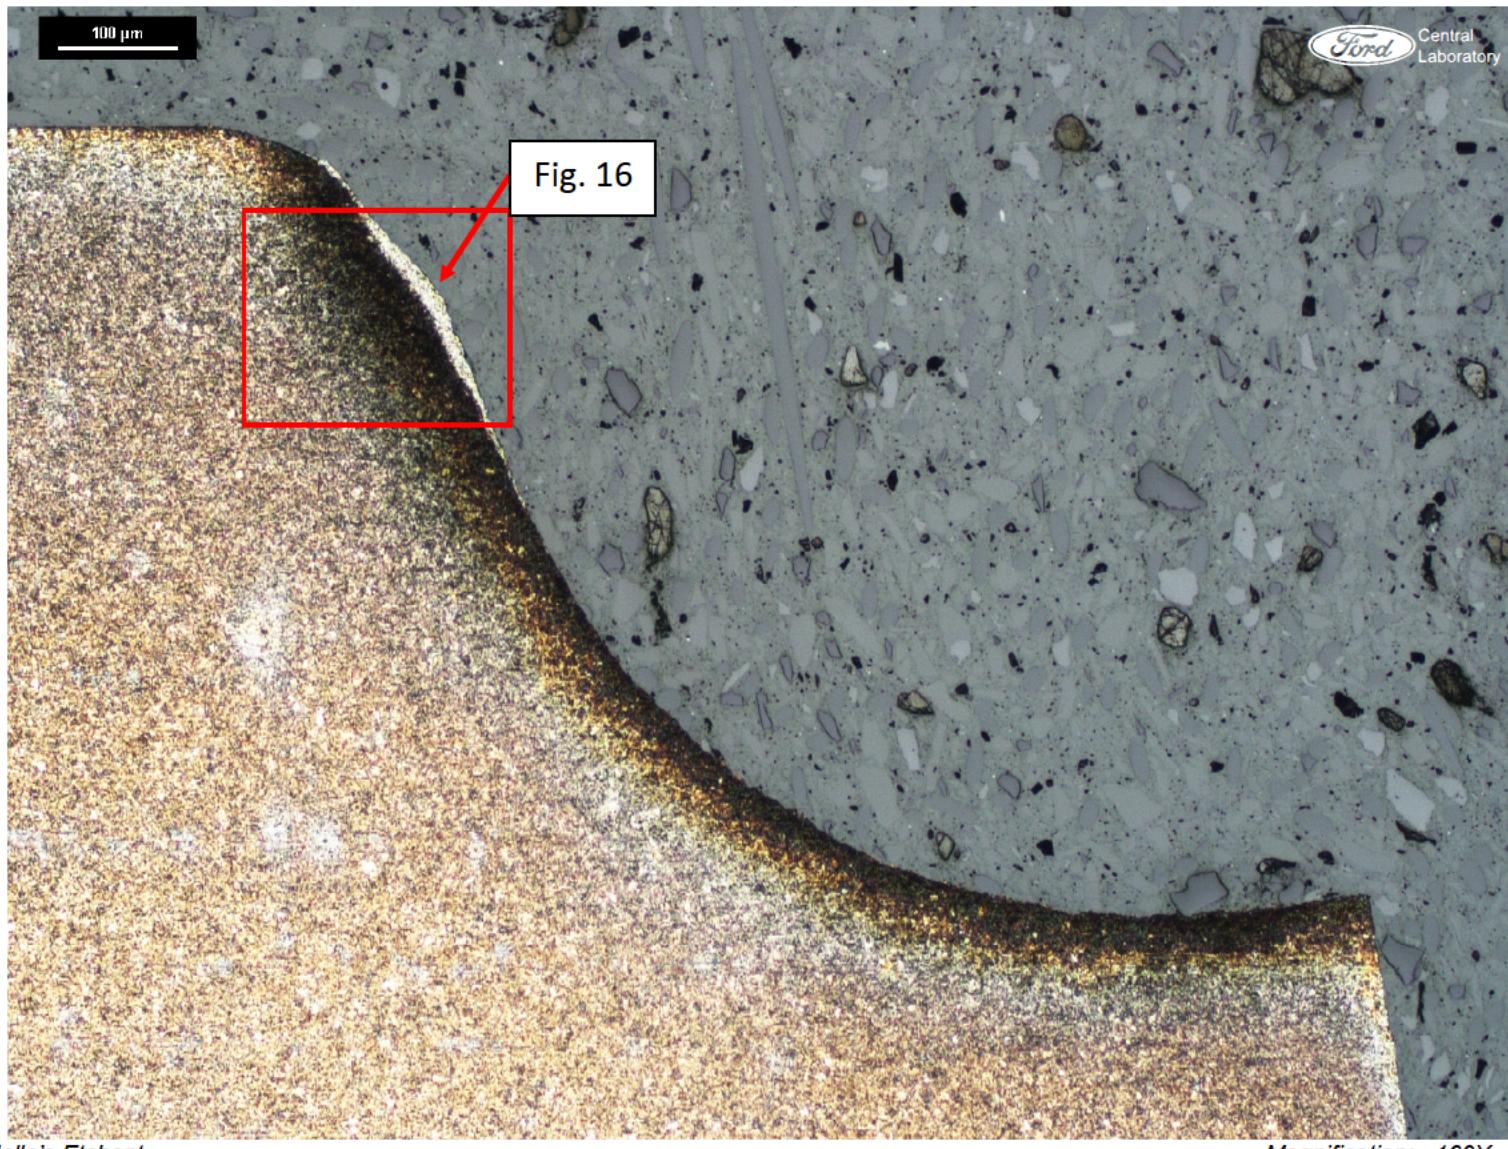
**Figure 15: Intake Valve – 10 – Magnified cross-sectional view of Figure 12 showing over tempering (dark phase) and retransformation products (white phase) indicated by the red arrow.**

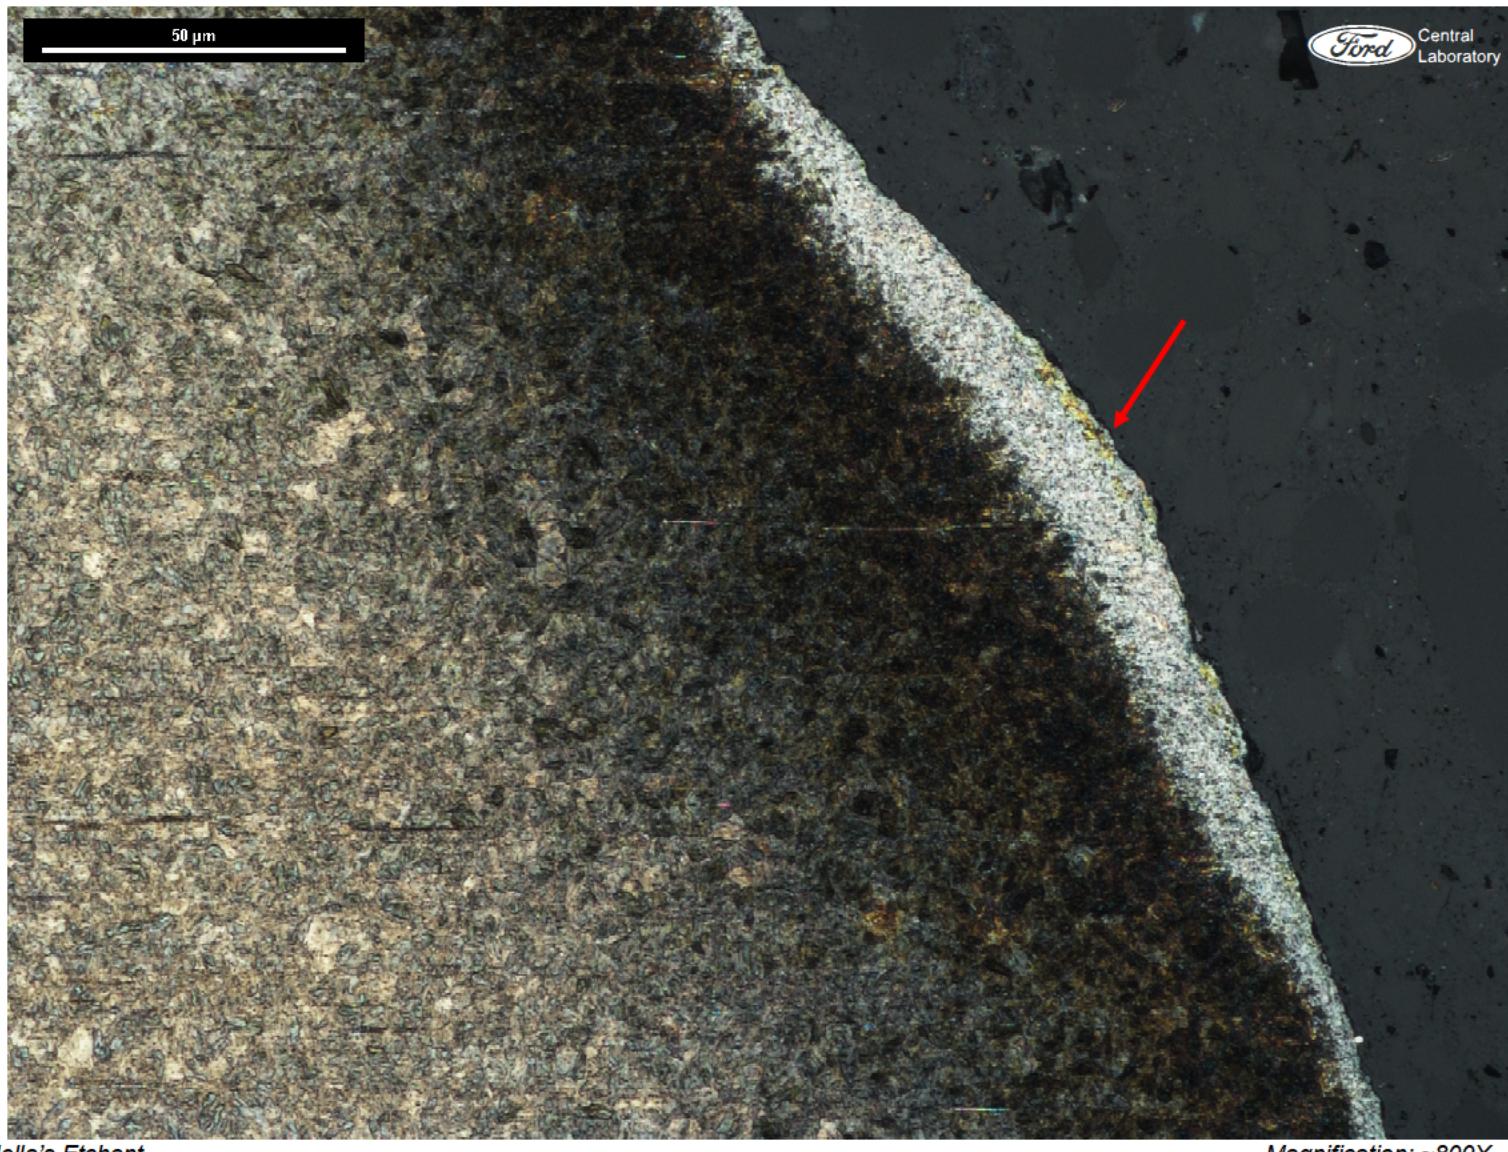
**Figure 16: Intake Valve – 10 – Magnified cross-sectional view of Figure 15 showing over tempering (dark phase) and retransformation products (white phase) indicated by the red arrow.**

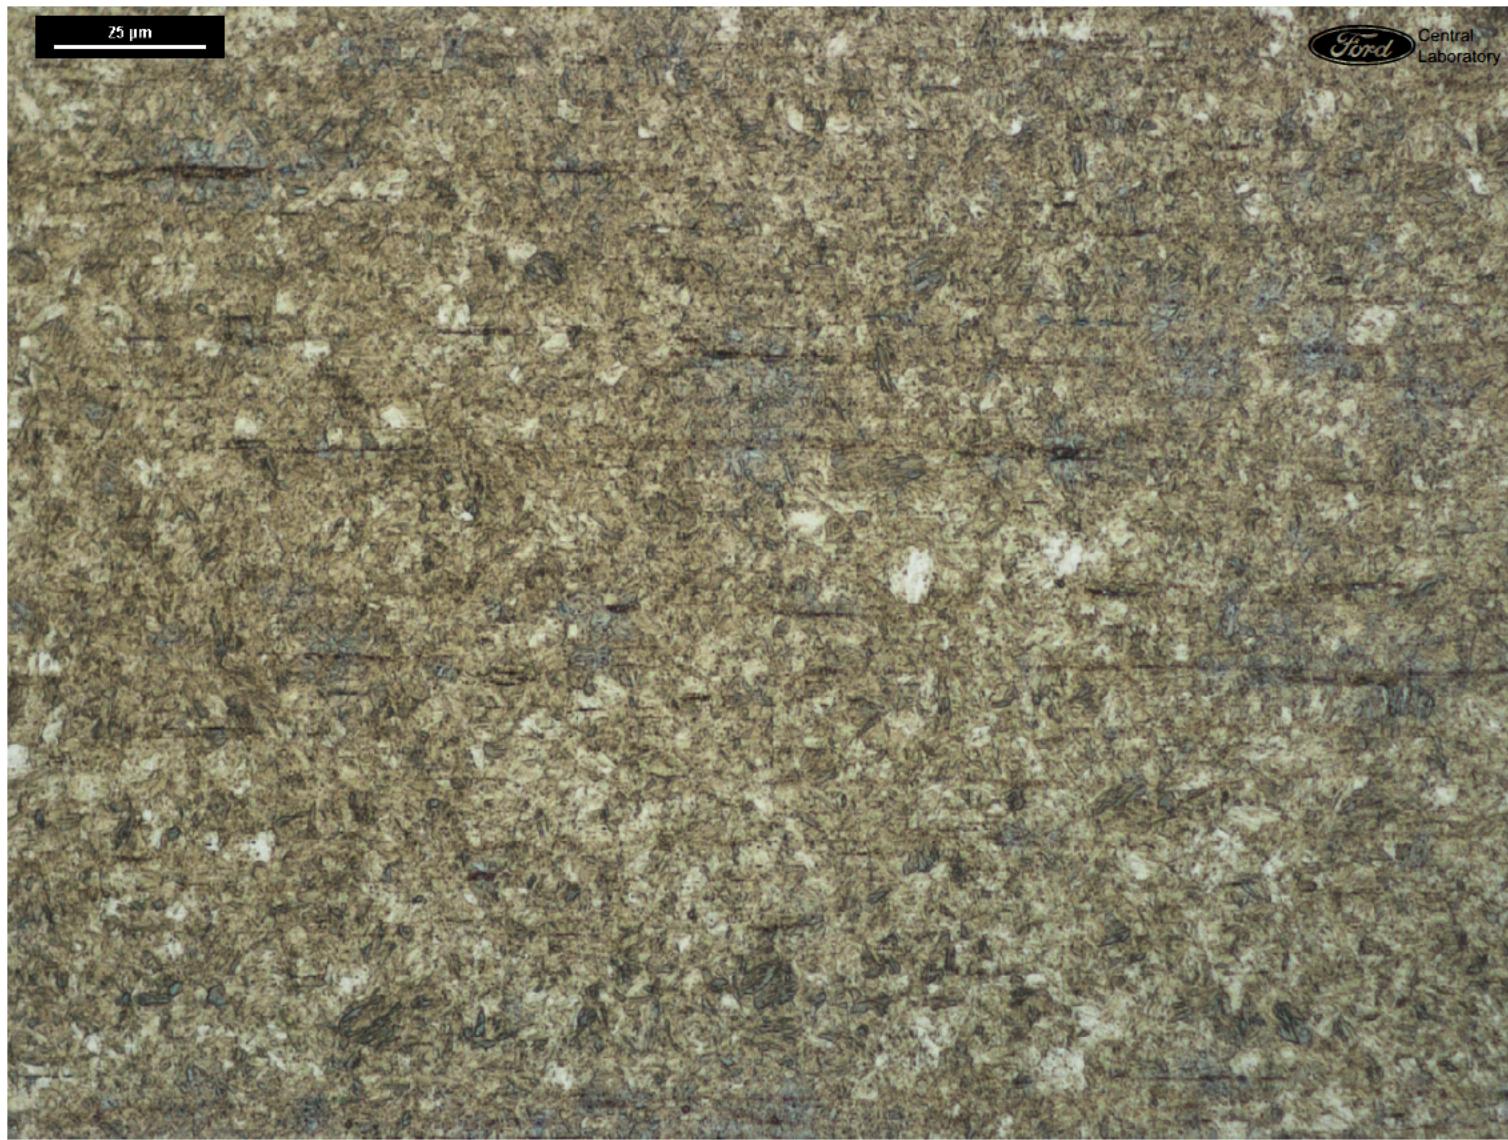
**Figure 17:** Intake Valve – 10 – Representative cross-sectional view showing the core microstructure consisting of predominately tempered martensite.
