Materials and Basic Processes Report

MAT # 21279_07515
Prepared By E. Vincent
Work Done By D. Osborne
Date 13 Oct. 2021
Pages 1 of 5

Ford returned 1 intake valve (P/N 372237) fractured thru the 3rd keeper groove. The valve was in the intake cylinder #5 position from VIN# 2FMPK4AP5 [REDACTED] with 388miles. The valve was returned from the Capital Ford dealership. The intake valve date code is 21-C-1.

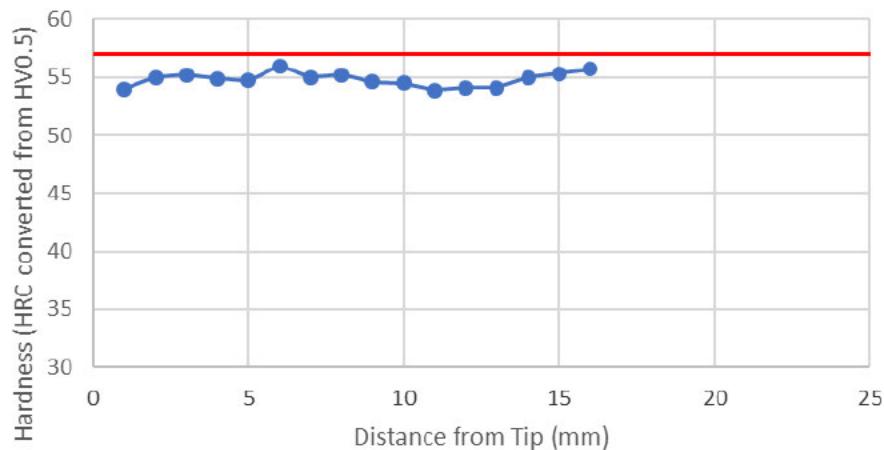
Tip Hardness Profile

Figure 3: Tip hardness profile measured HV0.5 and converted to HRC. The valve tips exhibit a typical induction hardened profile.

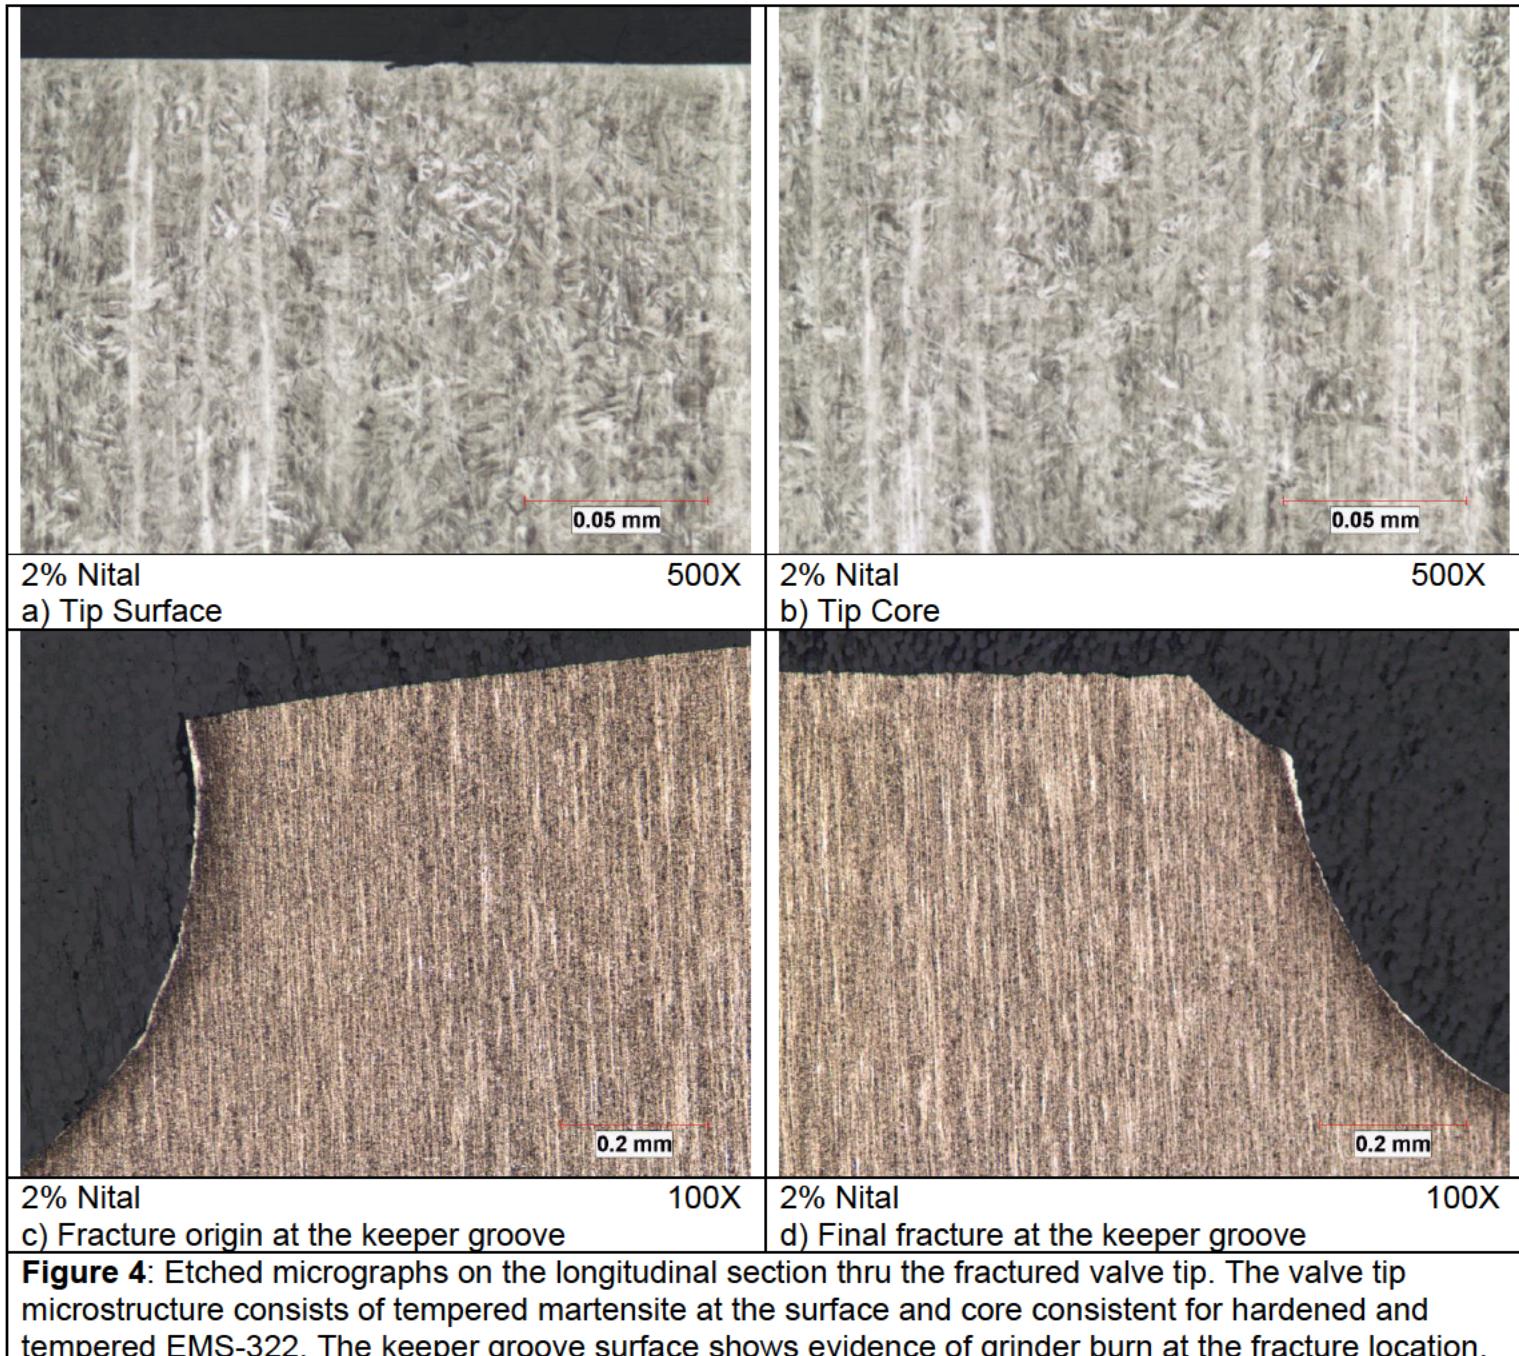
Figure 4: Etched micrographs on the longitudinal section thru the fractured valve tip. The valve tip microstructure consists of tempered martensite at the surface and core consistent for hardened and tempered EMS-322. The keeper groove surface shows evidence of grinder burn at the fracture location.
