CQIS DETAIL REPORT

VEHICLE: 2021 BRONCO 4X4,4DR,MPV VIN: [REDACTED]
Engine : 2.7L DOHC 4V DI GT V6 GAS/FFV Odometer: 4,488 MILES
Operating Environ: WCC :
Vehicle Use : Rsp. Act:

SYMPTOM: 4 40 1 02 START/RUN/MOVE STARTING
NO CRANK ALWAYS

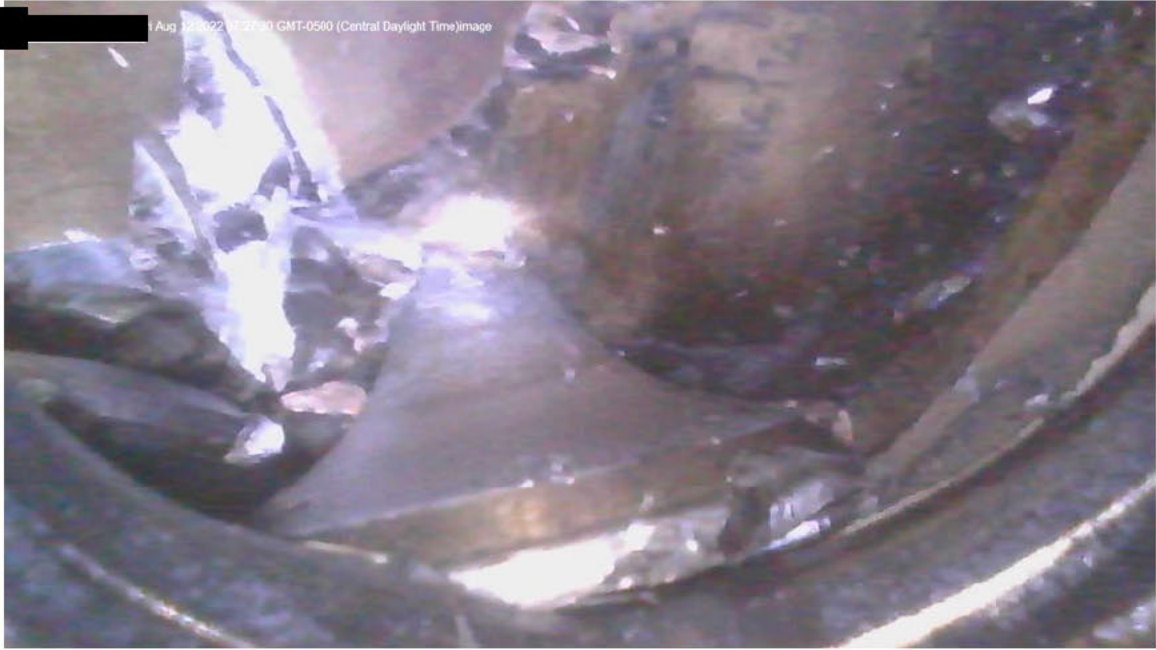
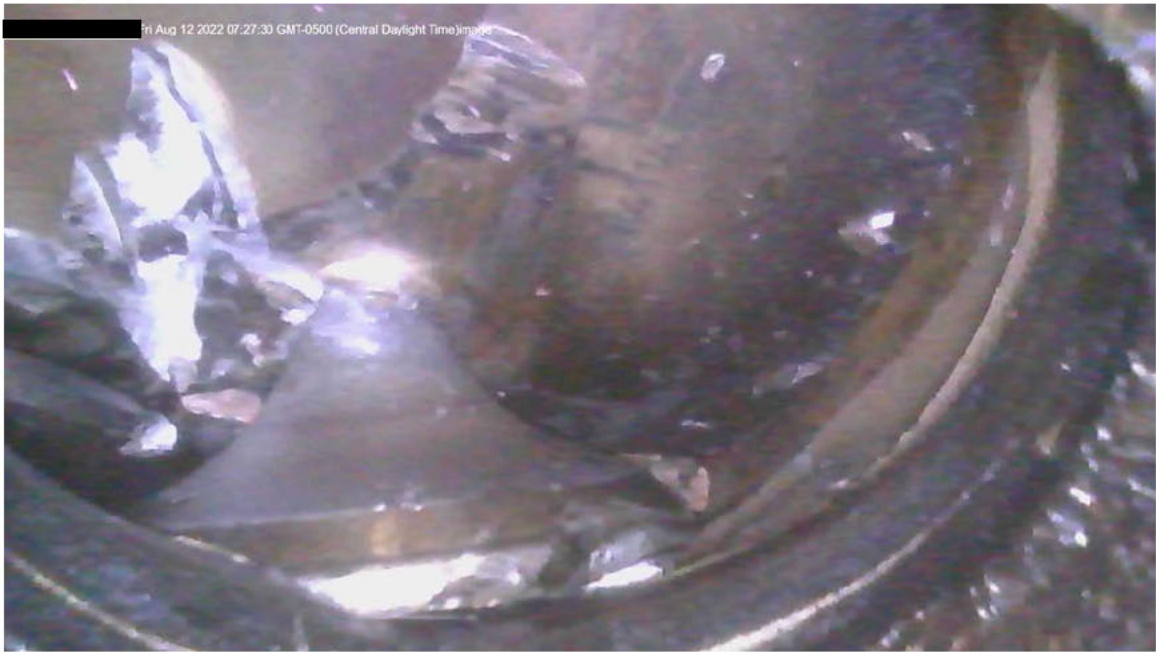
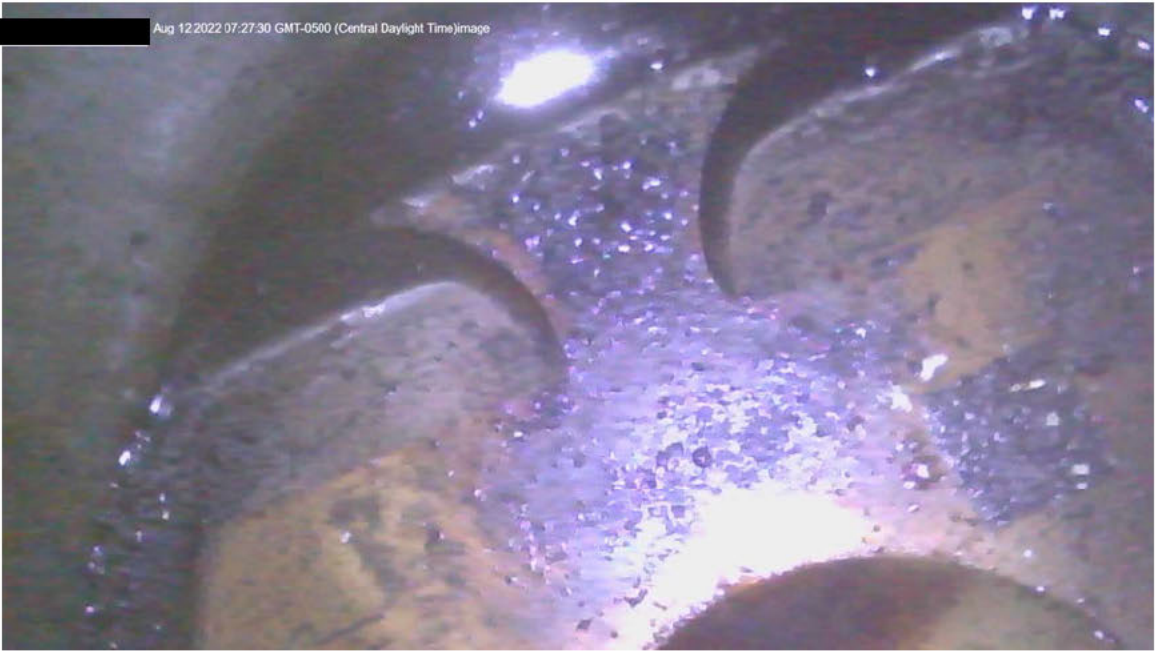
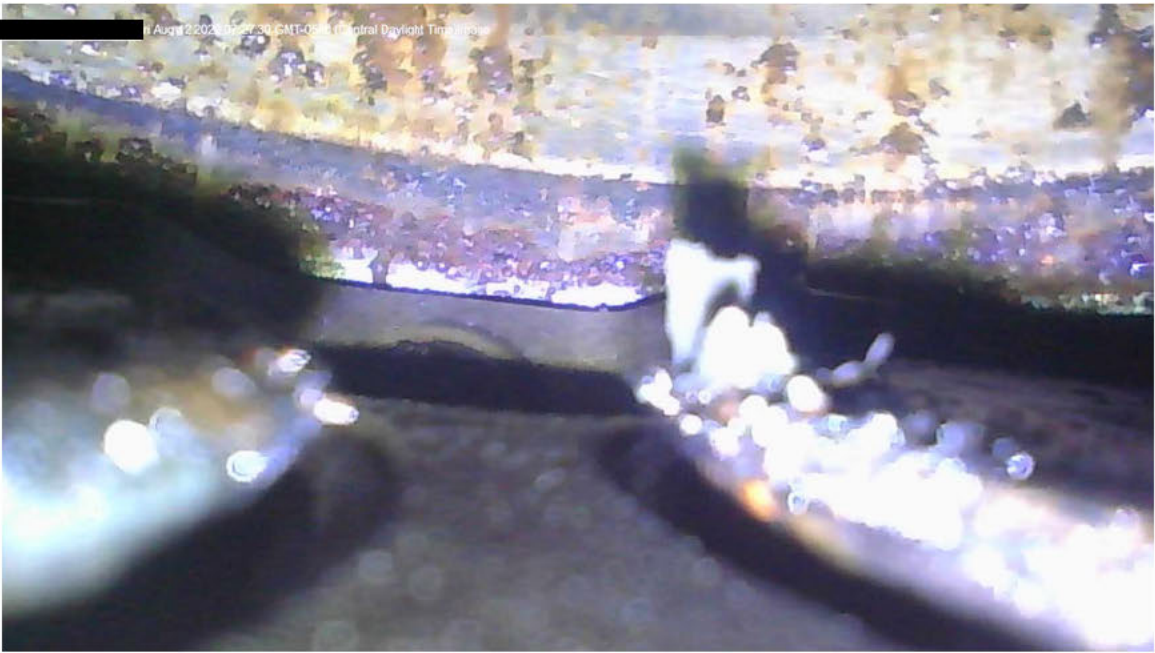
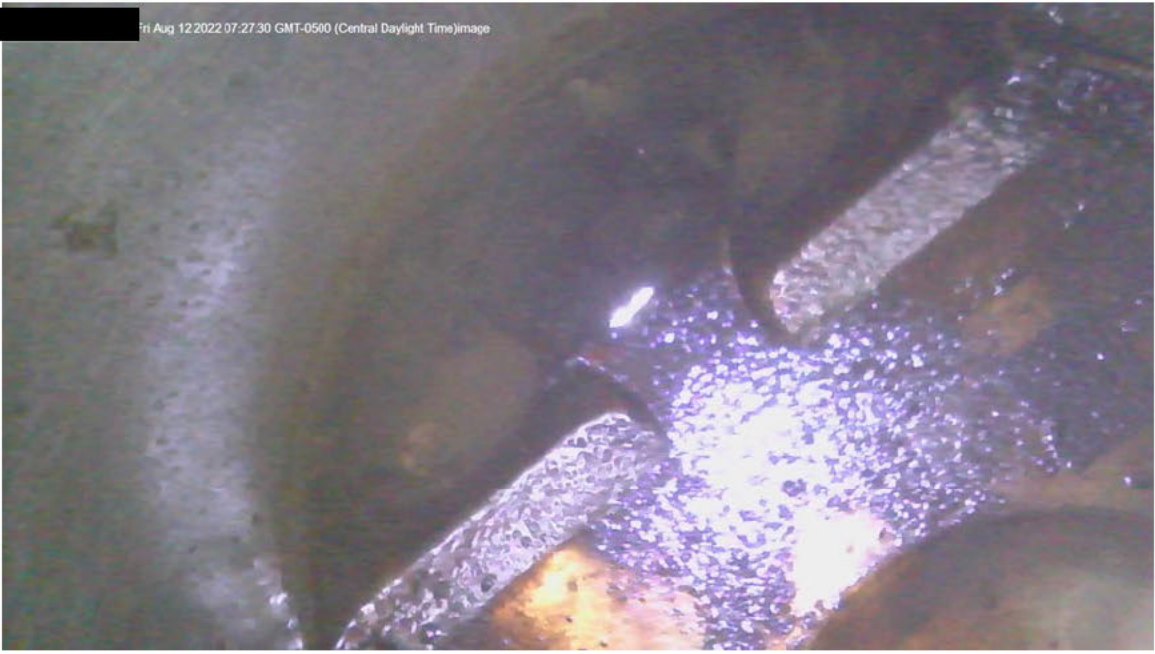
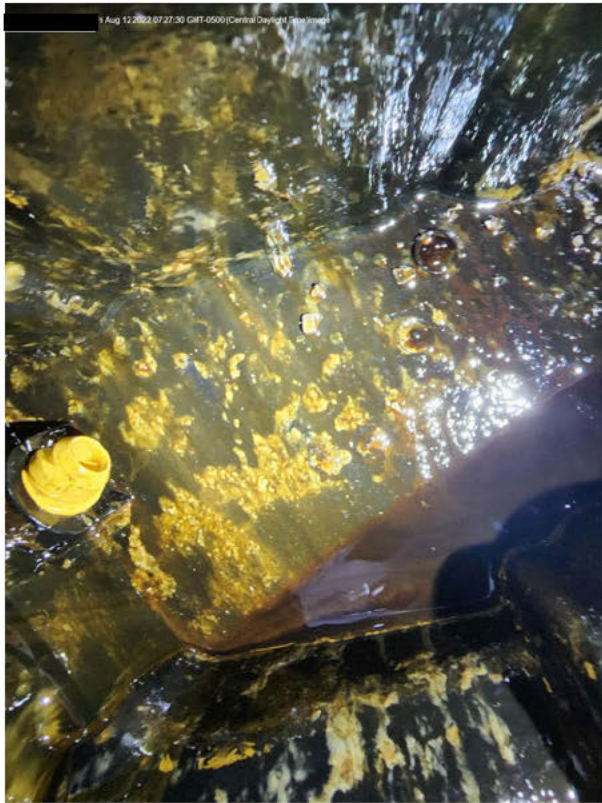
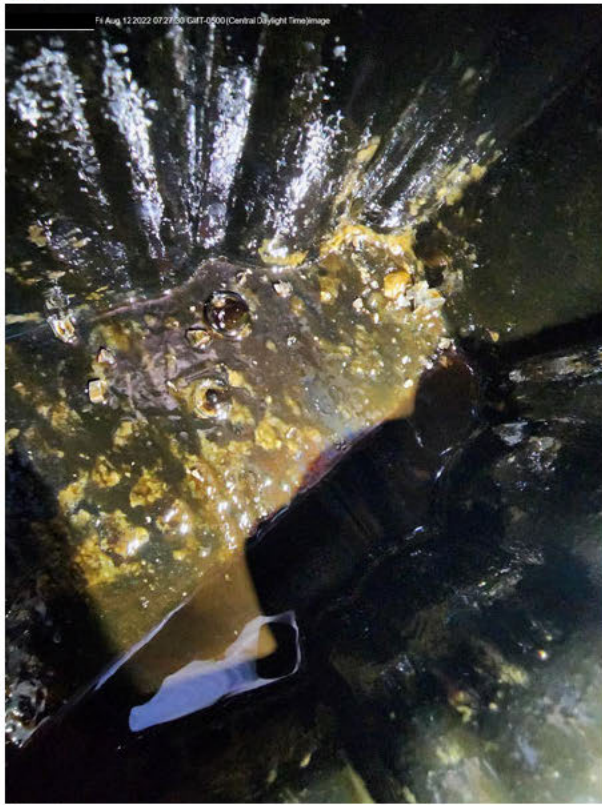
CONCER 08/12/2022 08:35AM GTCGCQIS
Ive gotten around to tearing down to find root cause- I found that
cylinder 6 dropped and intake valve- the valve is jammed against the
cylinder head and piston. I removed oil pan- and the valve stem, and a
ton of chunks and metal debris is inside the pan. removed exhaust from
turbos to borescope converters- I don t see any build up in converters
(seems as it wasn t ran long enough to do the significant damage to
exhaust system) But i do have oil and coolant dripping out of the
turbo. Removed turbo s- inspected turbo filters and feed line- i have
some sludge (coolant and oil mixture) on the filters- basically the
same stuff found in the pan. I also have the turbo s filled with

--TYPE-- ----- COMMENT TEXT -----
coolant/ oil. pictures have been taken and will be uploaded. Therefore coolant/ oil. pictures have been taken and will be uploaded. Therefore vehicle should qualify for LTIS bottom end and top end damage. Converters look good. but i believe turbos should be replaced.

RECOMM 08/12/2022 09:04AM WSMITH46
Harley, thank you for the update and photos. Inspect the turbocharger oil feed tubes, if any metal debris is present or contaminated oil the turbocharger bushings have been compromised and the turbocharger/s will need to be replaced. If no contamination or metal is present follow the WSM 303-04D Diag & Testing PPT C, in specific C6 for inspection and free spin testing. Please be sure to replace the engine oil cooler and the intake manifold during this repair. Walt S. Technical Assistance Center As your dealership is equipped with the See What I See (SWIS) headset, if additional technical assistance is required and a SWIS session would be beneficial (live video or picture would help), click <A target= blank

RECOMM 08/12/2022 10:45AM [REDACTED] FSE) MSS - FCSD - MID ATLANTIC REG
Hi Harley, Thank you for the update. Since the oil supply lines are contaminated, it would be advised to proceed with replacement of the turbochargers, oil supply lines and filters. In addition to replacing the long block, intake manifold and components listed above, it would be advised to replace the CAC if any metal debris is found in it.
