| Honda Motor Co.<br>Light Vehicles | NHTSA Report for TREAD Act | NHTSA Reporting Period: |

| Brief Description : steering is sticking/binding when driving | | |

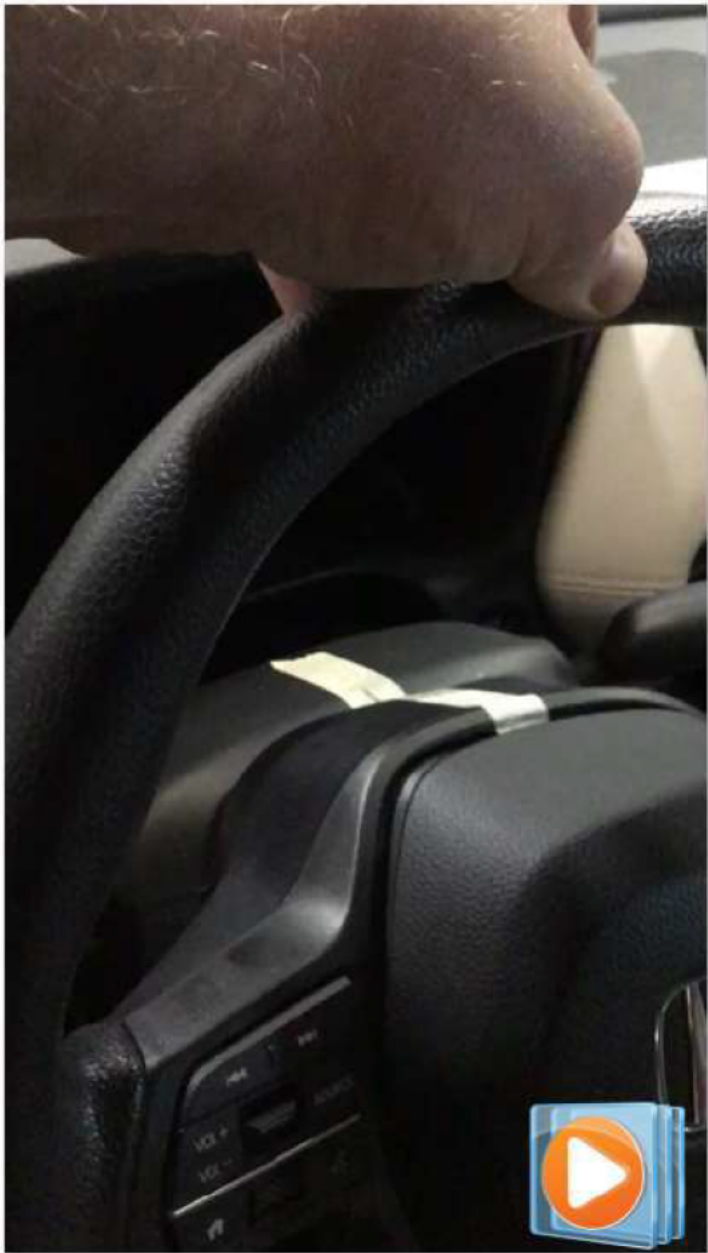
1697129394508.MO  
V

**Complaint / Symptom :**  
Steering feels abnormal feels like steering is catching

**Probable Cause :**  
Faulty steering rack

**Corrective Action :**  
Replace steering rack/motor assembly

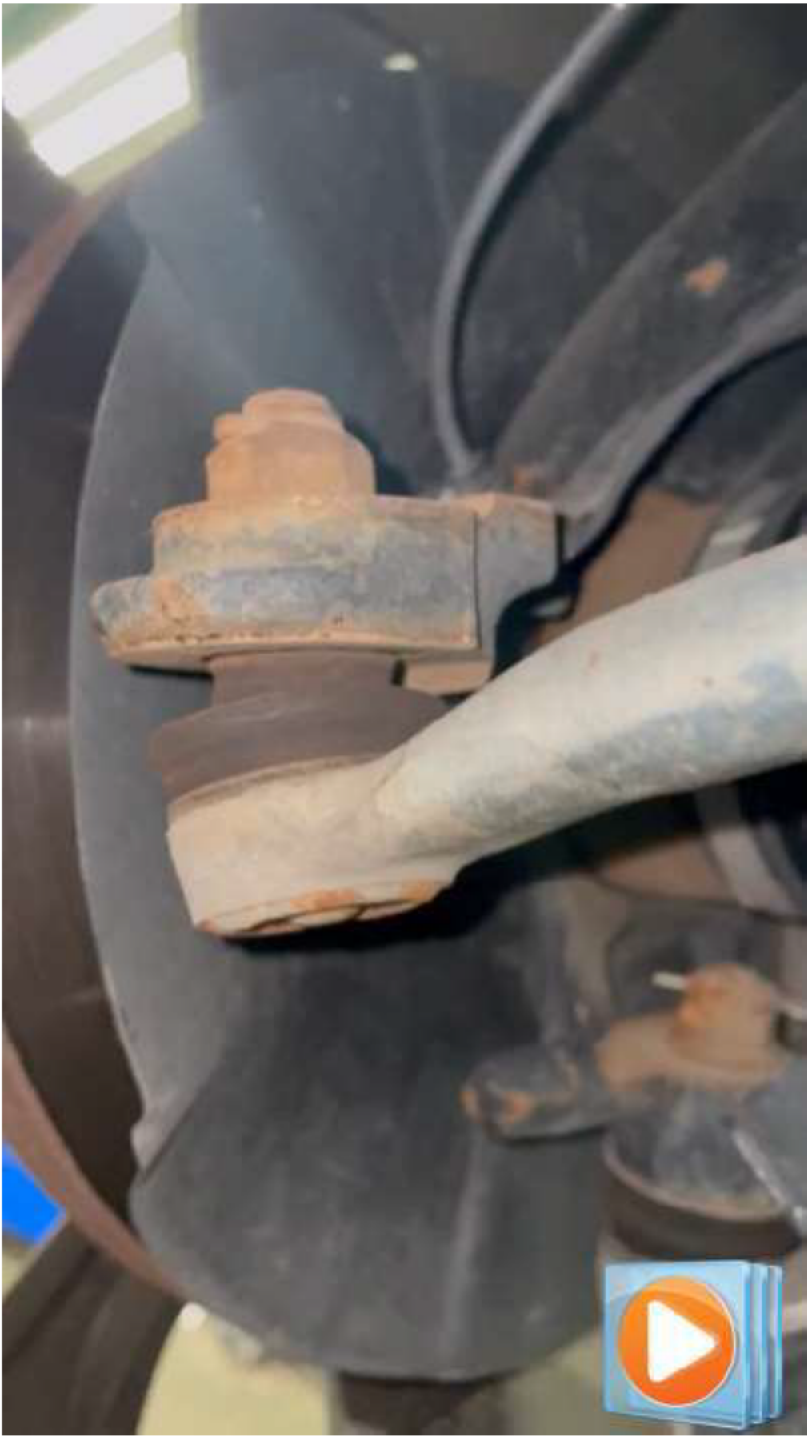
1685740018071.MOV

**Complaint / Symptom :**  
Clunking in the left front when steering

**Probable Cause :**  
Tie rod nut loose. Backed off to cotter pin left front

**Corrective Action :**  
Tighten and noise,play gone. Ordered tie rod end back ordered
