Technical Service Bulletin

GROUP	NUMBER
CAMPAIGN	23-01-060H
DATE	MODEL(S)
JULY 2023	IONIQ 5 (NE1) IONIQ 6 (CE1)

SUBJECT: DTC P1A9096 CHECK FOR ICCU & FUSE REPLACEMENT AND ICCU SOFTWARE UPDATE (SERVICE CAMPAIGN 997)

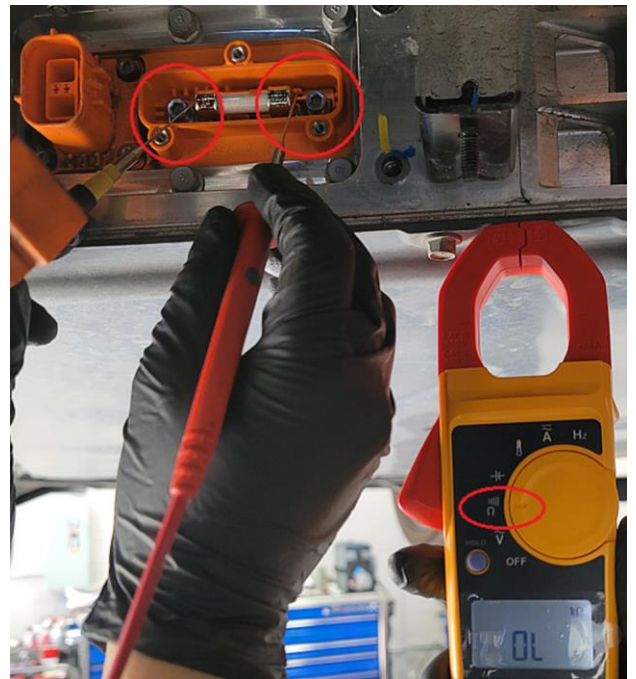
- **Fuse is Bad (Blown/Open):**
Resistance greater than 1.0 ohm or OL.

It can be difficult or with complication removing the fuse, which may include the nuts holding the fuse holder falling back into the battery.

**ONLY REPLACE THE FUSE IF
FOUND TO BE BAD
(BLOWN/OPEN).**

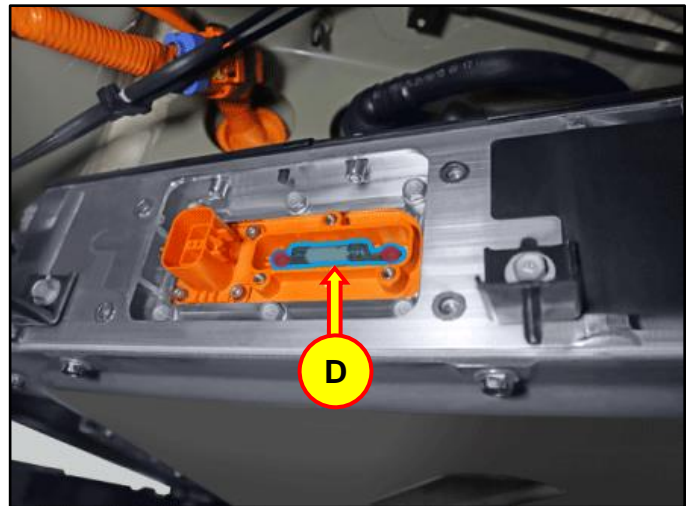
E7. Remove the ICCU fuse (D).

There can be difficulty removing the fuse, which may include the nuts of the at the back of the fuse holder falling back into the battery.

Avoid using power driver to remove and install the bolts. Use a hand tool only.

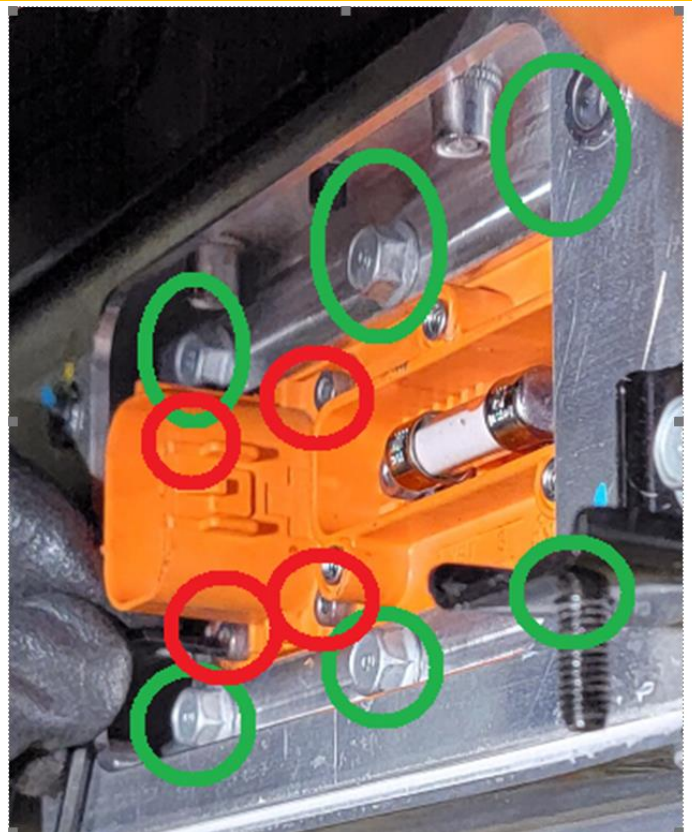
SPECIAL INSTRUCTION: Only applies when ICCU Fuse rear nut(s) falls back into the battery.

1. Remove:
 - 6 qty. 10mm bolts (Green marked),
 - 4 qty. bolts by Allen wrench (Red marked).
2. Push in bottom area. Pull out top area.
3. Reach in and grab the nut behind the plate on the bottom surface.
4. Hold the nut at the back side.
5. Install the fuse bolt at the place that the nut had dropped.
6. Install all the other bolts in reverse order of removal.
7. Install the rest of the fuse bolts.

NOTE: Contact Techline if the above procedure did not resolve a dropped nut problem.
