FORD MOTOR COMPANY (FORD) RESPONSE TO REQUEST 13Request 13

NHTSA's Office of Defects Investigation (ODI) opened this Preliminary Evaluation based on "consumer complaints alleging engine failure due to loss of oil pressure in model year (MY) 2018-2021 Ford EcoSport vehicles". Ford has investigated this subject, including the cause of these reports, the circumstances under which they occur, and the anticipated performance of the subject and peer vehicles moving forward.

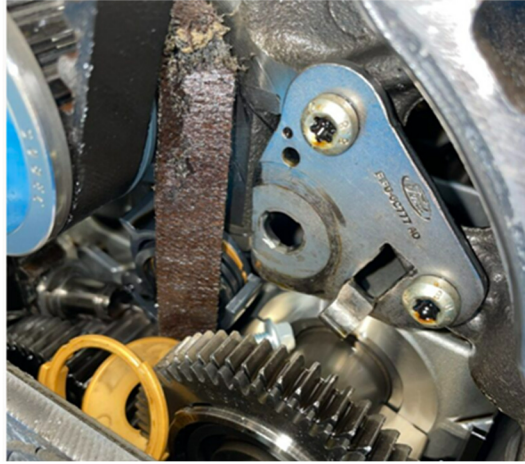
- Tensioner arms separating from backing plates as shown below:

For tensioner arms separating from the backing plate, the press fit retention method of the arm to the backing plate does not appear robust to the torsional vibration experienced by the components over time. For broken tensioner arms, it appears excessive arm rotation about the arm's pivot point is leading to contact with the balancer shaft resulting in fracture. Oil pump drive belt degradation/missing teeth is believed to be caused by a greater than expected load on the belt, which may result in failure prior to the belt's 150,000 mile service interval. Rubber and debris from the degraded belt may clog the oil pump pickup filter, causing an eventual loss of oil pressure.

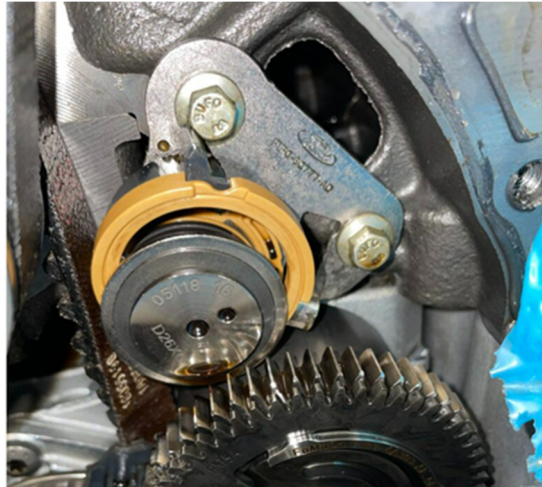
- Ends of tensioner arms broken off (while still retained to backing plate):

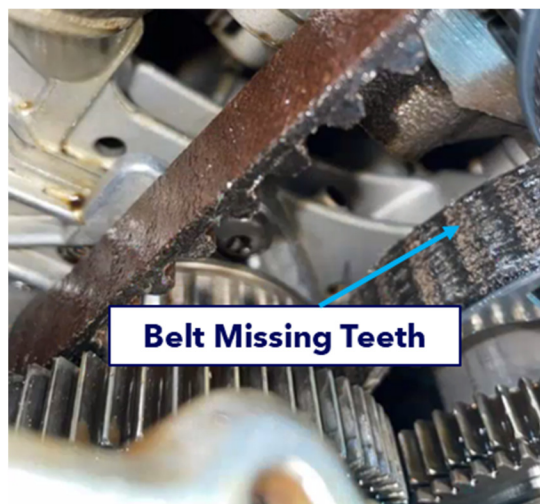
- Oil pump drive belts degraded/missing teeth:

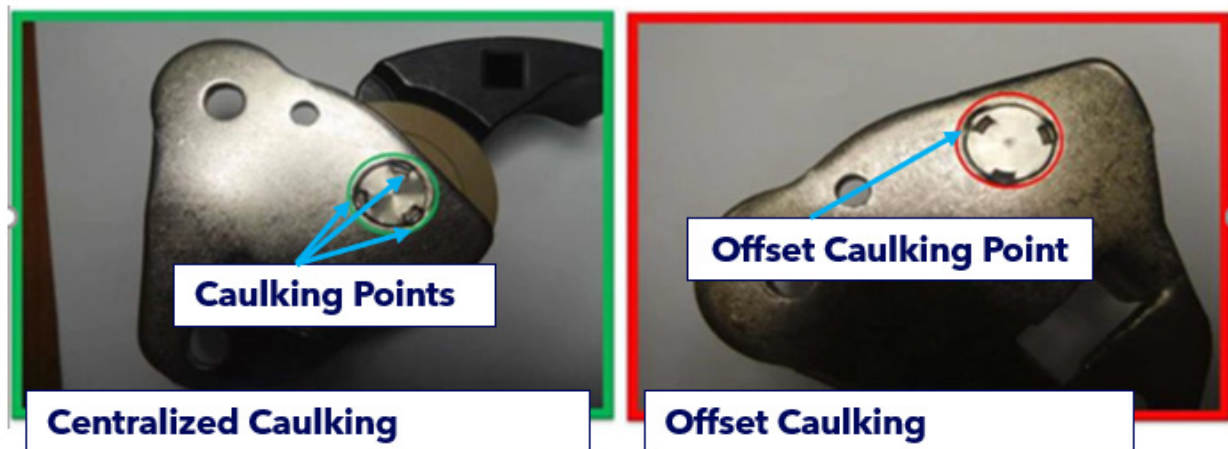
Regarding retention of the tensioner arm to the backing plate, a caulking (also referred to as staking) operation is performed during component manufacturing in addition to the pivot tube's press fit. Material is deformed at three points on the pivot tube to increase interference to the backing plate. Early warranty part returns showed that in some cases this caulking was offset, resulting in less interference than design intent at some points as shown below:

In February 2019, the supplier implemented a position monitoring system at their facility that ensures caulking is properly centered, however failures involving tensioner arms falling off backing plates have still been observed on parts produced after this change.
