Request 9

NHTSA's Office of Defects Investigation (ODI) opened this Preliminary Evaluation based on ten [10] Vehicle Owner Questionnaire (VOQ) reports of inadvertent deployment of the seatbelt pretensioner in model year (MY) 2019 Ford Expedition vehicles. Ford has conducted an investigation associated with this subject, including the cause of these reports, the circumstances under which they occurred, and the anticipated performance of these products.

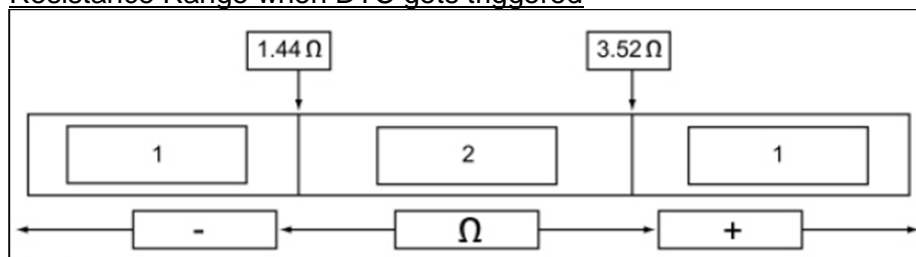
Resistance Range when DTC gets triggered-

(e) The threshold to trigger a MIL or other warning lamp due to the alleged defect- When the vehicle key is turned ON, the Restraints Control Module (RCM) sends the diagnostic check signal to the squib pin of the seatbelt pretensioner at a frequency of 500 milliseconds. This signal is a 40 milli-ampere current that lasts for 2 milliseconds. If the RCM encounters high resistance or open circuit in the seatbelt pretensioner, the diagnostic signals increase the current within the pre-defined range in response, which illuminates the airbag warning light. The threshold to trigger the airbag warning light is based on the resistance values given in the table below.

Range	Description
1	May set Diagnostic Trouble Code
2	Desired range
