# TECHNICAL SERVICE BULLETIN

## Water Leaking On Right Front Floor During Or After A/C Use - Built On 31-Aug-2018 And Through 02-Feb-2020

20-2170

14 May 2020

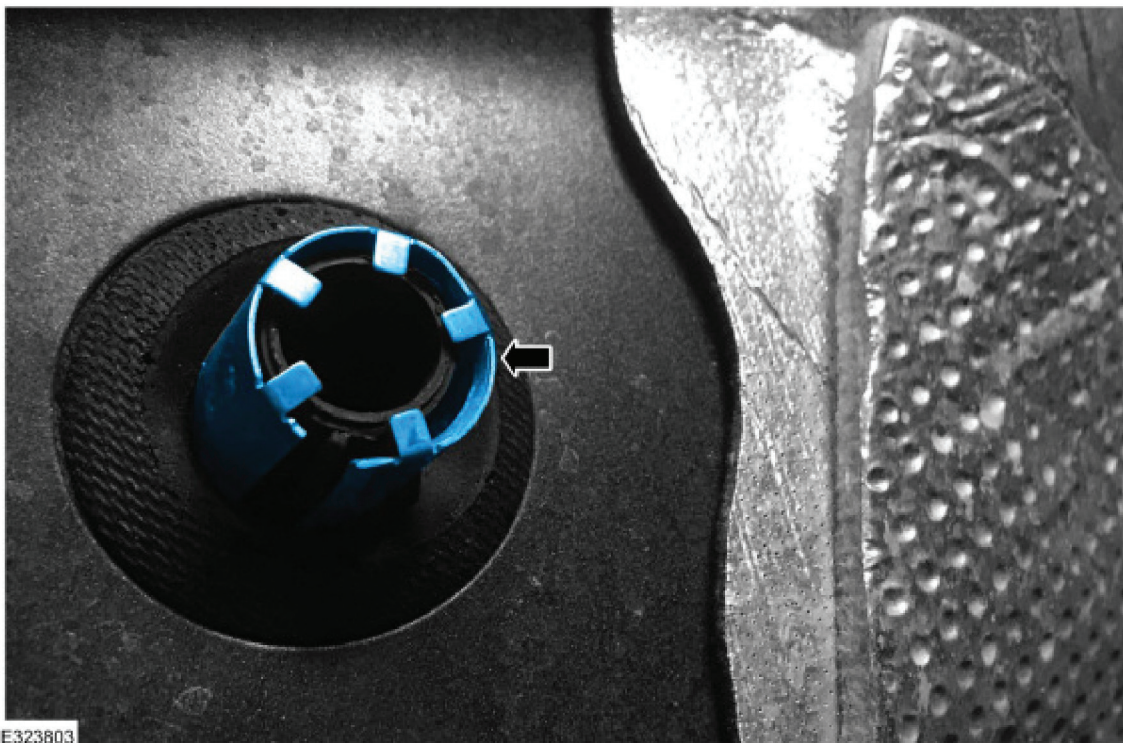
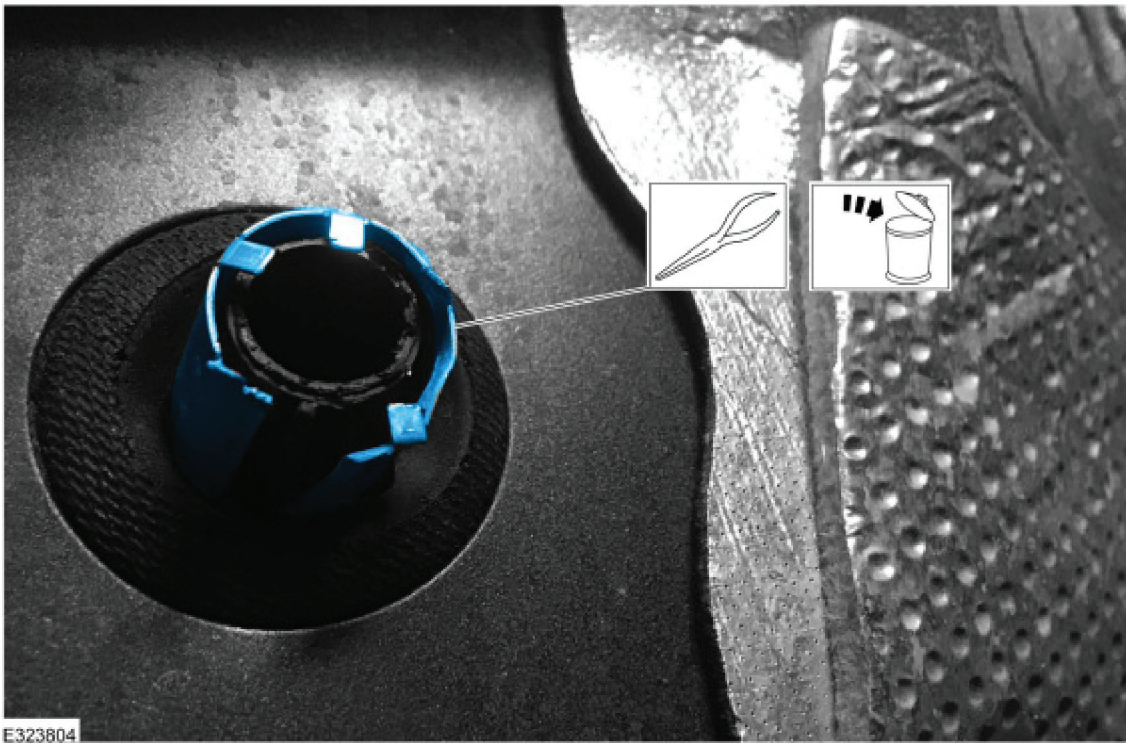
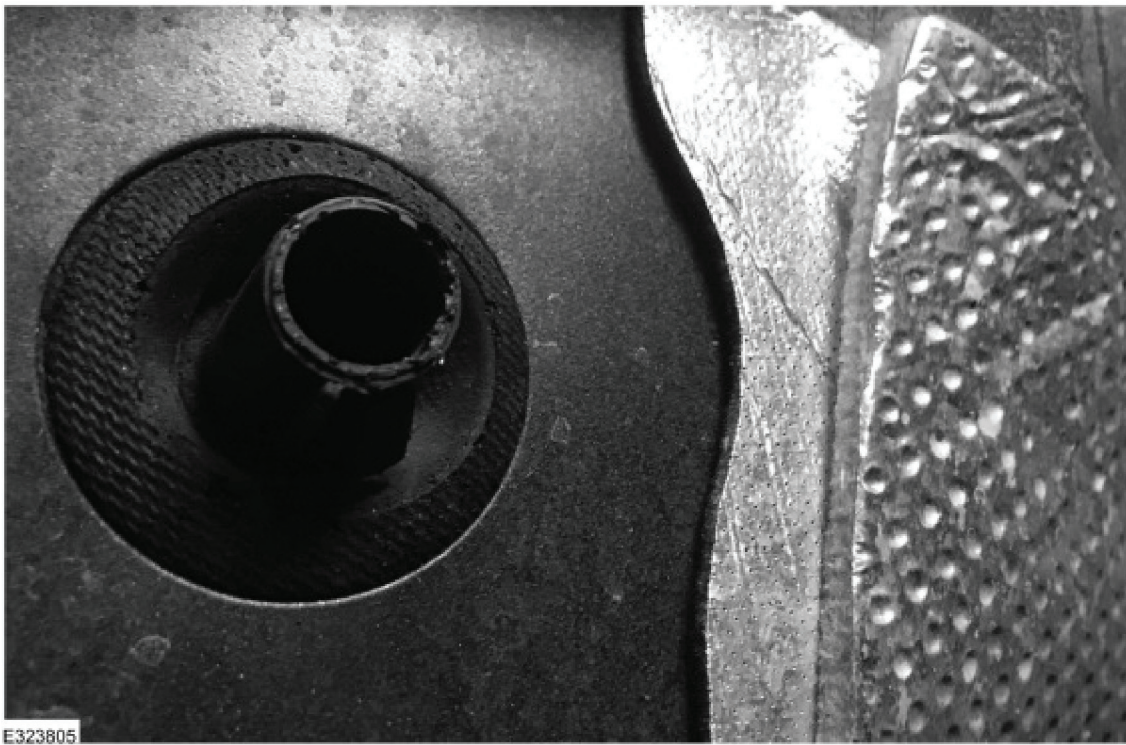
**Issue:** Some 2018-2020 F-150/Expedition/Navigator/F-Super Duty vehicles built on 31-Aug-2018 and through 02-Feb-2020 may exhibit a water leak on the right front floor during and/or after the air conditioning (A/C) is used. This may be due to condensation from the evaporator drain tube entering the vehicle through the drain tube seal. To correct the condition, follow the Service Procedure steps to install an elbow on the evaporator drain tube to direct the condensation away from the seal.

1. Raise the vehicle and remove the right front tire.
2. Remove the right front fender splash shield. Refer to the Workshop Manual (WSM), Section 501-02.
3. Using needle nose pliers or equivalent, remove and discard the metal shield from the evaporator drain tube by bending the tabs away from the tube. (Figures 1-3)
