Request 17

Answer

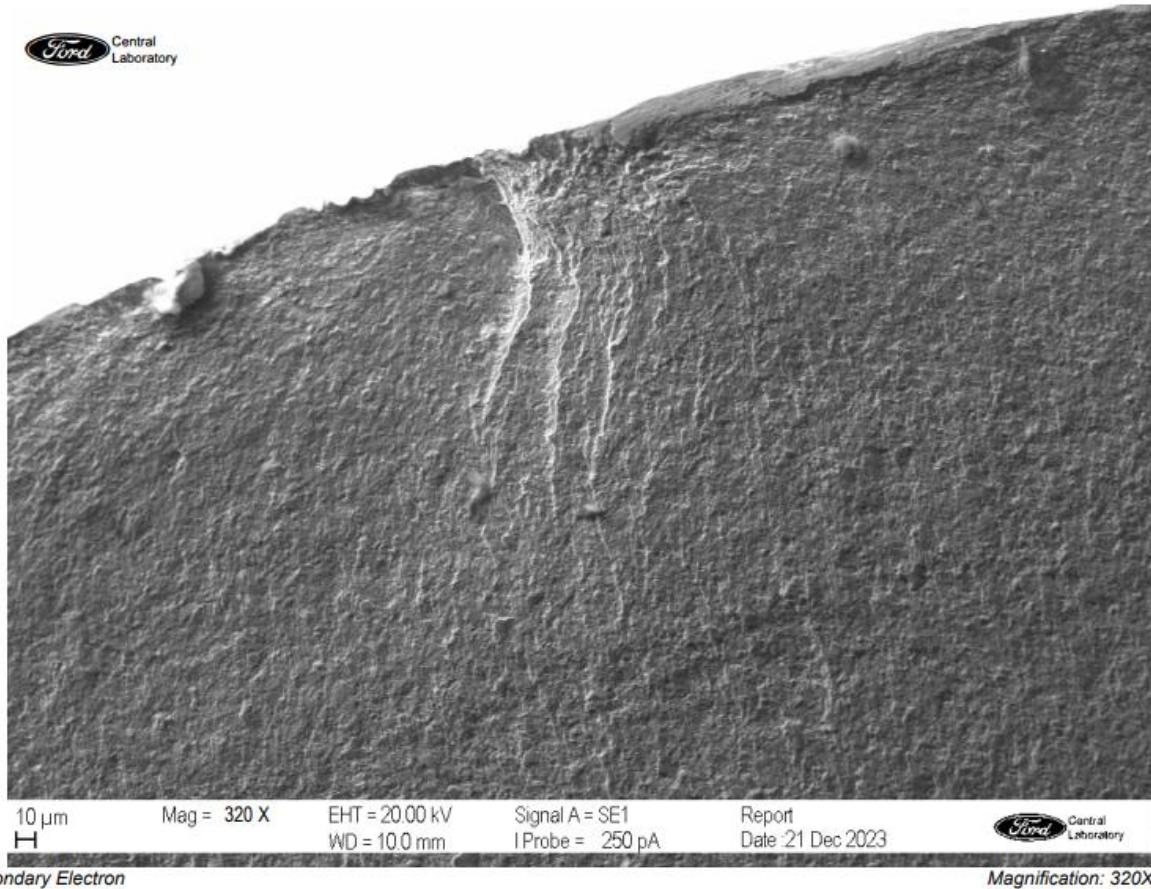
identify the fracture initiation region, also known as the nucleation site. Figure 1 below highlights a nucleation site as observed under SEM.

Figure 1: Magnified SEM view showing nucleation site

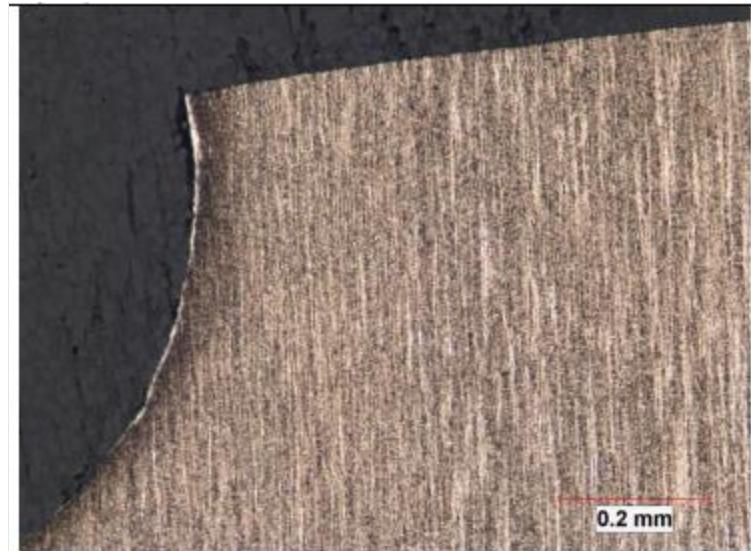
Figure 2: Excerpt from Supplier Lab Report showing white phase martensite on keeper groove

One finding used to determine that fractured valves experienced grinding burn is the evidence of white phase martensite near the fracture location. Figures 2 and 3 show excerpts from both the attached Ford and Supplier lab reports which highlight the formation of white phase martensite near the valve fracture location. As discussed in response 13, this white phase martensite forms when the intake valve is subject to temperatures above the material's austenitizing temperature and then rapidly cooled. Due to the location of the white phase martensite (in the keeper grooves), Ford and the Supplier concluded that the formation of white martensite in this area of the intake valve was the result of grinding burn caused by grinding processes that were not controlled.

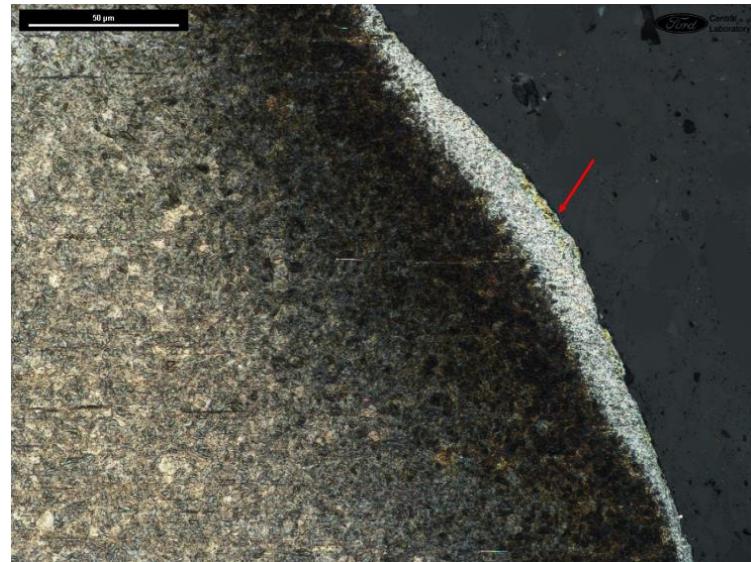
Figure 3: Excerpt from Ford lab report showing white phase martensite

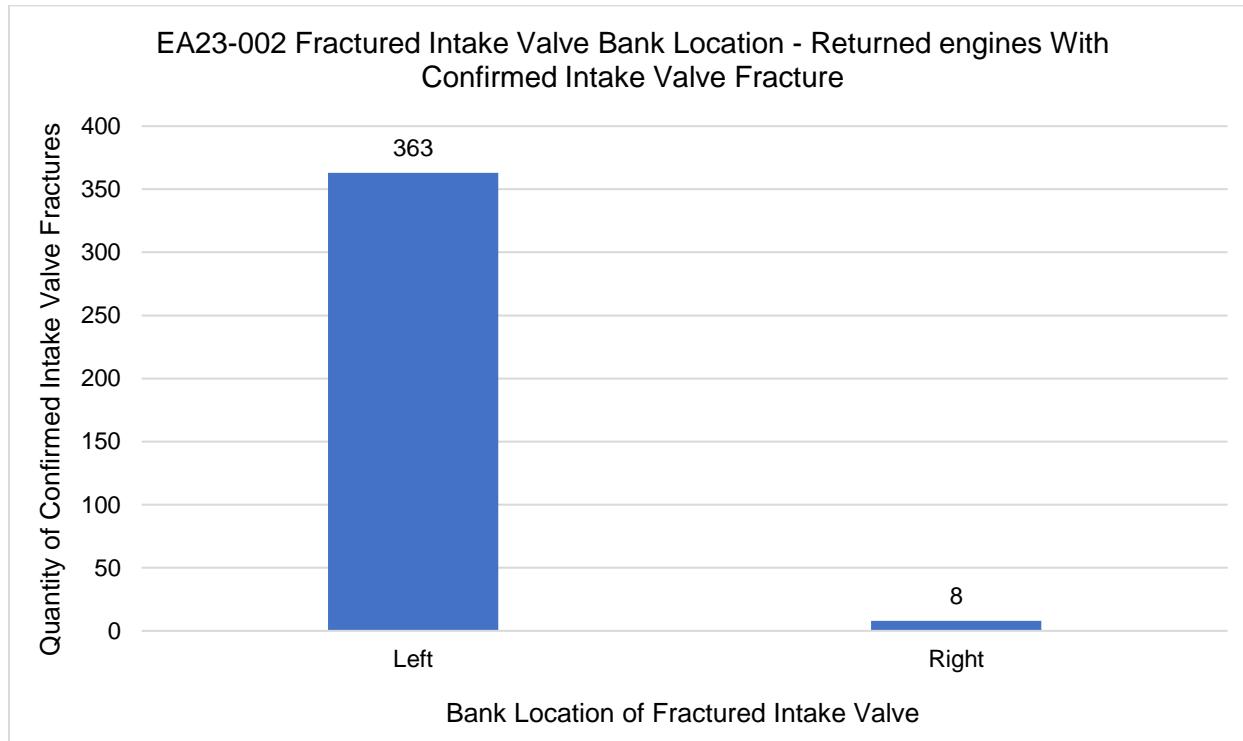
From the inspection results of engines returned from the field, Ford has determined that the intake valves on the left-hand side of the engine (cylinders 4, 5, and 6) are substantially more likely to fracture. The teardown results of engines returned to Ford as seen in the file "EA23-002 Request 12 – Engines Replaced" shows that engines that were found with a fractured left bank intake valve account for over 97% of all returned engines that were found with fractured intake valves.

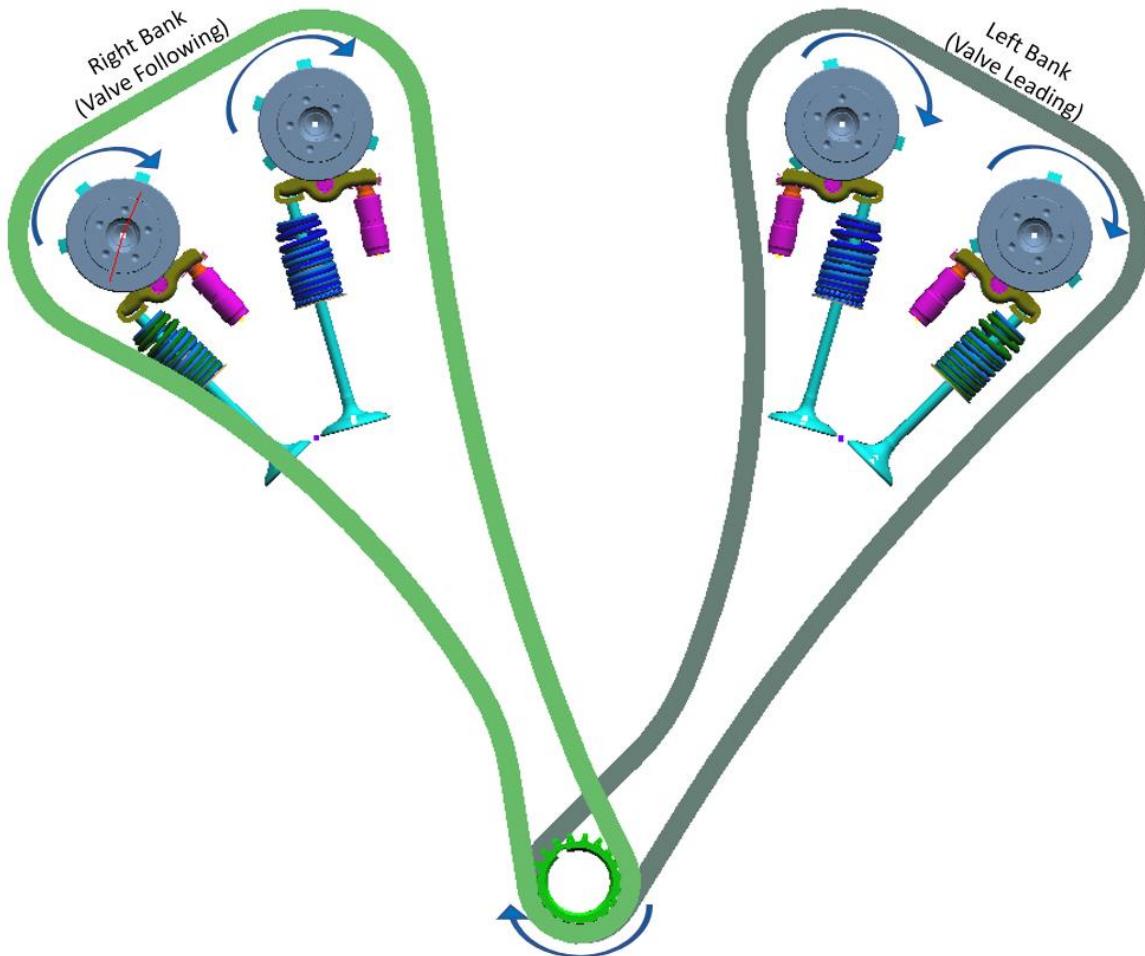
This mirroring of the valvetrain combined with common camshaft rotation direction results in two separate loading conditions for the valvetrain; Valve Leading (LH) and Valve Following (RH) on the 2.7/3.0L Nano V6 architecture. (Figure 17.1).

Figure 17.1: 2.7/3.0L V6 Valvetrain Layout (Front View)

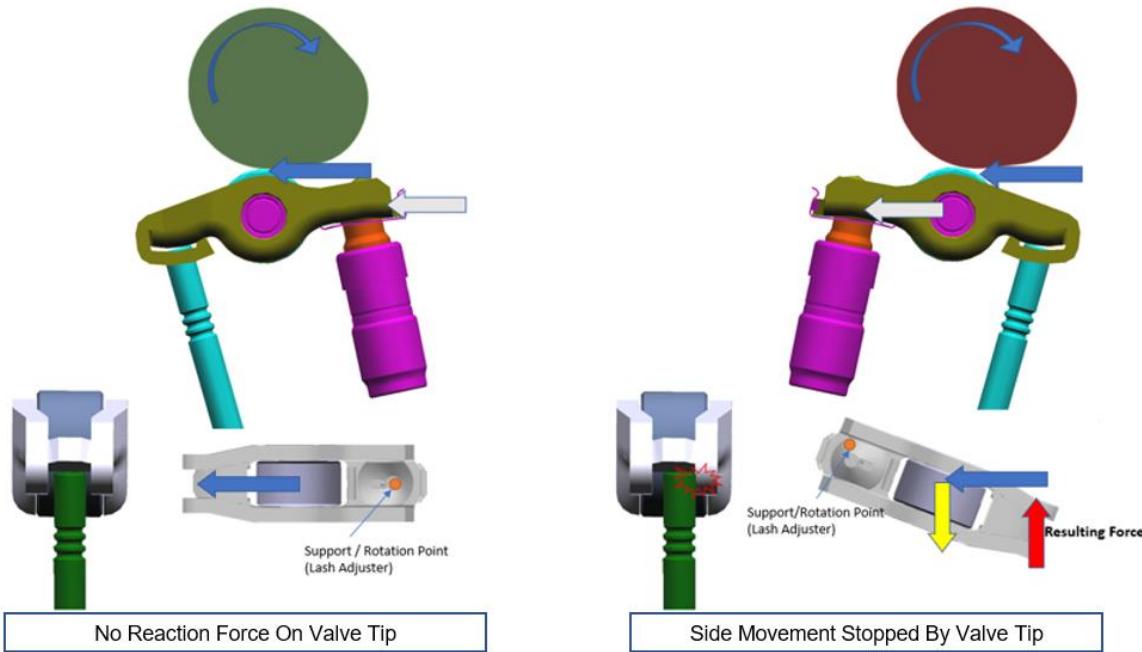
Figure 17.2 below depicts the different loading conditions between the valve following and valve leading layouts. In a valve following layout, as the cam lobe transitions onto the lift event, the load from the camshaft to roller finger follower contact is pulling away from the hydraulic lash adjuster pivot point. In this arrangement, the roller finger follower axis self-aligns to the axis created between the lash adjuster pivot point and the load application point on the roller. The valve does not experience any side load or side impact from the roller finger follower. In a valve leading layout, as the cam lobe transitions on to the lift event, the load from the camshaft to the roller finger follower contact point is in front of the hydraulic lash adjuster pivot point. In this arrangement, rather than self-aligning, any misalignment between the camshaft lobe to roller contact point and the lash adjuster pivot point will create a moment in the roller finger follower, resulting in rotation around the pivot point. The roller finger follower rotation is stopped by the valve tip impact with the sidewall of the roller finger follower, inducing a side-load into the valve tip. This side-load into the valve tip is inherent to a V-engine design and the valve design is robust to the side-load. In a valve with grinding burn, the combination of brittle material, high surface residual stress, and this application loading

will initiate a microcrack at the valve's surface. Analysis of failed valves indicates that this microcrack serves as a nucleation site for fatigue.

Figure 17.2: Loading conditions for valve following and valve leading layouts.
