1. Who directed the design change to the bend radius on the hitch that took effect 1/23/23?
  - Lippert Engineering team directed the change as an added precaution to increase the strength of that area of the hitch after learning of Thor's reported concerns. The original design met the requirements of 8000 pound towing / 800 pound tongue weight rating under SAE J684 testing.
2. Who applies the load limit sticker to the hitch (8,000 lb trailer max weight, 500 lb max tongue weight)? There were 2 instances where the pictures in the documentation show a sticker with a 800 lb max tongue weight, instead of the 500 lb max. All of Thor's production data details a 500 lb max tongue weight. Below are the 2 VINs with those stickers.

3. Question 16 – LCI responded that the hitch has a load limit of 8000 lb max trailer weight, and 800 lb max tongue weight. TMC states the hitch load limits are 8000 lb max trailer weight, and 500 lb max tongue weight. Can you explain the difference?

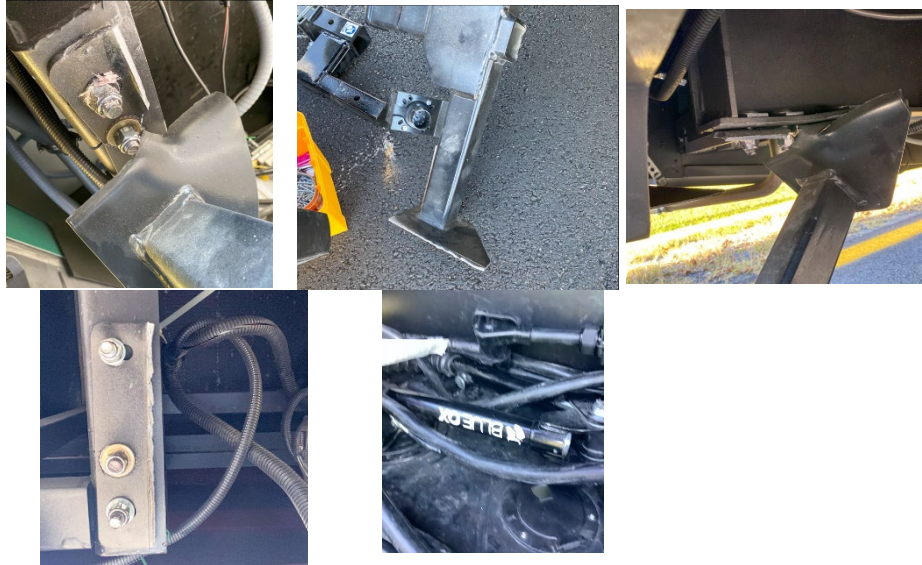
VIN [REDACTED] (reported by LCI) is in SF under case# [REDACTED]. There was no involvement from the retail customer. All information provided came from Thor. The photos associated with this case (as provided by TMC) are below:

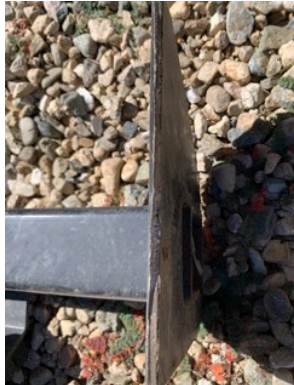
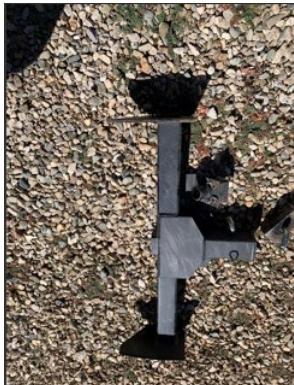
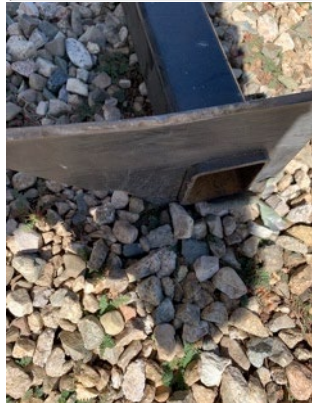
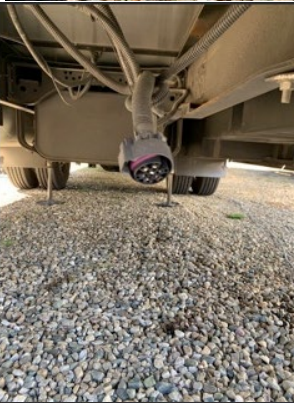
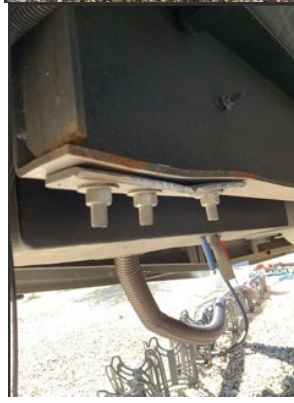
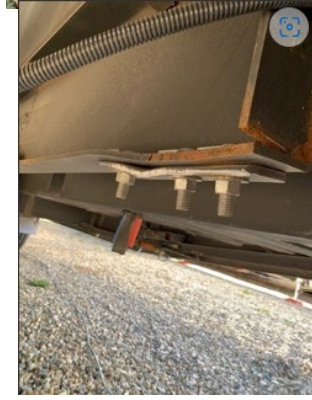
- Three cases appear for this VIN
- Case# [REDACTED]
- Appears to be the original case# and contains photos of the hitch in question. This is the case that will provide all the needed info. Pics below:

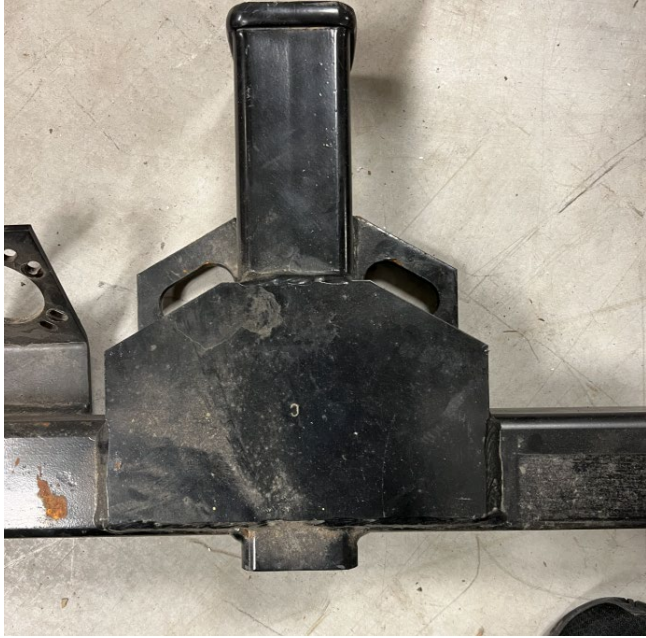
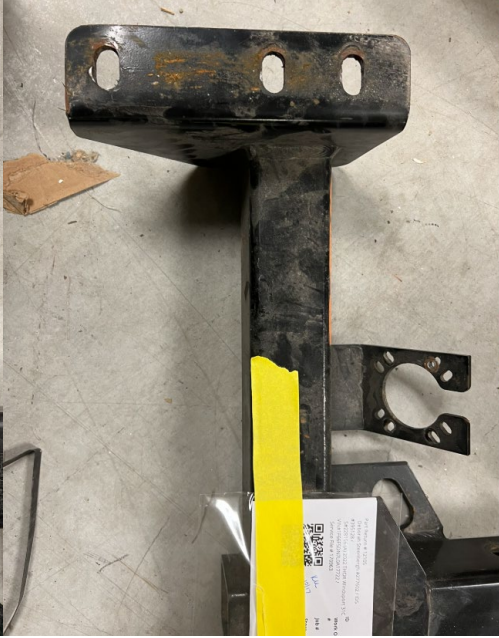
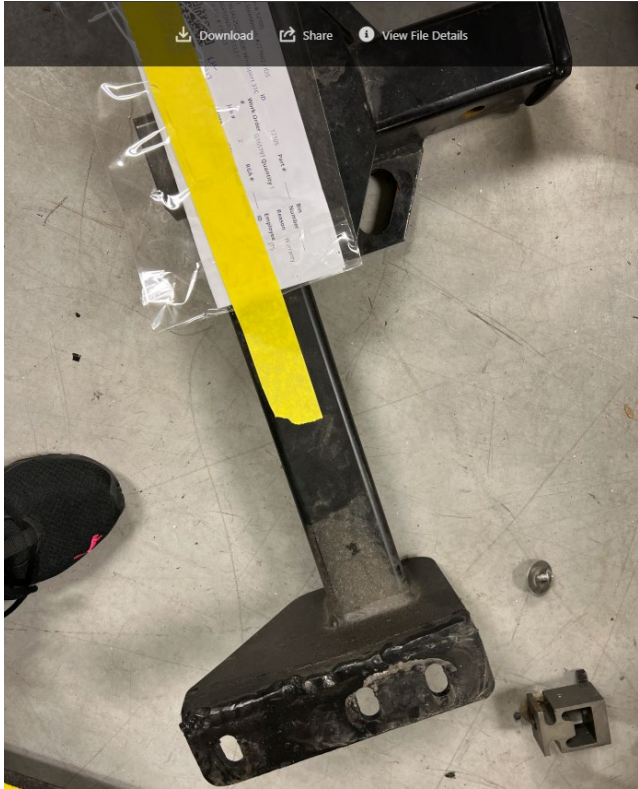
Hi we have a 2016 Thor Miramar. Yesterday we found that the hitch was splitting apart. Luckily we saw it before losing the car we were flat towing. I am not contacting you with the expectation of a repair, I just want you to know about it in case it's an issue with other rigs. We purchased the rv and car together from our sibling. So both of our families have towed the same car.. I cannot say what the original owners towed. Because I do not know. Our setup is 2016 Miramar 34.3 with 40,000 miles and the car we flat tow is a 2019 GMC Acadia. The Acadia should be around 5,000 lbs or less. The hitch is rated at 8,000.
