TIPM Heat Return Teardown Analysis

Rev 3

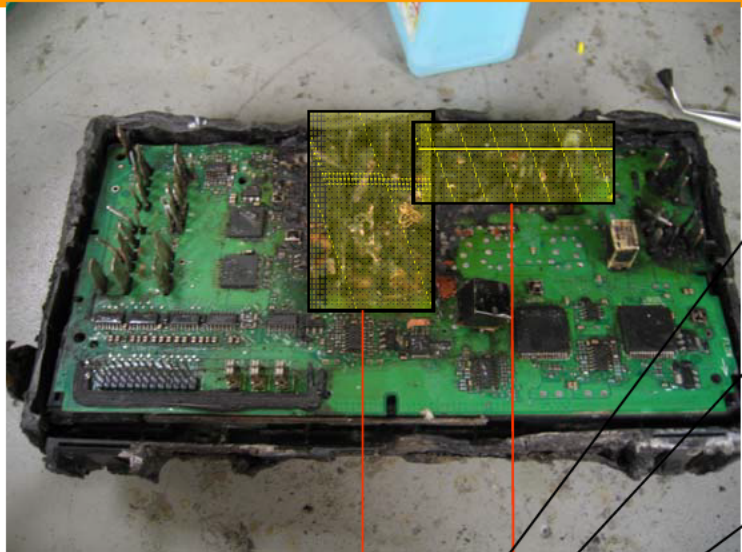
- ▶ Serviceable Area Teardown: The serviceable area was very hard to distinguish. The plastic cover had melted over onto the fuses and relays. It was noticed that the Rear HVAC blower area seemed like it the was the hottest. The coil winding of relay was visible. This area is right above the brown connector.

- ▶ Medium Board Teardown: The damage on the medium board was around the BDPW2 connector and FLPW connector. PTPW pin 17 (GND) was missing. Rad Fan High Side Driver was in the damage area. The driver had come off the board. Same was true for the Rad Fan Serviceable relay coil low side driver. In this area there are 2 BATT Bypass caps. PCB relays K22 (Front Wiper Select and Driver Door Unlock), K23 (Rear Washer and Front Wiper On/Off), K19 (Horns), and K24 (Fuel Pump) had fallen off the medium board. K20 (Rear Wiper and Pass Door Unlock) was about to fall off the board. It was soldered on one side only. All the PCB relays were opened to investigate for damage or overcurrent markings. The relays looked good.

Serviceable RAD FAN low side relay driver

BATT Bypass Caps

Rad Fan Driver (Unused)

No Electrical Components

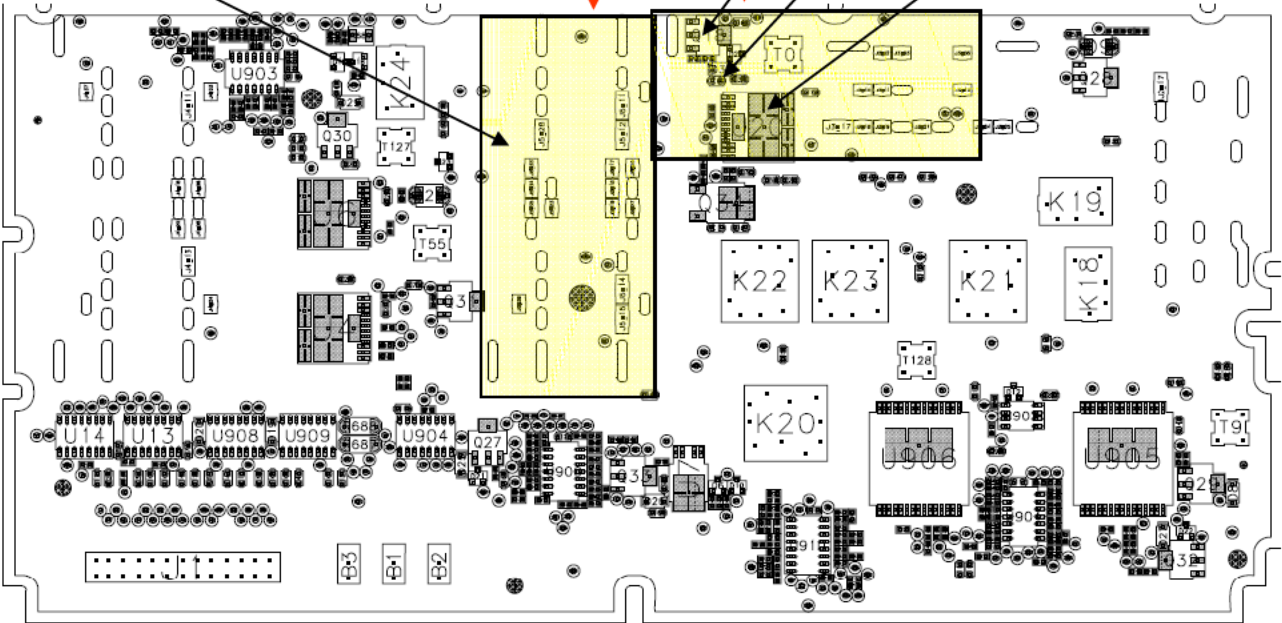
▶ Serviceable Area Teardown: There were signs of hot spot near the following relay and fuses: Rear HVAC blower Relay, M25 (Fuel Pump Output), M24 (Rear Wiper) and J15 (Rear HVAC Blower).

▶ Medium Board Teardown: The damage on the medium board was around the BDPW2 connector and FLPW connector. PTPW pin 17 (GND) was missing. Rad Fan High Side Driver was in the damage area. The driver had come off the board. Same was true for the Rad Fan Serviceable relay coil low side driver. In this area there are 2 BATT Bypass caps. All the PCB relays were still on the board.

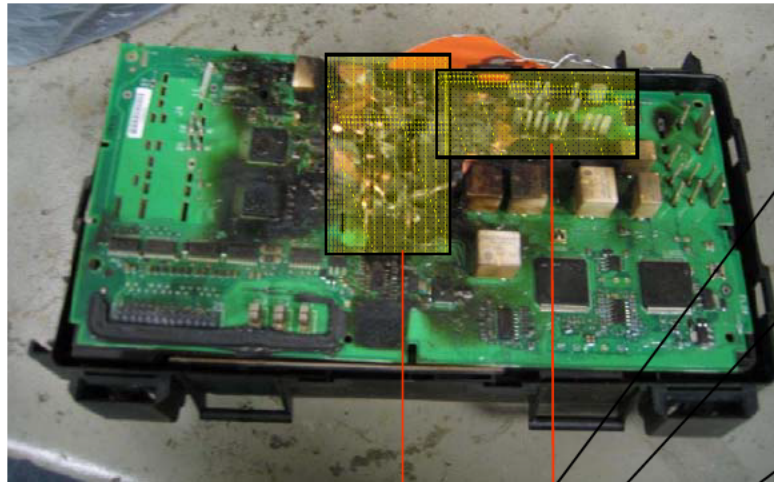
No Electrical Components

Serviceable RAD FAN low side relay driver

BATT Bypass Caps

Rad Fan Driver (Unused)

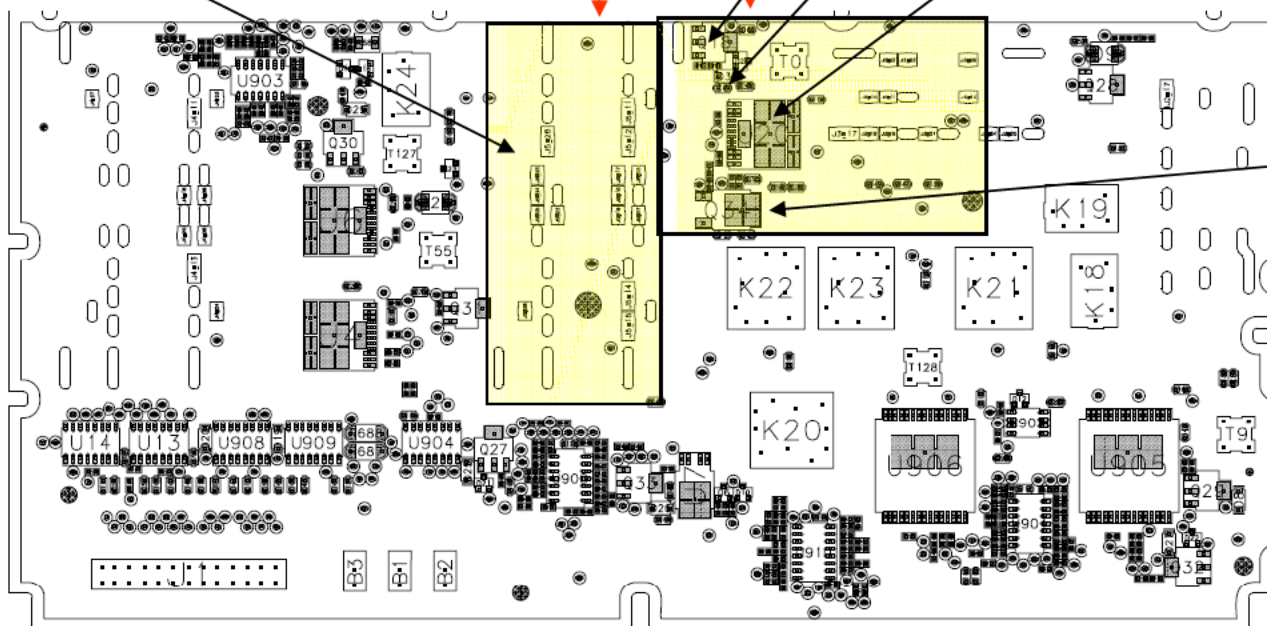
Front Wiper FET

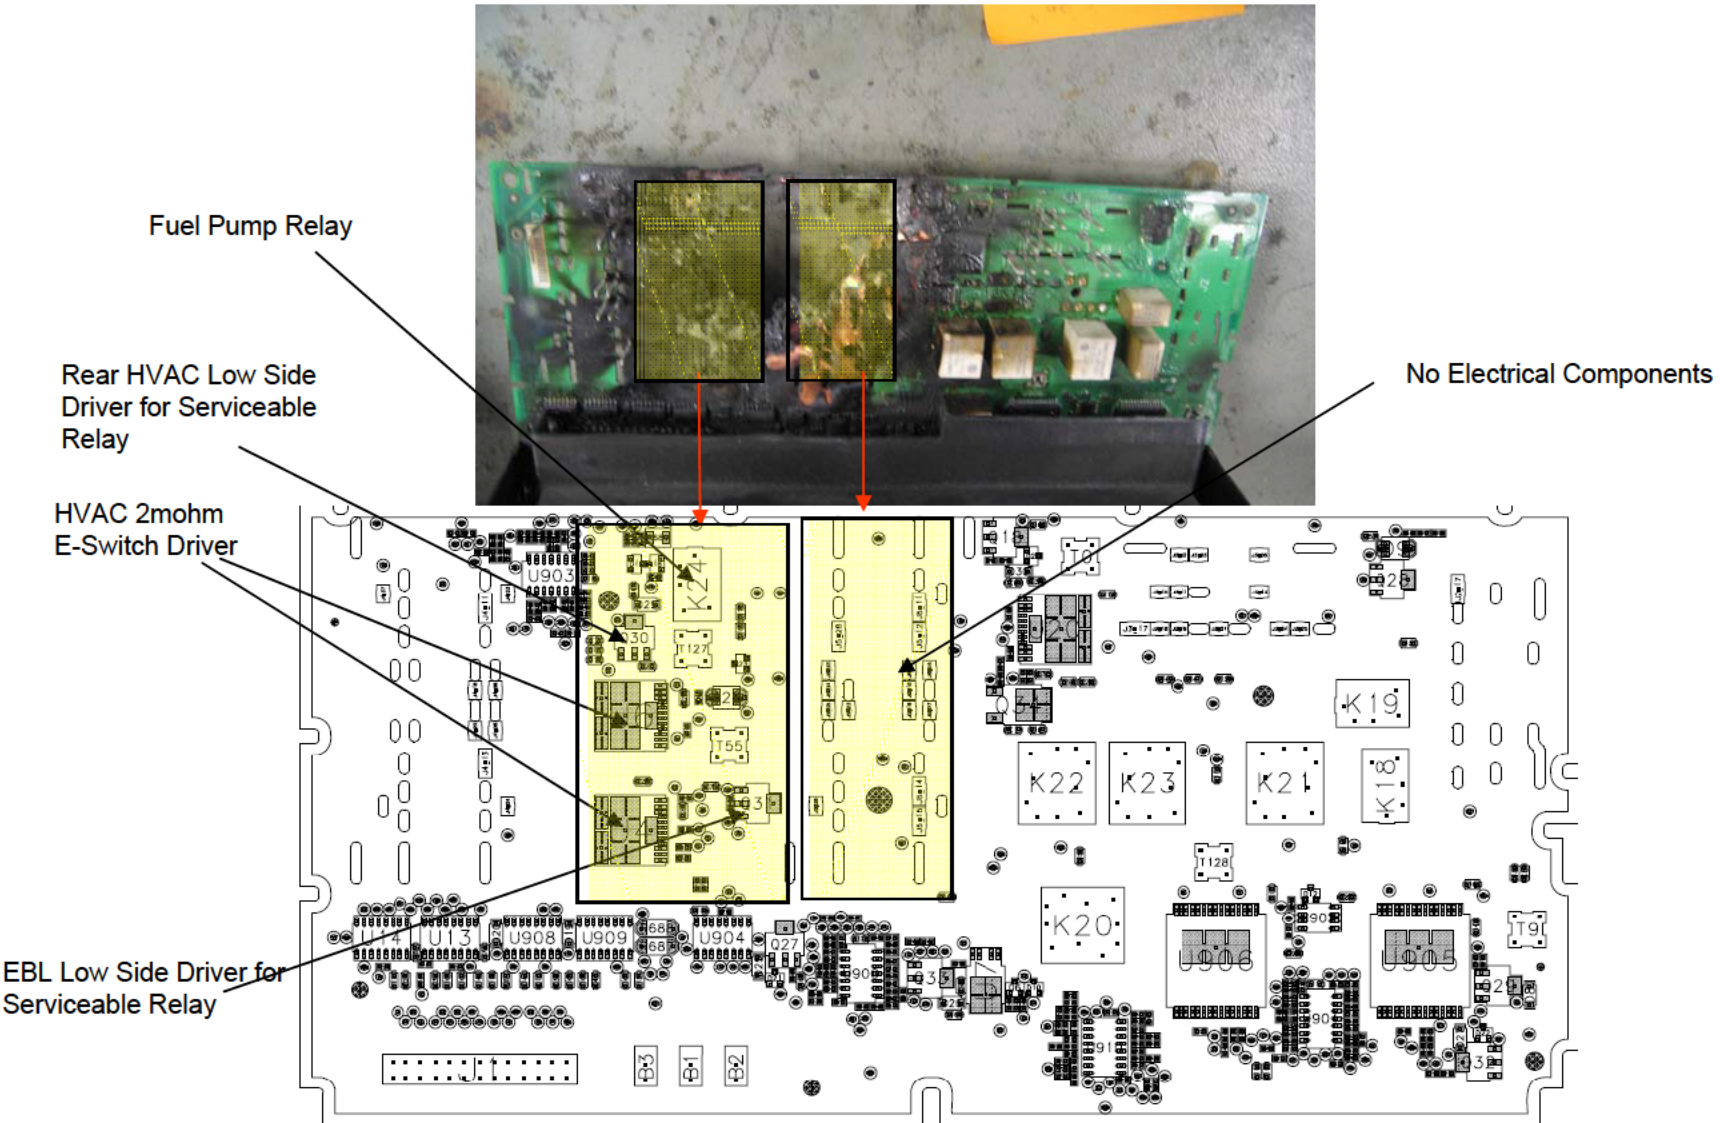
- ▶ Date Module Built: 11/21/07
 - ▶ Medium Board Serial Number: TM1000M57Z
 - ▶ Date Medium Board Built: 10/22/2007
 - ▶ Passed all testing on first pass
 - ▶ Serviceable Area Teardown: TBD
 - ▶ Medium Board Teardown: The damage on the medium board was around the BDPW2 connector. PTPW pin 17 (GND) was missing. The 2 E-Switch 2mohm drivers that drive the Front HVAC came off the board. Fuel Pump PCB relay was off the board also. EBL low side coil drivers was off the board.
