## FORD MOTOR COMPANY (FORD) RESPONSE TO PE24-002

Request 14

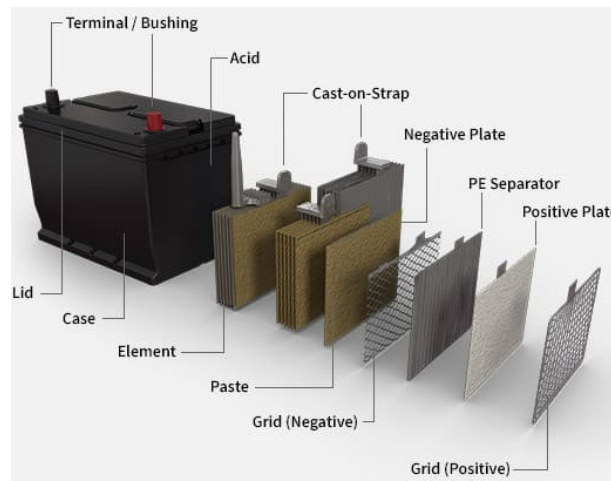
Figure 1. Generic Example of Enhanced Flooded Battery

The tear-down and evaluation of a 12-volt battery that had experienced a failure in the field revealed heavy internal corrosion that is indicative of long exposures to high heat environments. The specific battery failure was attributed to corrosion related growth of the positive battery plates, eventually shorting themselves on either the cast on strap (lead (Pb) busbar) or onto the negative plates (see generally Figure 1). The condition of the failed battery points to a conclusion that the failure event occurs quickly.
