Dealer Service Instructions for:

Customer Satisfaction Notification T57 Software and Drivability Enhancement

2017 (GA) Alfa Romeo Giulia

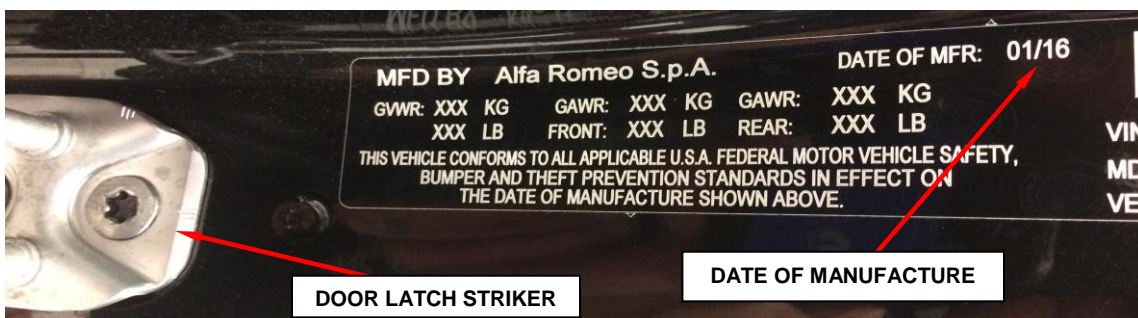
Figure 1 – Door Label

NOTE: Vehicle manufactured date must be verified for each service requirement, this information can be found on the label that is adhered to the inside of the driver's door opening near the door striker (Figure 1).

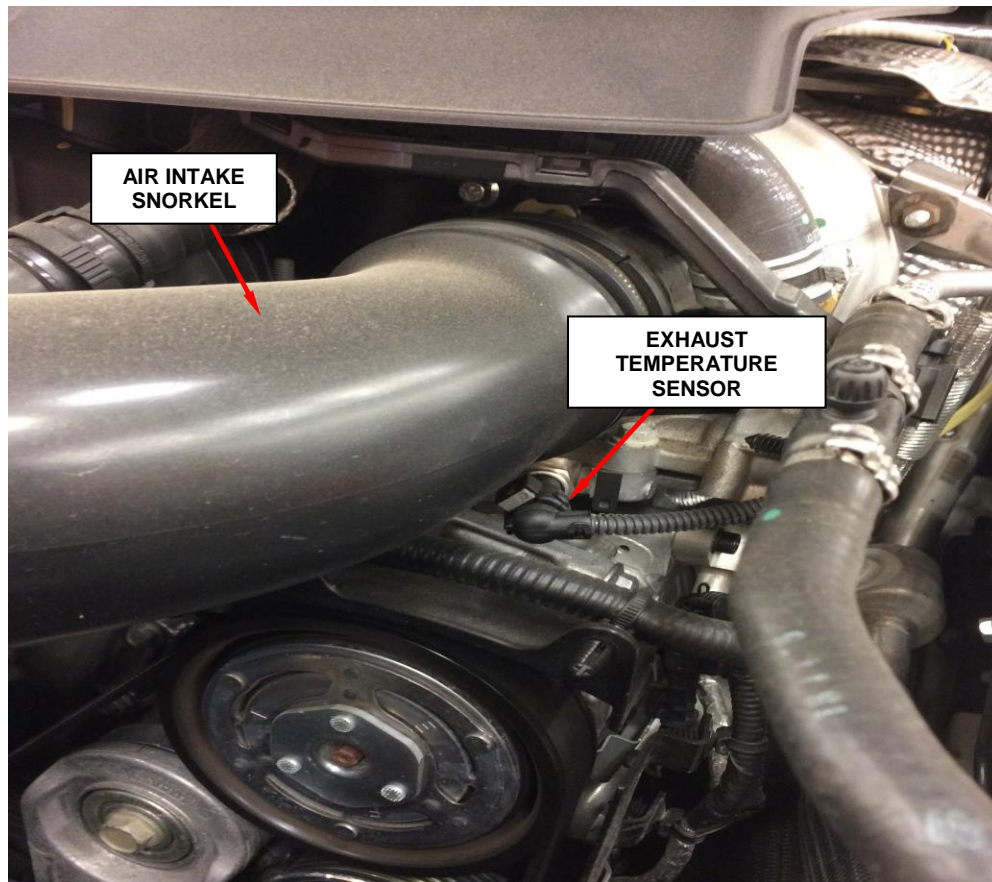
Figure 2 – Exhaust Temperature Sensor

1. Open the engine hood.
2. Disconnect and isolate the negative battery cable.
3. Disconnect the electrical connector from the exhaust temperature sensor.
4. Using an adequate light source and an inspection mirror, inspect the exhaust temperature sensor plastic body for any visible cracks (Figure 2).

- a. **If cracks are NOT** visible on the exhaust temperature sensor, proceed to Step 6.
- b. **If cracks are** visible on the exhaust temperature sensor, proceed to Step 5.

5. Follow the replacement of the exhaust temperature sensor procedure below:
 - a. Remove the exhaust temperature sensor and discard.
 - b. Install the **NEW** exhaust temperature sensor and tighten to 37 N·m (27Ft. lbs.).
 - c. Reconnect the electrical connector to the temperature sensor.
 - d. Reconnect the batter negative cable.
 - e. Close the engine hood.
6. Reconnect the electrical connector to the exhaust temperature sensor.
7. Close the engine hood.
8. Return the vehicle to the customer.
