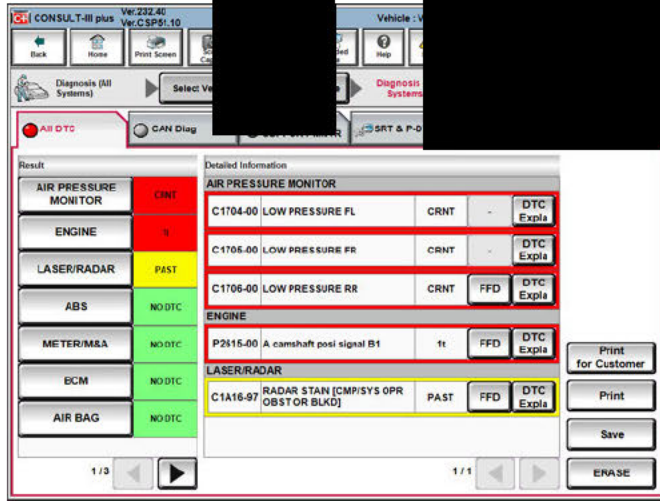
Incident Conditions During Reduced power after stall due to poor clutch engagement

DTC P2615 issue can be reproduced by the stall induced stall procedure shown below.
