# Damage mechanisms in a short glass fiber reinforced polyamide under fatigue loading

**Keywords:** Short Fiber Reinforced Plastics, Damage Mechanisms, Fatigue, Electron Microscopy

This paper presents a damage investigation on a short glass fiber reinforced polyamide (PA66-GF35) under fatigue loading. Plain and notched specimens were tested at room temperature and humidity with load ratio  $R = 0$ . Electron microscopy was used to analyze the fracture surface of failed specimens and the crack path of specimens subjected to interrupted fatigue tests. Damage mechanisms were studied investigating the following fractographic features: ductile / brittle matrix fracture behavior, fiber failure / pull-out, degree of fiber-matrix interfacial adhesion. The aim of the present paper is to understand the nature of damage initiation and propagation in order to lay the foundations for the development of a multi-scale, mechanism-based lifetime prediction model for short fiber reinforced plastics.

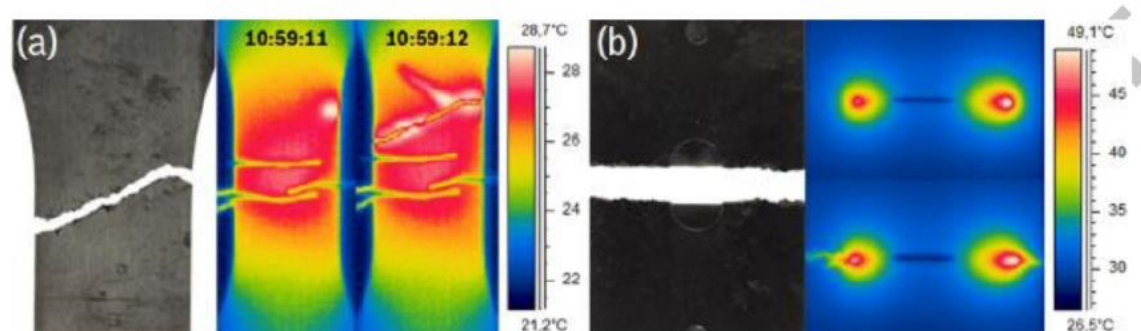
et al. [10]. Instead, the notched specimens show stable FCP at the sides of the notch (Figure 3b). The peaks of temperature, observable at a certain distance from the notch tips, indicate the crack front (Figure 3).

**Figure 3.** Crack path and temperature distribution at failure in (a) Plain specimens; (b) Notched specimens.

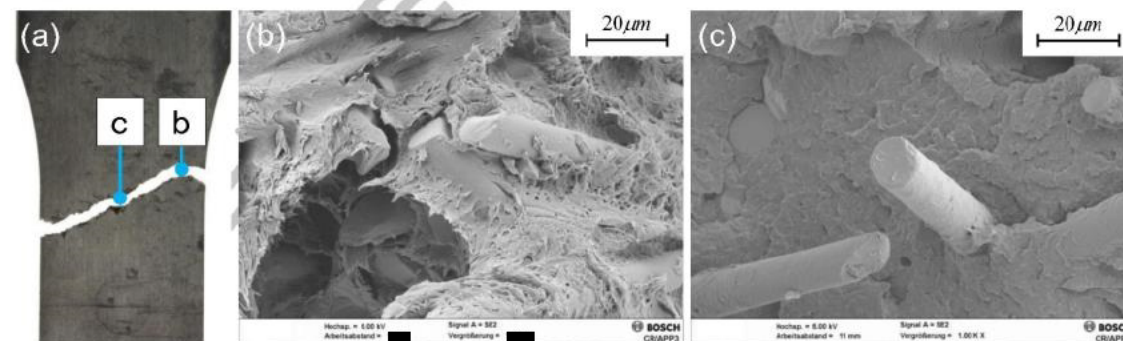
The microscopic analysis of the fracture surface of plain specimens reveals [11]. At crack initiation, where the temperature spot was observed (Figure 3a), the matrix exhibits a ductile behavior (Figure 4b). The rest of the fracture surface is comparatively brittle (Figure 4c).

**Figure 4.** Fracture surface morphology of a plain specimen; (a) Investigated specimen; (b) Fracture surface at crack initiation; (c) Fracture surface caused by unstable crack propagation.

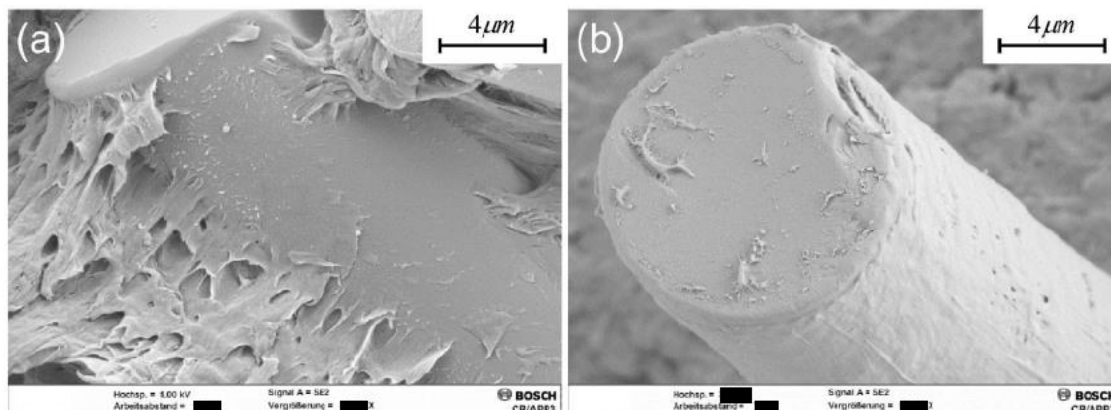
The examination of the fracture surface at high magnifications provides valuable insight into the state of the fiber-matrix interfacial adhesion (Figure 5). On ductile and brittle areas, fibers are covered by a resin layer. Evidence of local matrix yielding in form of polymer fibrils is shown in Figure 5a. The high stress carried by the fibrils can cause either their failure or their detachment from the fiber surface. This may be

the reason of some clean regions on the fiber surface (5a). Conversely, on the brittle zone of the fracture surface, fibers are covered uniformly by a resin layer (5b).

5. Degree of fiber-matrix interfacial adhesion on the fracture surface of a plain specimen; (a) Fracture surface at crack initiation; (b) Fracture surface caused by unstable crack propagation.

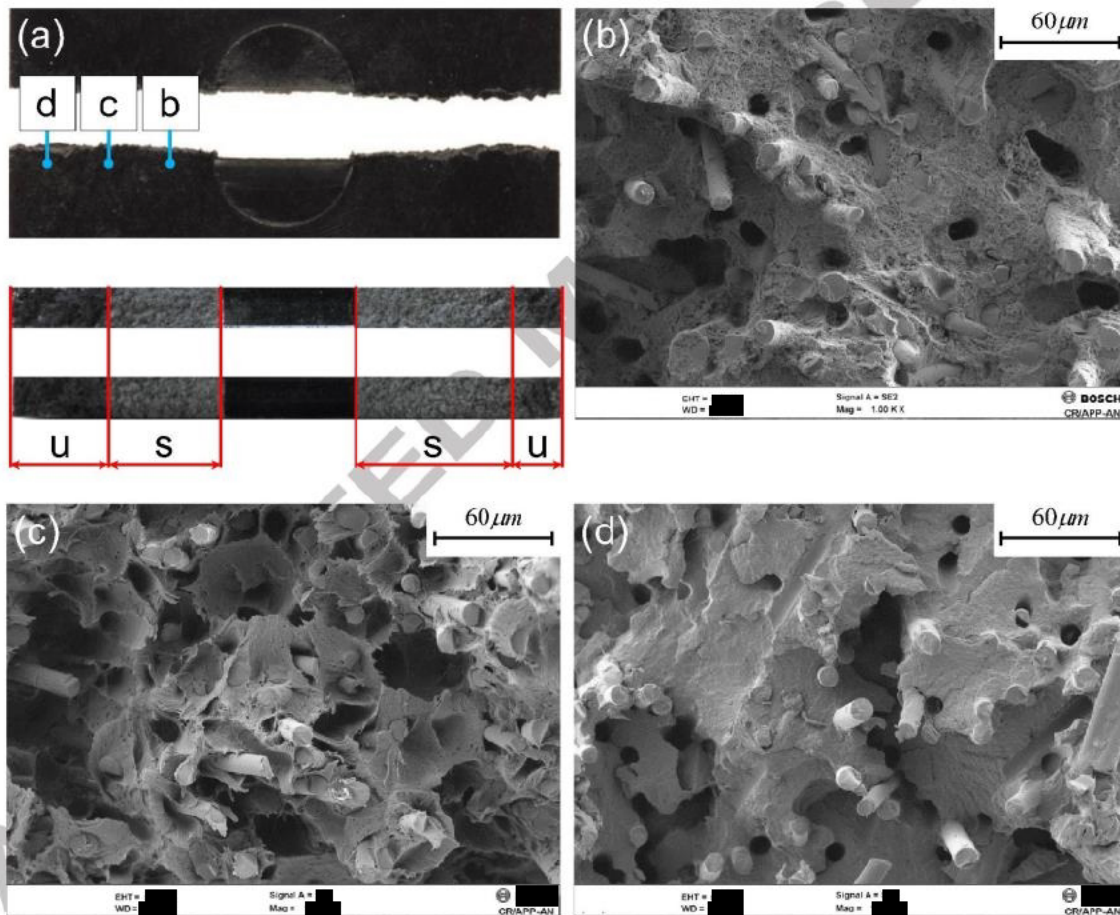
Failure of notched specimens occurs in crack initiation, stable and unstable fatigue crack propagation. Fracture surface caused by stable and unstable FCP can be identified with unaided eye. The fracture surface caused by stable FCP is stress whitened and smooth (5a). Instead, fracture surface caused by unstable FCP has a comparatively more irregular morphology (5b). This result was also reported in [4, 10] for similar material systems. In 5a, the stable FCP is indicated by the letter “s”, while the unstable FCP is indicated by the letter “u”. The fracture surface morphology varies according to the crack propagation mode. Near the notch tip, no evidence of ductile matrix deformation was observed (5a). At the end of the FCP, higher degree of matrix ductility was observed (5b). However, as indicated in 5b, this region is very small. Next to this area, the fracture surface is brittle (5b). This region is caused by unstable FCP and it is similar to that observed in 5b. Hence, unstable FCP leads to brittle fracture surface regardless of the specimen geometry. Comparing 5a with 5b, the matrix material behavior can be described neither as ductile nor as brittle. A similar description was provided in [10, 11, 40], although there is no full agreement on the terminology to be used. Hereinafter, the term “microductility” is associated with the evidence of ductile deformation at micro-scale only. The degree of the matrix ductility depends in fact on the scale of observation. An example is provided in 7. 7a shows a low magnifications FESEM micrograph of the fracture surface caused by stable FCP. The micrograph shown in 7b is an enlargement of 7a. In this case, the ductile matrix response is evident. Moreover, matrix cavitation around particles is observed.

The pull-out length on the fracture surface caused by unstable FCP is longer when compared with stable FCP. This result confirms the observations in [4, 15, 41]. During the stable FCP, crack propagates in a fiber avoidance mode. This mechanism was also observed in [5, 14, 19, 22, 41, 42]. Therefore, either the fibers are slightly below the free surface of the crack, or just a small portion of them is visible from the observation of the fracture surface. On the fracture surface caused by unstable FCP, the high amount of released energy leads to a more irregular crack path. Fibers are extracted from the fracture surface. [REDACTED] are observed on [REDACTED] the fracture surfaces caused by stable and unstable FCPs. This indicates that fiber failure is not the dominant mechanism.

**Figure 6.** Fracture surface morphology of a notched specimen; (a) Failed specimen; “s” and “u” indicate the fracture surface caused by stable and unstable FCP respectively; (b) Fracture surface at crack initiation; (c) Fracture surface at the end of the stable FCP; (d) Fracture surface caused by unstable FCP.

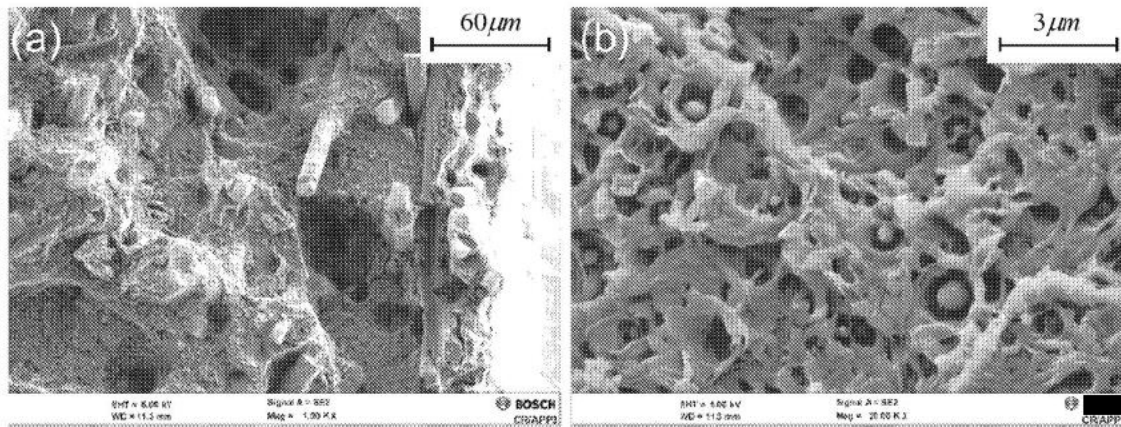
**Figure 7.** Fracture surface caused by stable FCP (notched specimen); (a) Low magnification; (b) High magnification.

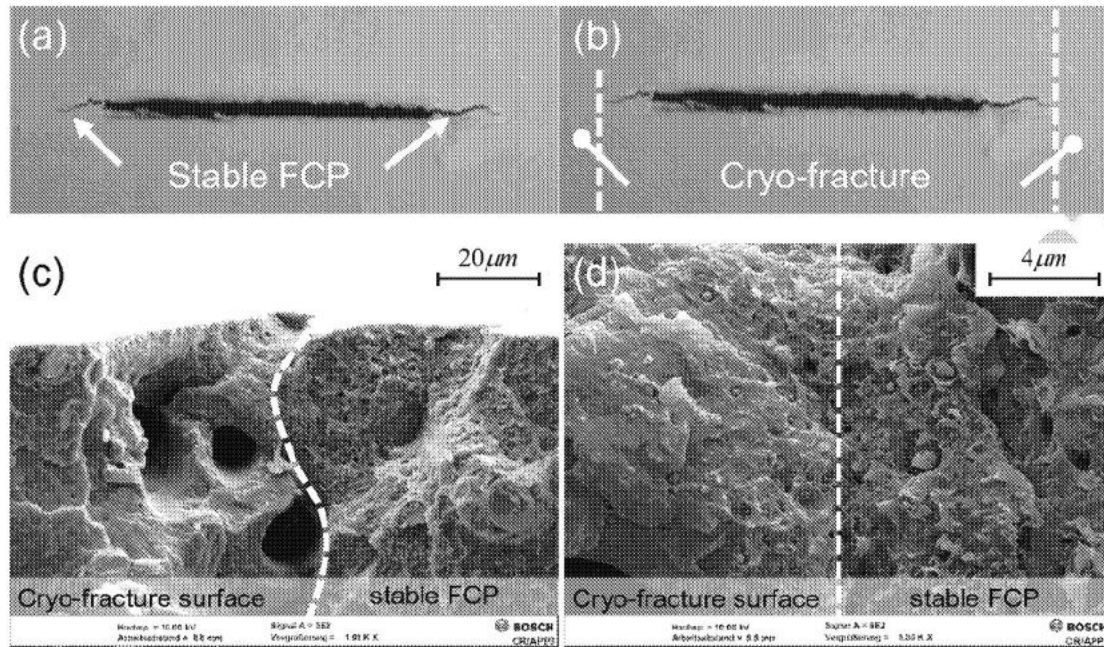
So far, it is not clear if cavities observed on the fracture surface precede or follow the crack onset. In order to study this mechanism, a fatigue test of a notched specimen was interrupted at crack initiation (Figure ■■■). Then the specimen was cryo-fractured at  $T = -196\text{ }^{\circ}\text{C}$  (Figure 5.8b). This test has a twofold aim: 1) Investigate whether the cavities can be observed also in the region ahead of the crack tip. 2) Investigate if there are pre-existing foreign particles in the material. If so, evidence of particles should be provided also on the cryo-fractured surface. Figure 5.8c-d shows the fracture surface caused by stable FCP and the cryo-fractured surface. Cryo-fracture leads to brittle fracture surface.

**Figure 5.8.** Stable FCP and the cryo-fractured surface: (a) Fatigue test was interrupted at crack initiation; (b) Cryo-fracture; (c) Fracture surface, low magnification; (d) Fracture surface, high magnification.

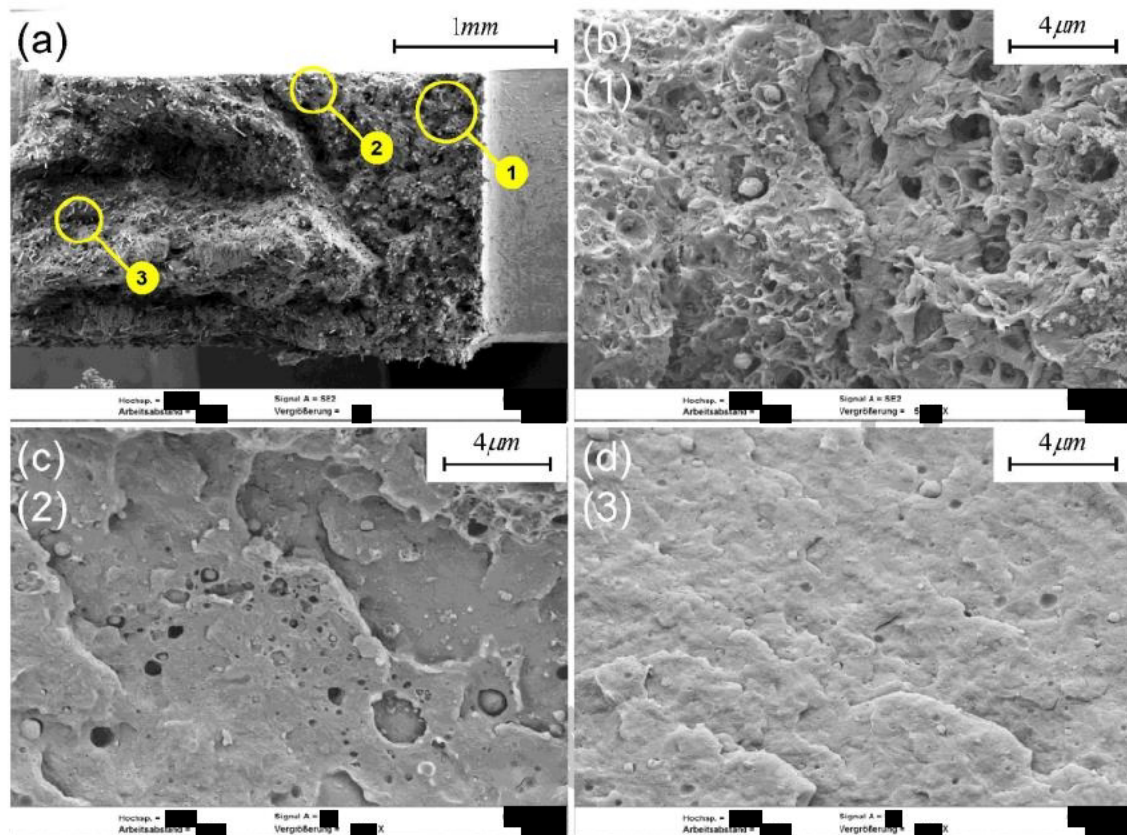
Figure 9 shows FESEM micrographs of different regions on the fracture surface of the cryo-fractured specimen shown in Figure 5.8. Cavities and particles are observed on the fracture surface caused by stable FCP (Figure 9b). On the region immediately ahead of the crack tip, a certain amount of cavities is observed (Figure 9c). Cavities can also be observed on the cryo-fractured surface (Figure 9d), far away from the crack tip. However they are few in number and also smaller. This preliminary investigation suggests that coalescence of voids precedes the formation of a micro-crack. The result would confirm some experimental evidence of voids in a short fiber reinforced polyamide under static loading, recently provided in [11, ■].

**9.** Fracture surface of notched specimen. Fatigue test was interrupted at crack initiation and then cryo-fractured. (a) Overview of the fracture surface; (b) Fracture surface caused by stable FCP region; (c) Cryo-fractured surface ahead the crack tip; (d) Cryo-fractured surface far from the crack tip.

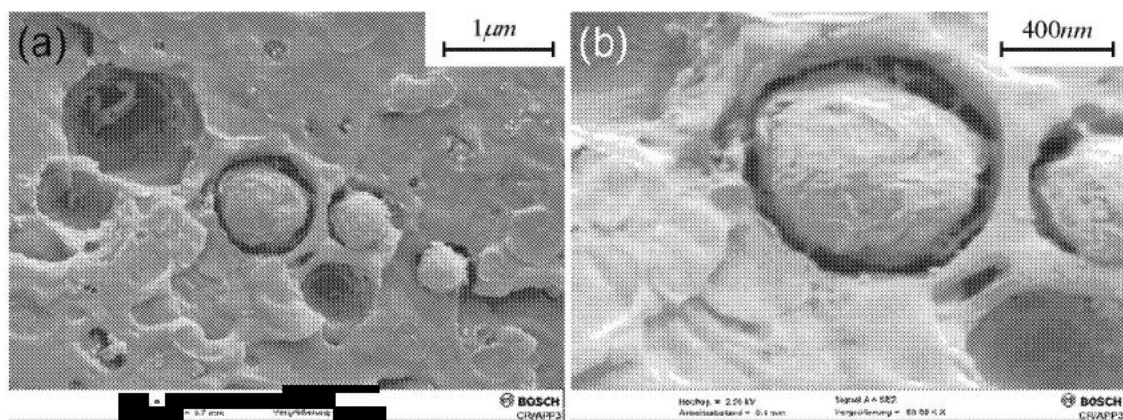
**1** shows examples of particles on the cryo-fracture surface, immediately ahead of the crack tip. The smooth fracture surface is interrupted by cavities of different sizes. Some cavities are filled by particles, some others are instead empty. A difference in terms of surface appearance between the particle and the matrix around it can be also appreciated in **1**. This experimental evidence seems to suggest that the particles are not made by the same material of the matrix.

**Figure 10.** Particles on the cryo-fractured surface ahead the crack tip.

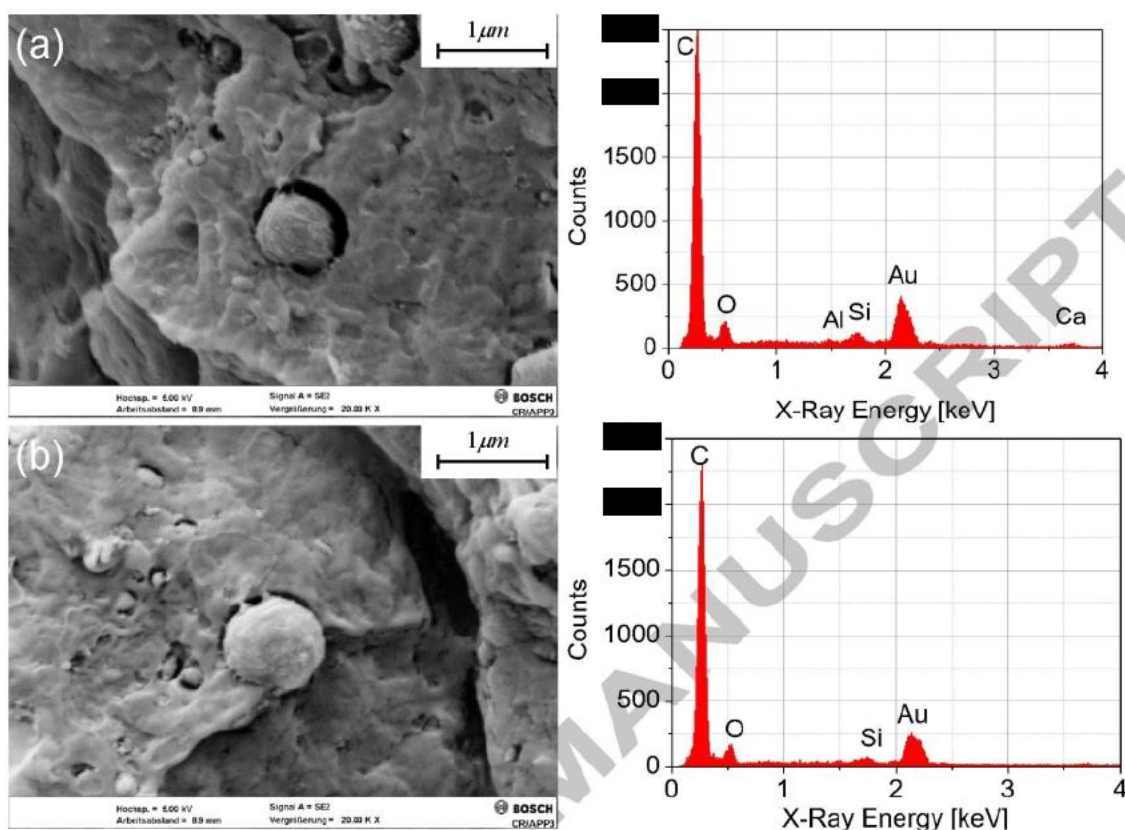
Energy-dispersive X-ray (EDS) analyses of the particles were also performed to study their elemental composition (Figure 11). The EDS analysis was performed with an excitation voltage of 20 kV. The peaks of carbon, oxygen and nitrogen (between the 0.1 and 0.3 keV) are attributed to the polymer. A peak of gold is due to gold-sputtering. Smaller peaks of Silicon and Calcium were also noticed and may be related to the occurrence of a fiber fragment in the analyzed volume. Hence, the EDS analysis did not provide clear indication on the nature of the observed particles. It is worthwhile noting that the spatial resolution of the EDS detector is on the order of 3  $\mu\text{m}$  and it is probably too coarse for the elemental analysis of particle of diameter 0.1 - 0.3  $\mu\text{m}$ . The aim of this preliminary analysis was to highlight a new damage mechanism occurring below the micro-scale and preceding the formation of a micro-crack. For better understanding of this mechanism, further investigations are needed using more accurate experimental techniques.

# 11. EDX analysis of particles found on the cryo-fractured surface ahead the crack tip.

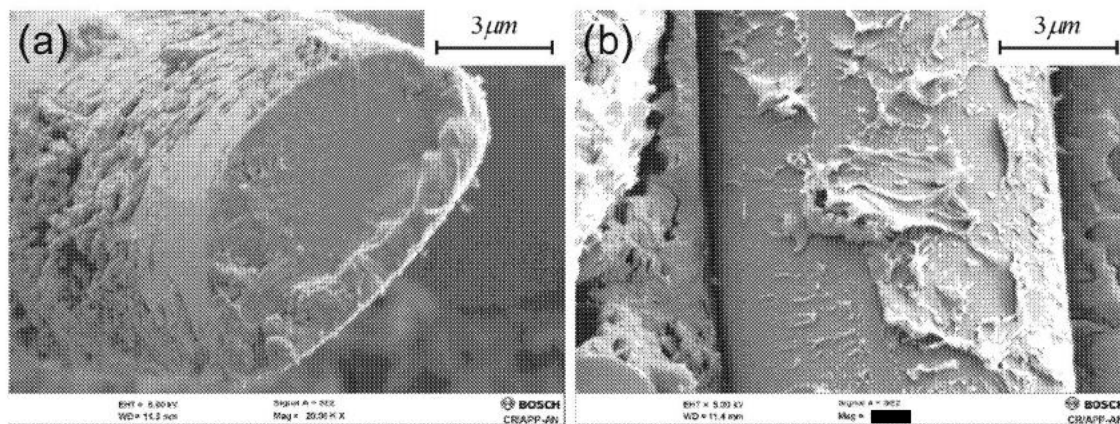
The fracture surface shown in [REDACTED] is caused by stable FCP. Therefore, between the [REDACTED] described in [REDACTED], the area shown in [REDACTED] was examined at high magnifications in order to observe the state of the fiber-matrix interfacial adhesion. [REDACTED] shows [REDACTED] perpendicular to fracture surface, ([REDACTED]) and the other lying on the fracture surface, ([REDACTED]) near the free surface of the notch. In [REDACTED] fibers are covered by a resin layer. The microscopic examination suggests that damage occurs at a certain distance from the fiber-matrix interface. A thorough examination reveals that the resin layer is thicker for the fiber perpendicularly oriented to the fracture surface than for the fiber lying on the fracture surface.

**Figure 12.** Fiber-matrix adhesion on the fracture surface of a notched specimen caused by stable FCP; (a) Fiber perpendicular to the fracture surface; (b) Fiber lying on the fracture surface.

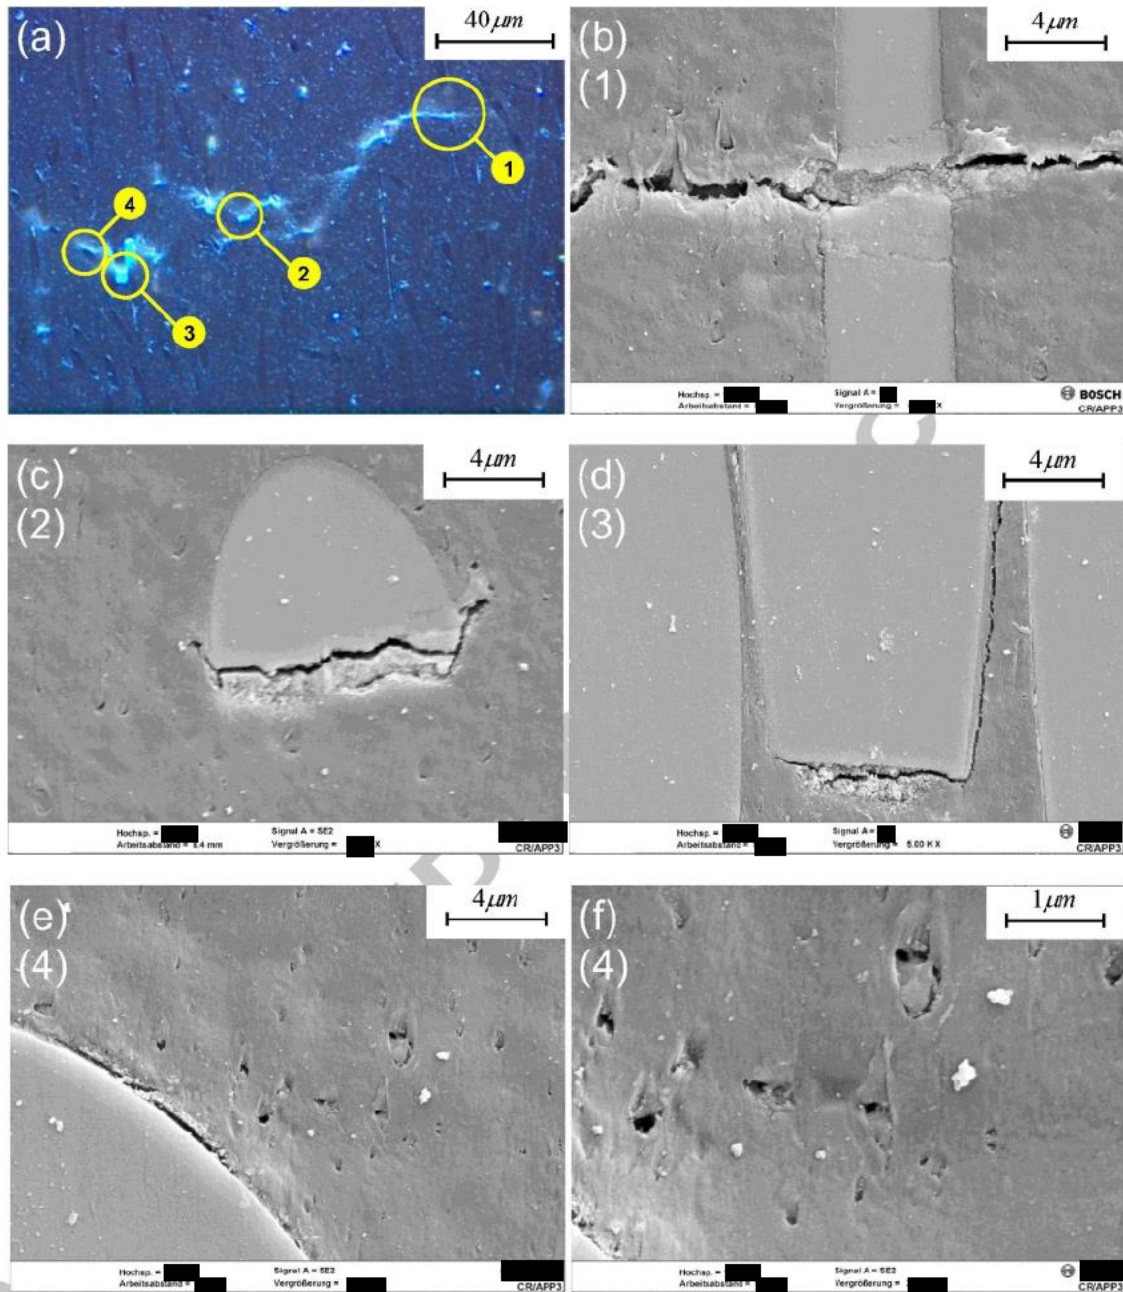
Figure 13 shows the damage analysis on the side surface of a plain specimen. Evidence of damage was found using the reflected light microscope (Figure 13a). This region was thoroughly investigated by means of FESEM. Figure 13 shows typical mechanisms occurring just before the specimen failure. Several micro-cracks were observed indicating that a macro-crack forms due to the coalescence of micro-cracks. An example of fiber failure is shown in Figure 13b. Figure 13c shows a small crack occurring between the matrix and a fiber fragment. Figure 13d shows a crack at the end of a longitudinally oriented fiber. Here the crack propagates at a distance of 10 μm from the fiber surface. Figures 13e and 13f represent SEM pictures of the region 4. Voids can be observed close the fiber (Figure 13g). Coalescence of voids seems to represent the damage stage preceding the formation of a micro-crack in the matrix. If one compares Figure 13g with Figure 9b-c, it can be deduced that the size of the voids is comparable.

**Figure 13.** Damage investigation on the side surface of a plain specimen, interrupted fatigue test; (a) Damage zone observed through optical microscopy; (b) Fiber failure; (c) Crack at fiber fragment; (d) Crack at the fiber end; (e),(f) Voids in the matrix.

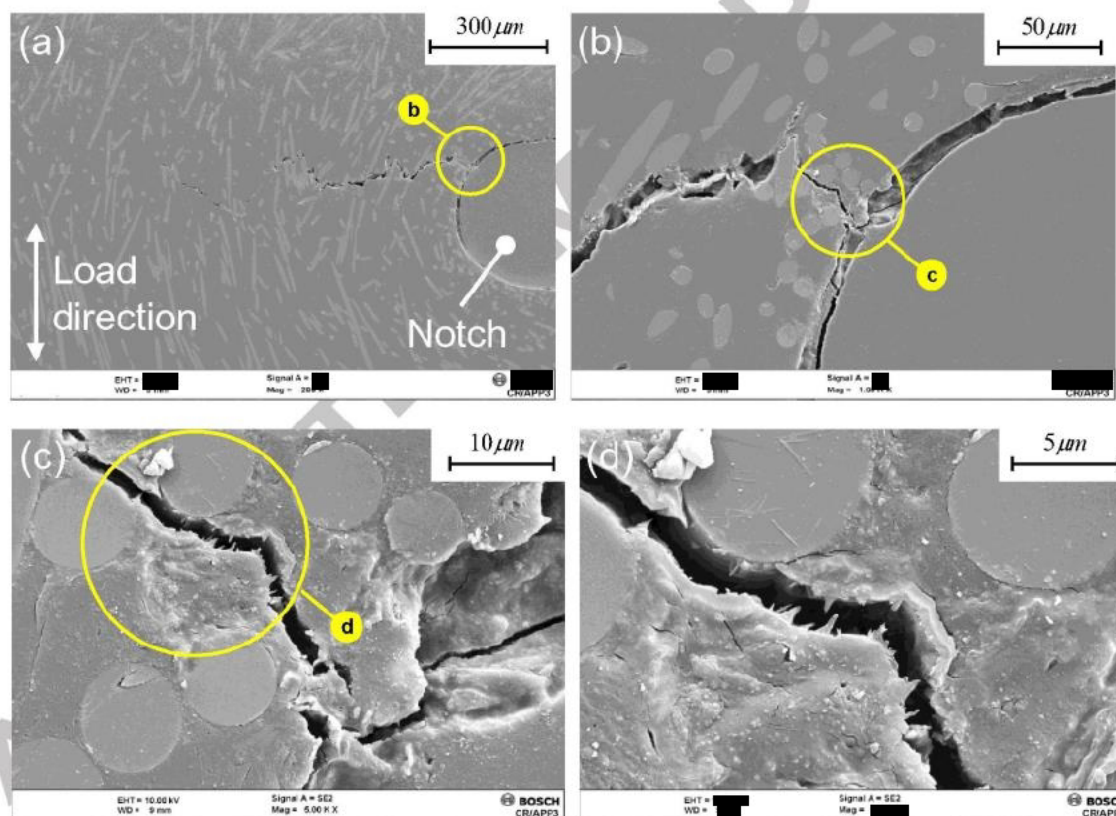
shows the side surface of a notched specimen subjected to interrupted fatigue test. The crack does not initiate at the notch tip as it would be expected if the material was homogeneous. At higher magnifications (c), it is possible to examine the fiber orientation distribution around the notch. At the close vicinity

of the free surface of the notch, fibers are oriented through the thickness. This is deduced observing the circular footprints left by the fibers on the polished section. [REDACTED] from the free surface of the notch, the fibers are mostly in-plane oriented. Around the notch, fibers are unevenly distributed. They tend to agglomerate and form clusters. It is worthwhile noting that the location of crack initiation corresponds with a cluster of through-the-thickness oriented fibers (Figure [REDACTED]d). The analysis of the side surface of other specimens confirmed the occurrence of fiber clusters around the notch. As well as being a geometric discontinuity, the insert also represents an obstacle for the melt stream during injection molding affecting the local fiber orientation. The analysis of the crack propagation shows that the crack exhibits a zig-zag path (Figure [REDACTED]). As soon as the effect of the insert vanishes, the crack follows the direction imposed by the in-plane fibers growing in a fiber avoidance mode (Figure [REDACTED]).

**Figure 14.** Fiber distribution at crack initiation for a notched specimen, interrupted fatigue test; (b), (c), (d) are magnified views of the crack.

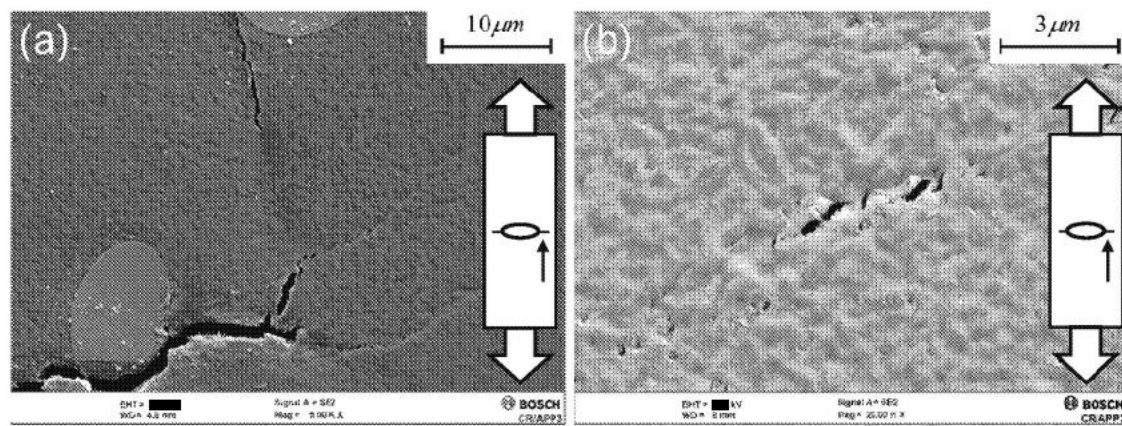
[REDACTED] shows examples of matrix-cracking at the tip of a crack. [REDACTED] micrographs suggest that the crack forms by coalescence of voids.

Matrix cracking (notched specimen)

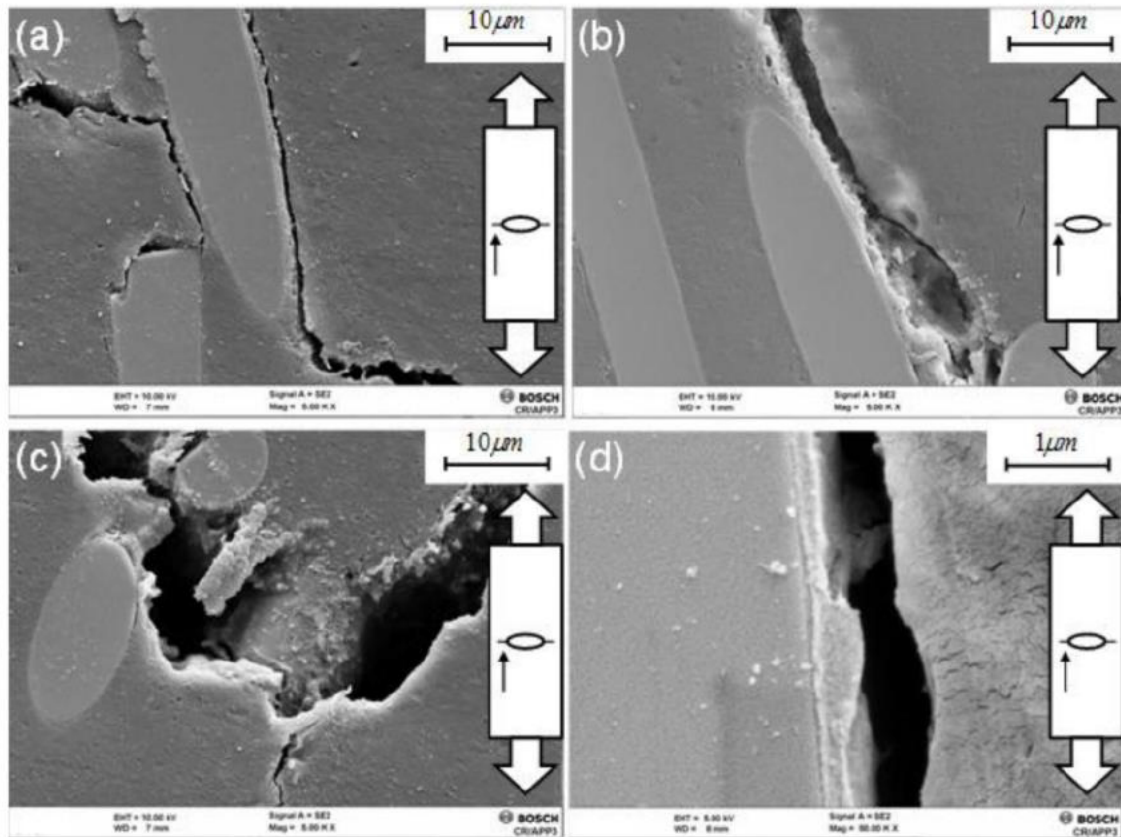
Figure 16 shows damage mechanisms along the crack path in different specimens. Crack propagates in a fiber avoidance mode (Figure 16b). Fibers are covered by a resin layer. Figure 16c provides an example of fiber pull-out in which the fiber extracted from the fracture surface is completely covered by resin layer. This layer is around half a micrometer thick (Figure 16c). The FESEM micrographs shown in Figure 16 indicate that damage occurs at a certain distance from the fiber matrix interface in form of matrix cracking and not in form of fiber-matrix debonding. Hence, the lifetime prediction model should be able to reproduce the damage initiation and propagation at the resin layer covering the fibers. These results confirm the observations of the fracture surface in Figure 16. They are valid for the material system and for the testing conditions reported in this paper.

**Figure 16.** Damage mechanisms along the crack path (notched specimen).
