## THOR MOTOR COACH TEST SUMMARY

**DATE:** 5/9/2022  
**BY:** GLS  
**PROJECT:** TAE22-0029 Hitch Review

Scope of this report is to verify steel properties in fabrication of a failed hitch from a Outlaw motorhome. Fracture analysis was also performed to determine mode of failure.

QA Lab Report No. 7190

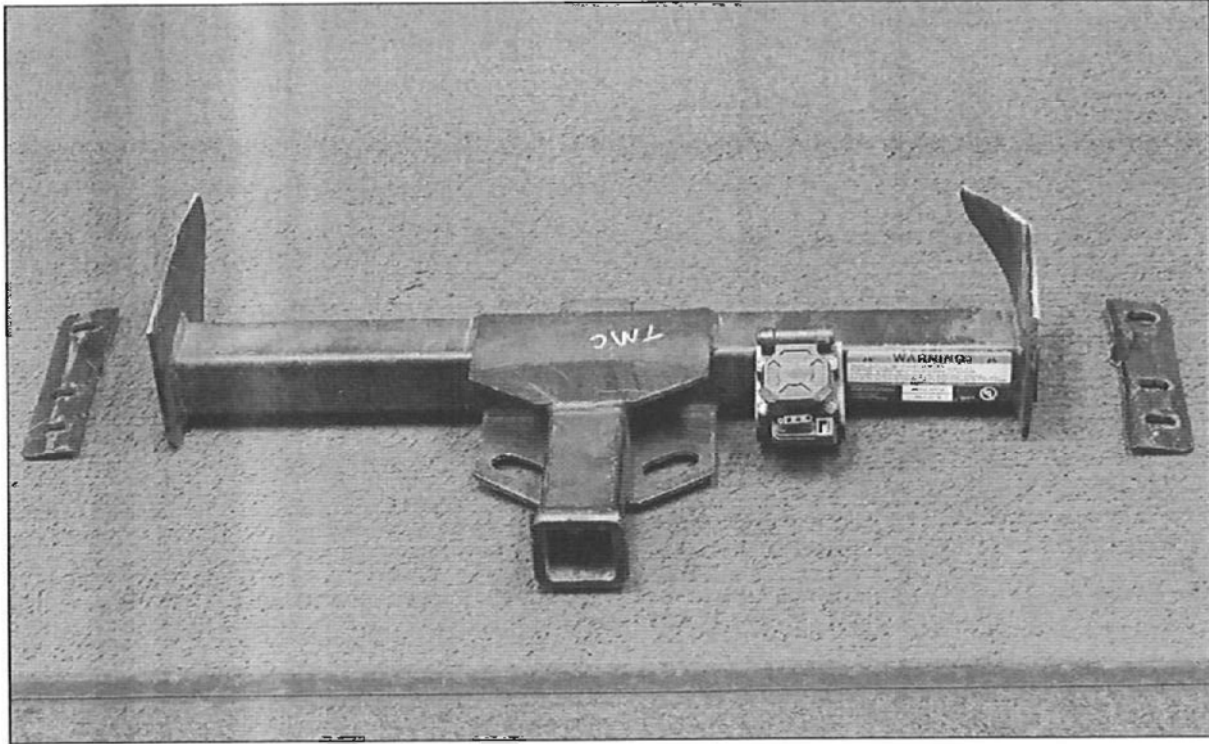
Both end plates broke along the bend radius adjacent to the mounting face (Figure 1). The left plate remained essentially straight (Figure 2), but the right was bent inward on the front (Figure 3) as if the hitch had been pushed forward after the left broke.

Figure 1. Both ends broke along the radius to the mounting face – the front side of the end plate on the right side bent inward, presumably because the left side broke free and the hitch was pushed forward

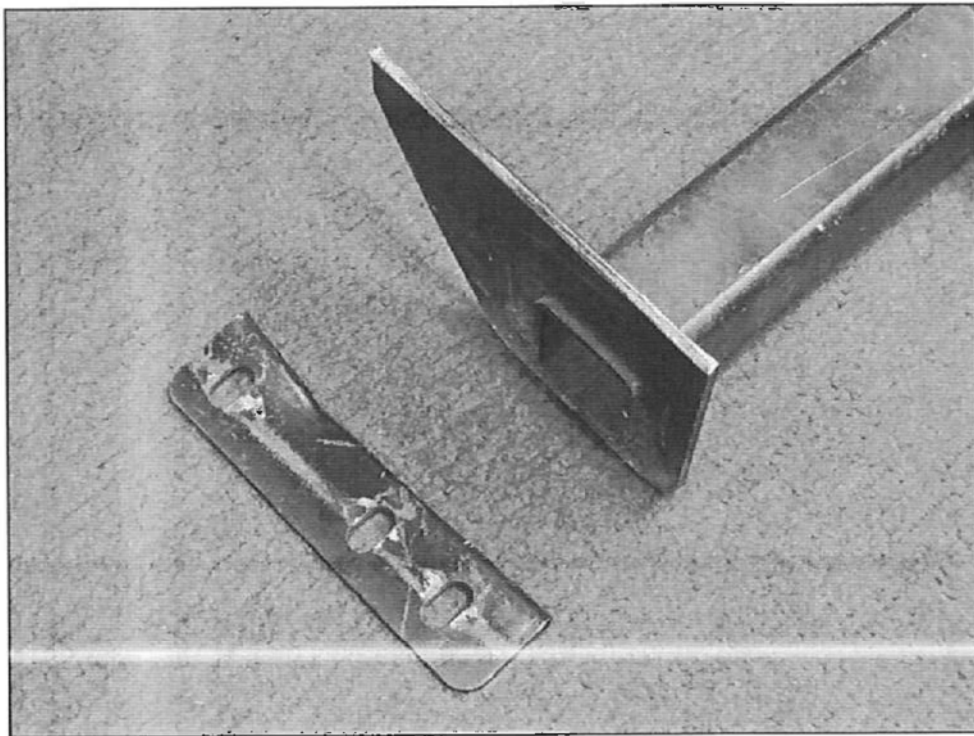
Figure 2. Left Side – breakage followed the radius to the mounting – the fractured end was relatively straight

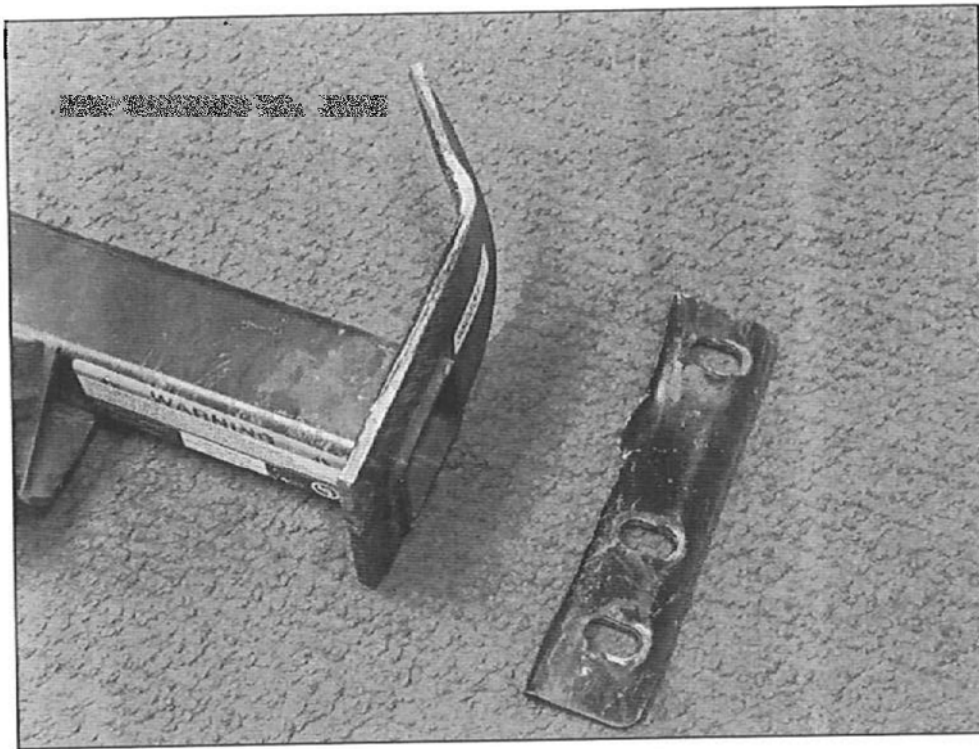
Figure 3. Right Side – breakage followed the radius to the mounting – the fractured end plate bent inward, apparently because the hitch had been pushed forward

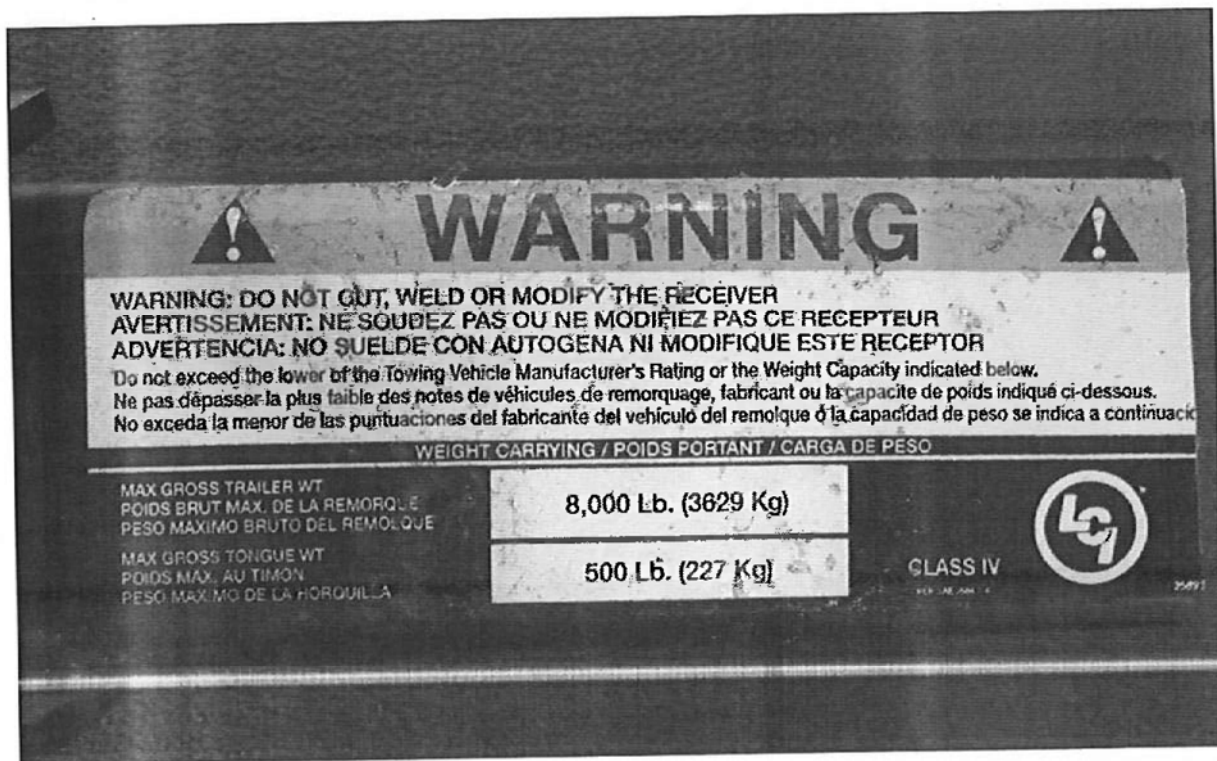
The safety decal (Figure 4) identified the hitch as a Class IV per SAE J684 5 4 35893 made by LCI. It specified a maximum gross trailer weight of 8000 pounds and a maximum gross tongue weight of 500 pounds. A paper sticker on the right end bore the identification "360231" and "#2014-1175 03/11/19"

Figure 4. The safety decal identified the manufacturer, hitch type and load capacity ratings

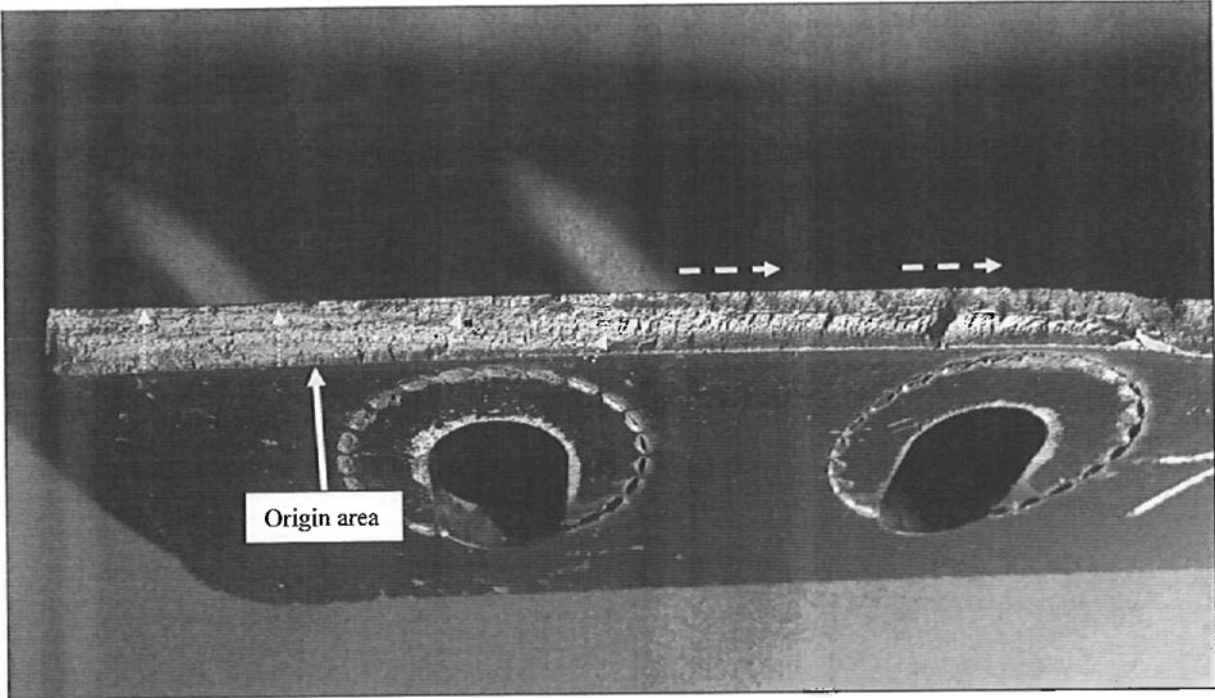
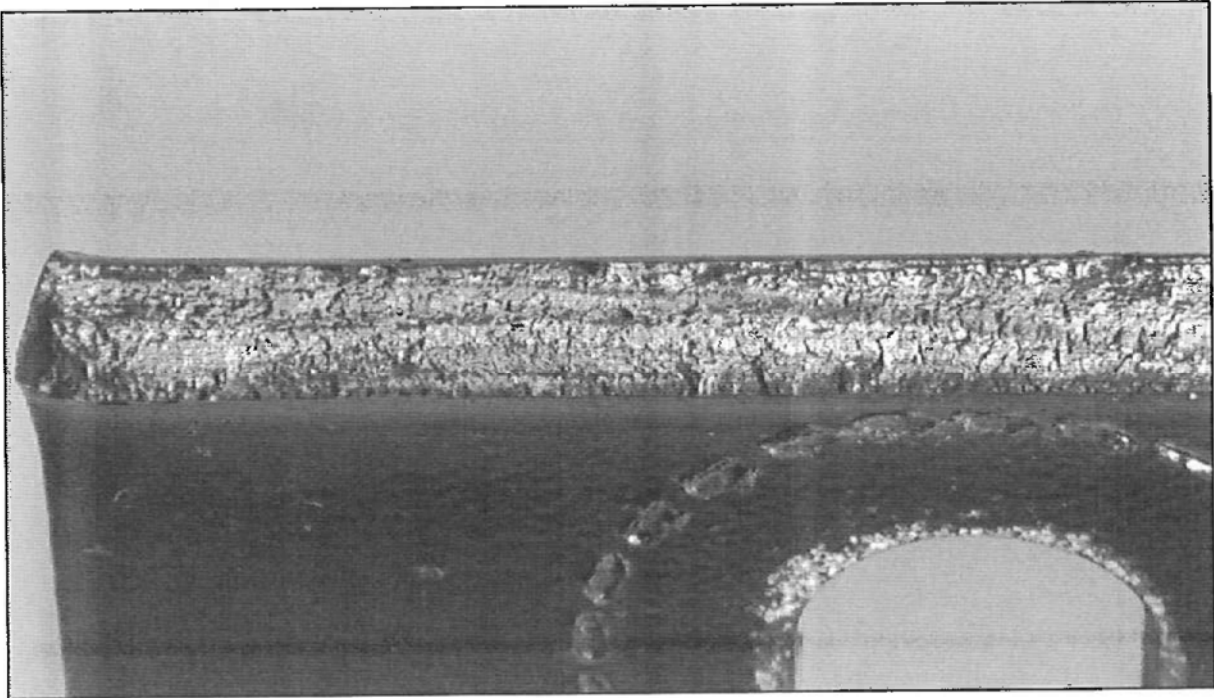
Fracture features included beach marks that show crack propagation in fatigue and ratchet marks indicating multiple fatigue origins. Primary cracks formed in bending fatigue off the inside radii of the end plates. These origins were towards the rear, just past the rear mounting hole on both the left and right. Fracture origins were also found on the front, especially on the left, also off the inside radius of the end plate (Figures 5 to 8). No material flaws or defects were found in association with the origins.

Figure 5. Left, Rear – beach marks point to bending fatigue origins off the inside bend radius, centered behind the rear mounting bolt hole – ratchet marks or steps reveal multiple fatigue origins – no material flaws or defects were found in association with the origin area – ductile tearing extended from the fatigue zone to the mid length of the mounting

A hitch fail such as this should not occur. The hitch needs to be strengthened in this lateral direction to prevent this failure. Cyclic testing may also need to be addressed in this hitch design. The SAE standard for this hitch is SAE J684 it does not require cyclic testing but SAE J2638 for 5th wheel and gooseneck hitches does. Guidance for cyclic testing could be taken from this latter SAE standard and applied to this design.

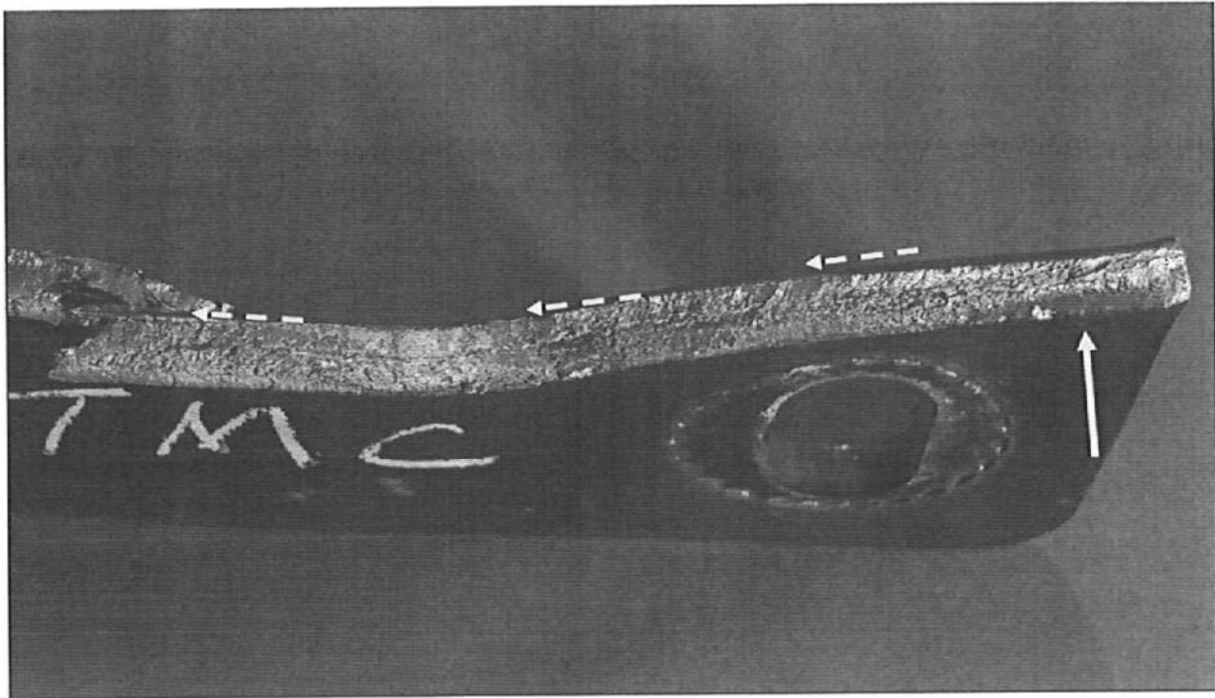
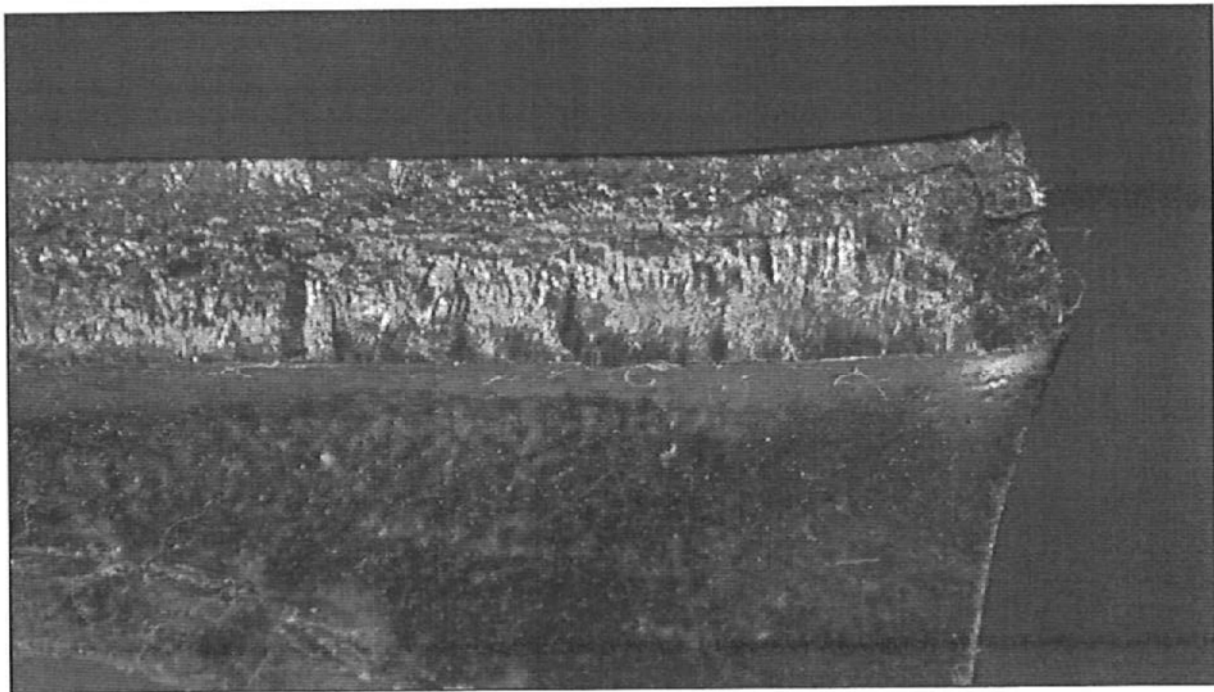
Figure 6. Left, Front – beach marks were not as well defined, but ratchet marks show the fracture at this end originated in bending fatigue off the inside radius, ahead of the front mounting bolt hole – no material flaws or defects were found in association with the origin area – ductile tearing extended from the fatigue zone to the mid length of the mounting where final fracture occurred in a ductile manner

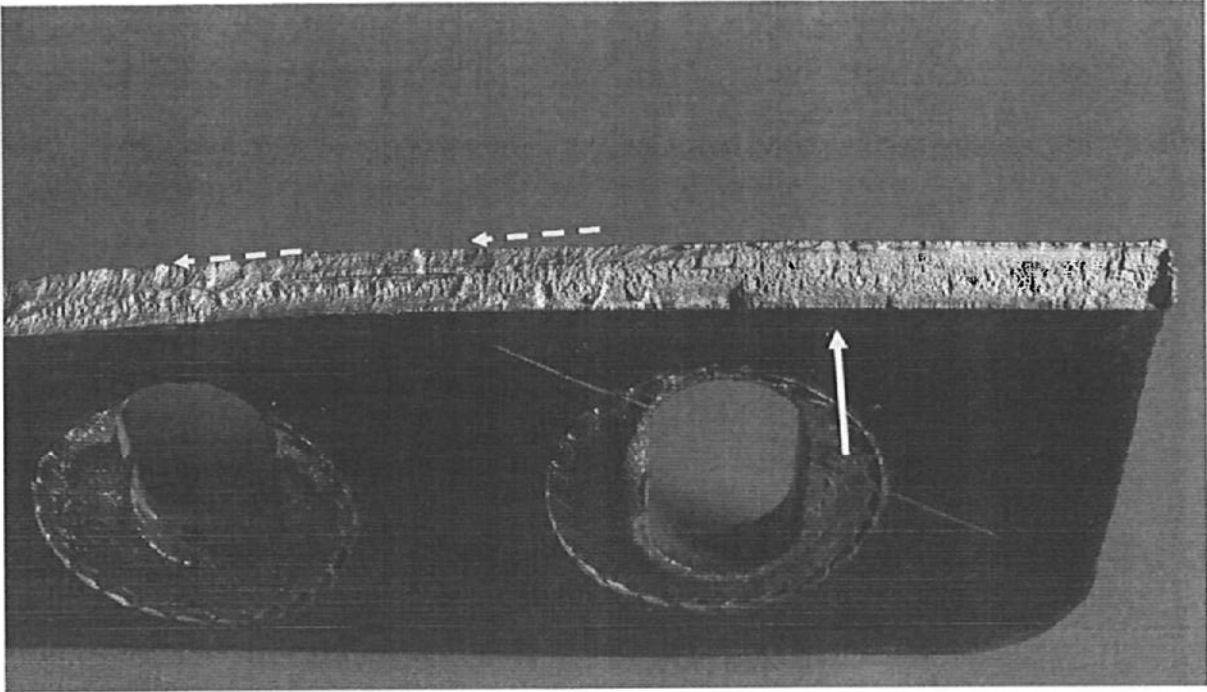
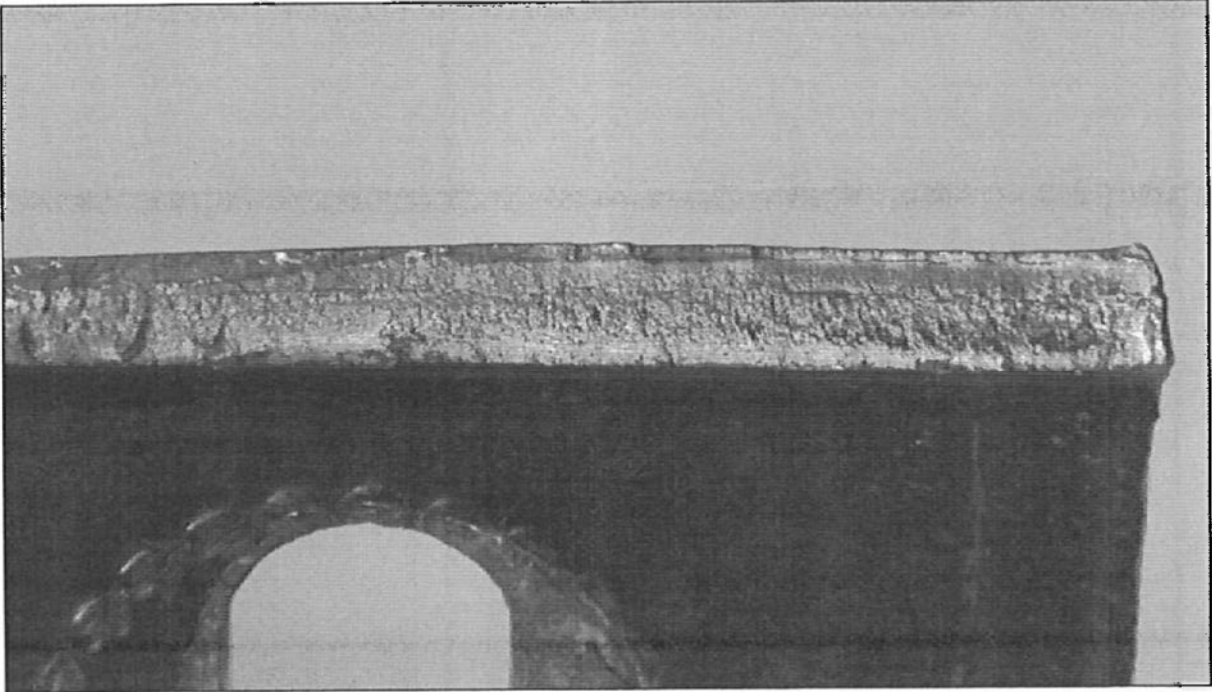
Figure 7. Right, Rear – beach marks point to bending fatigue origins off the inside bend radius, centered near the rear mounting bolt hole – ratchet marks or steps reveal multiple fatigue origins – no material flaws or defects were found in association with the origin area – ductile tearing extended from the fatigue zone to the mid length of the mounting

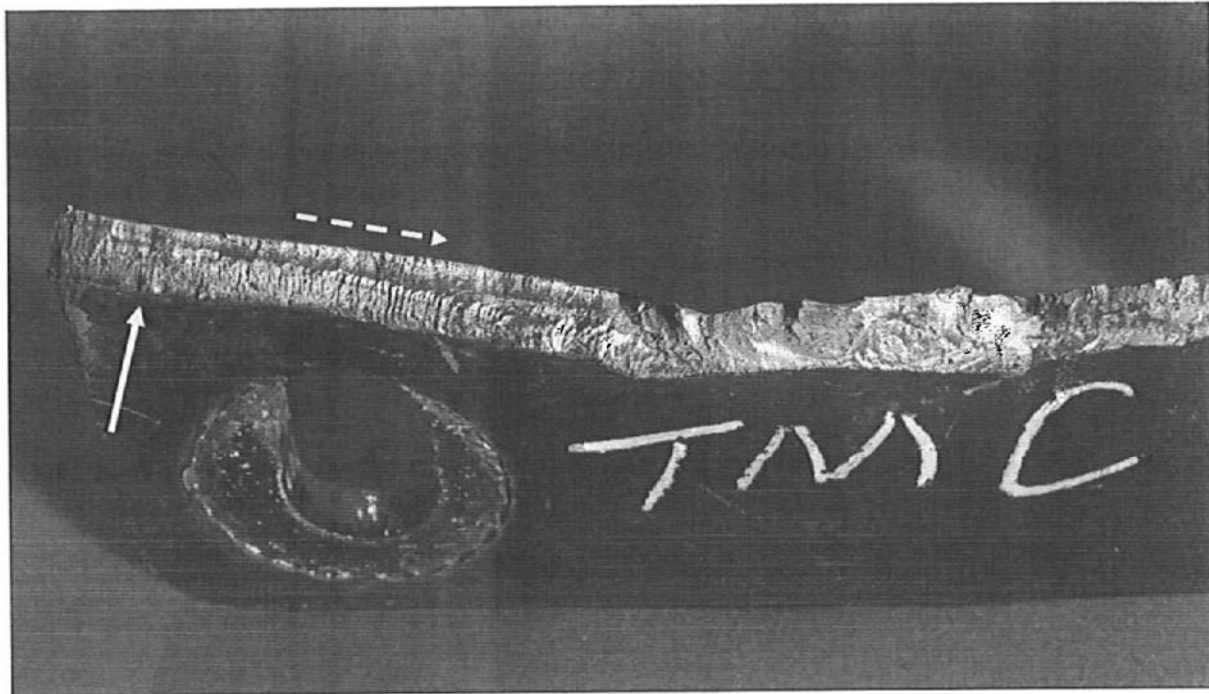
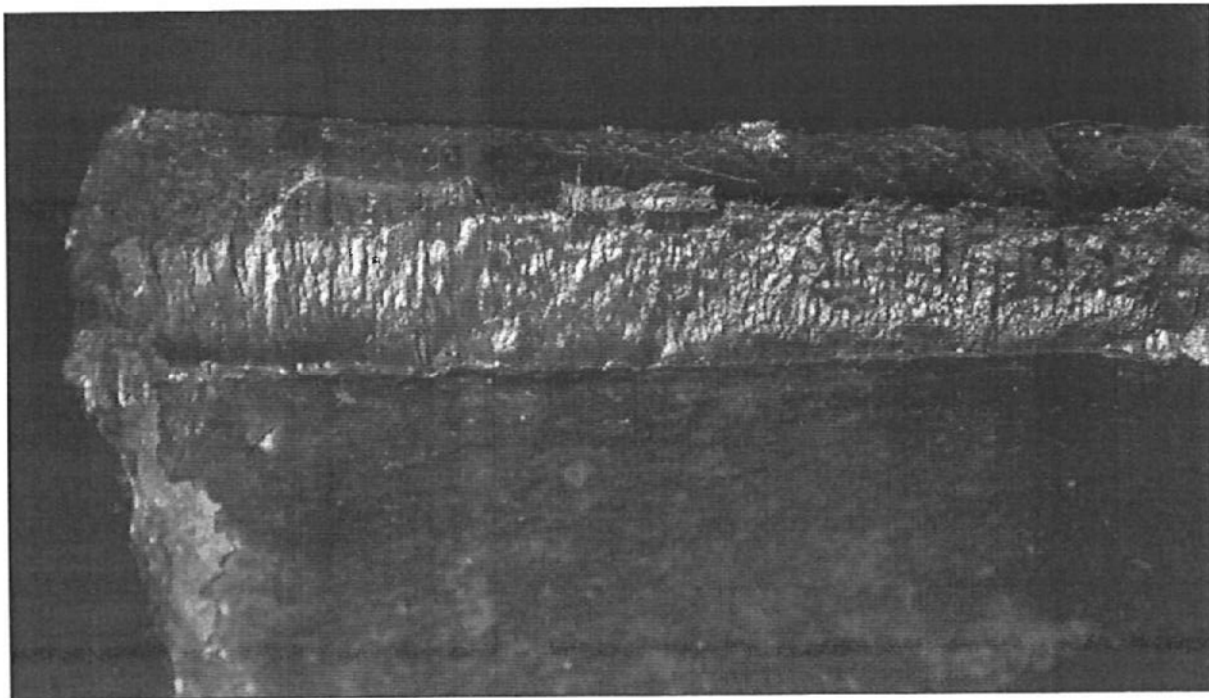
Figure 8. Right, Front – fracture features did not include beach marks – some traces of ratchet mark steps were found on the inside radius, but no significant propagation in fatigue – a majority of the fracture appears to be the result of ductile overloading – no materials flaws or defects were found in association with this fracture

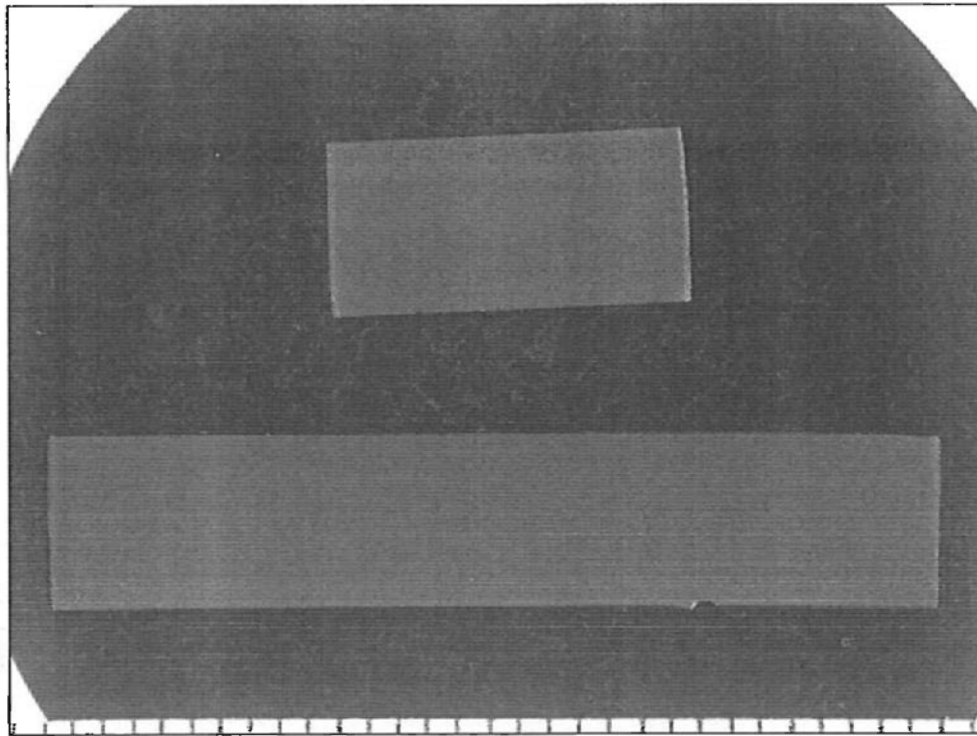
Figure 9. Left – metallographic cross sections cut from the mounting face in the longitudinal and transverse directions – indents are from the bolts – Nital Etchant, mm Scale

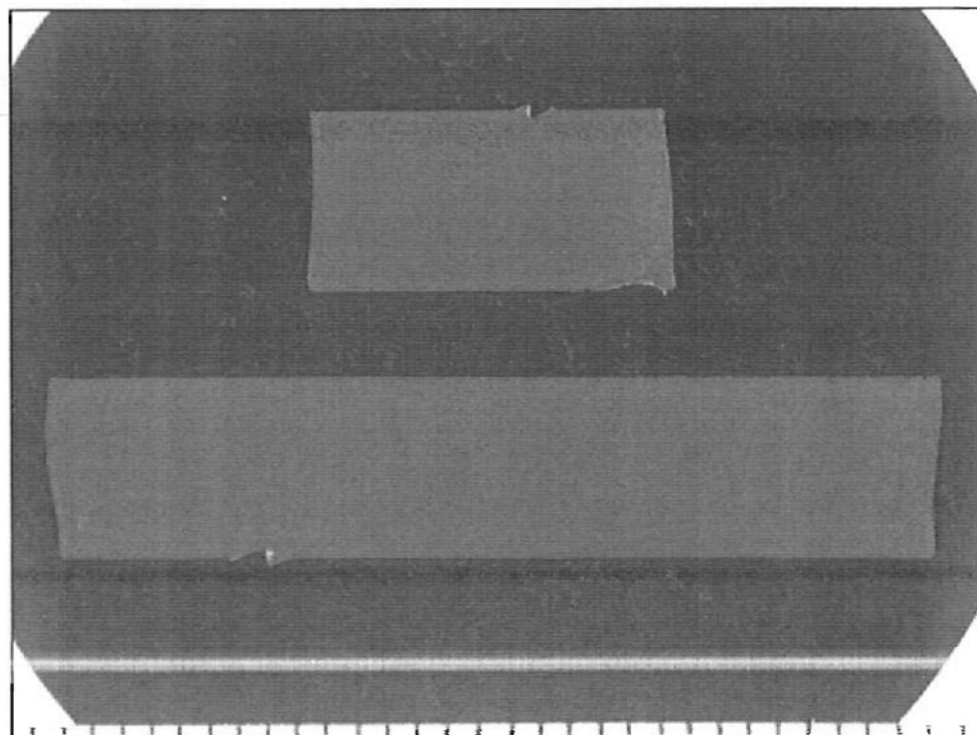
Figure 10. Right – metallographic cross sections cut from the mounting face in the longitudinal and transverse directions – indents are from the bolts – Nital Etchant, mm Scale

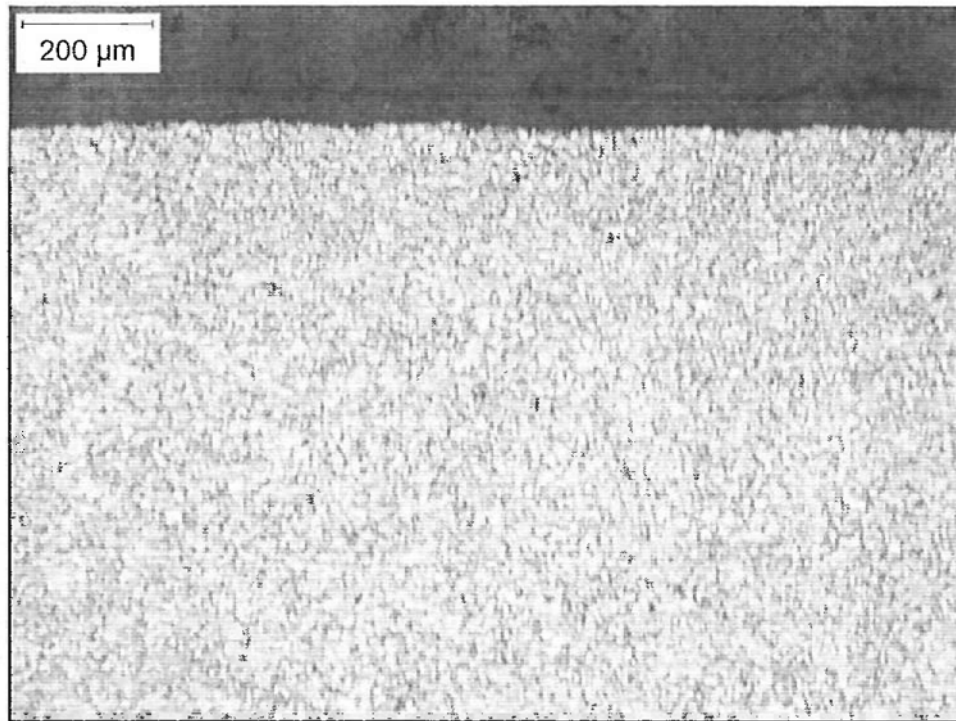
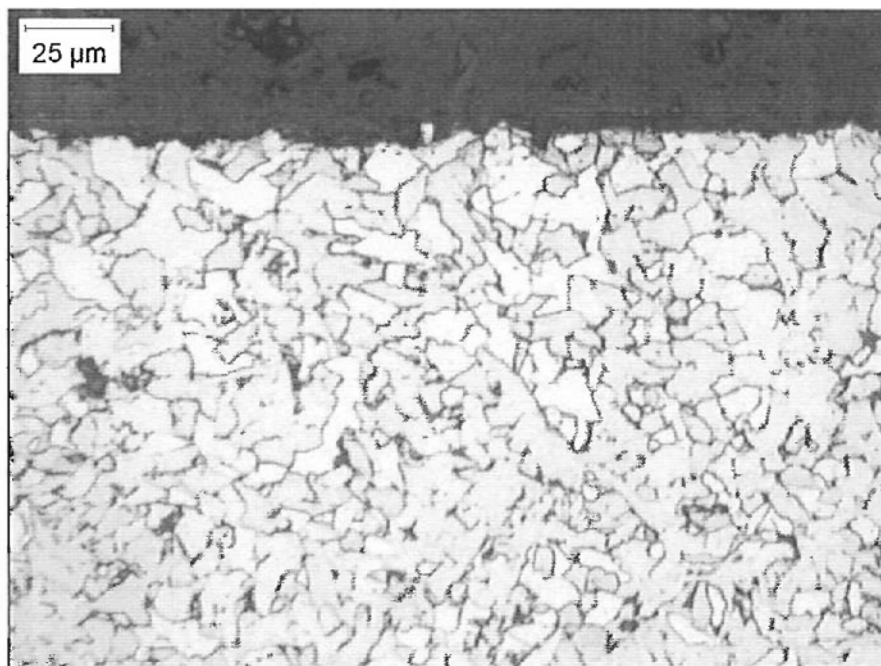
Figure 11. Left, Surface – the microstructure consists of fine ferrite grains (white) with scattered islands of pearlite (dark) – no objectionable features of the microstructure were found – this microstructure is consistent with expectations for the specified low carbon steel

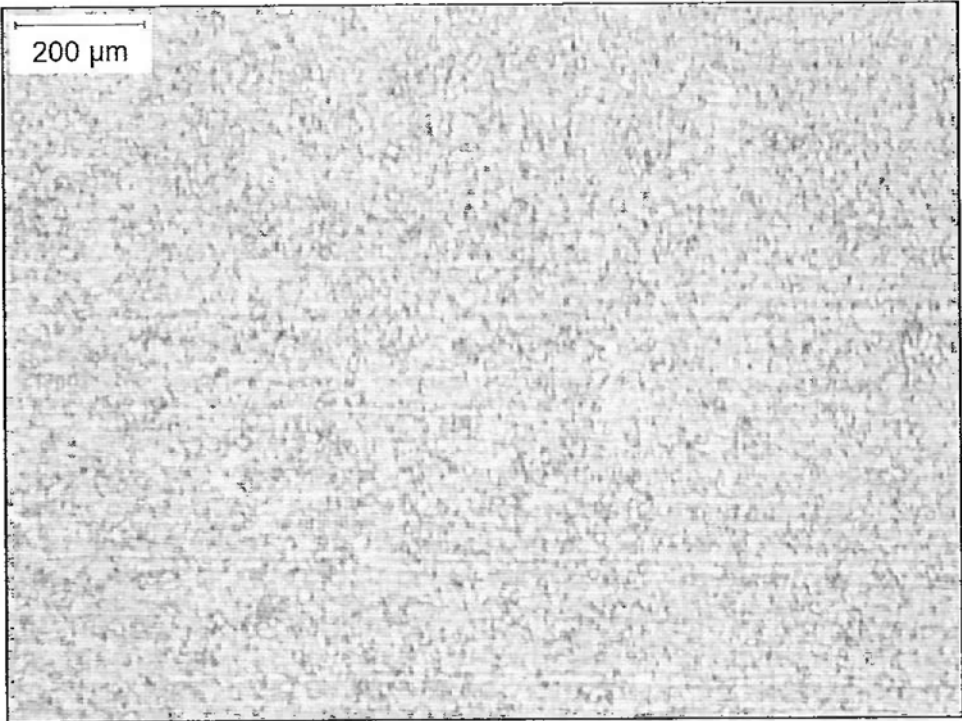
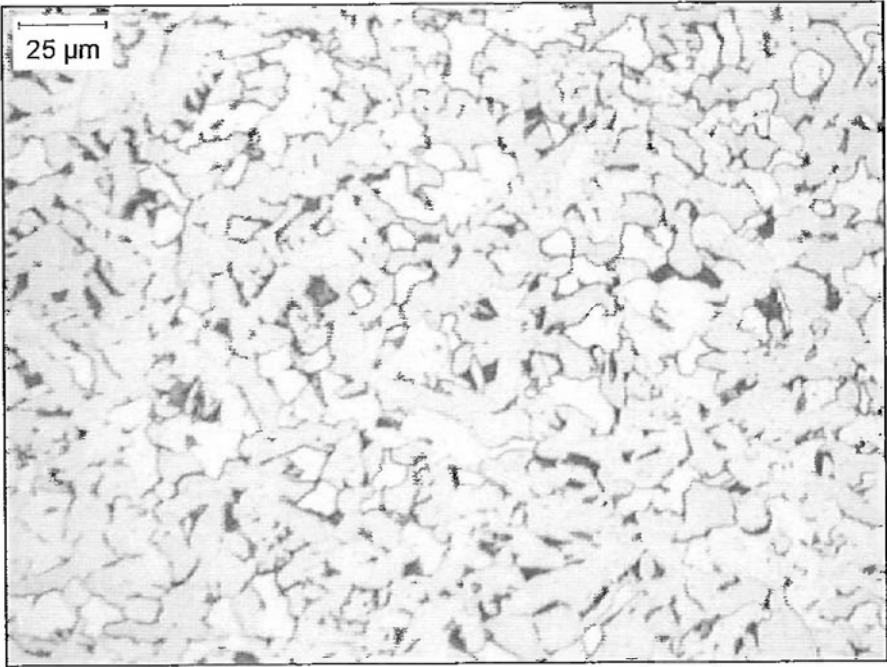
Figure 12. Left, Core – the microstructure consists of fine ferrite grains (white) with scattered islands of pearlite (dark) – no objectionable features of the microstructure were found – this microstructure is consistent with expectations for the specified low carbon steel

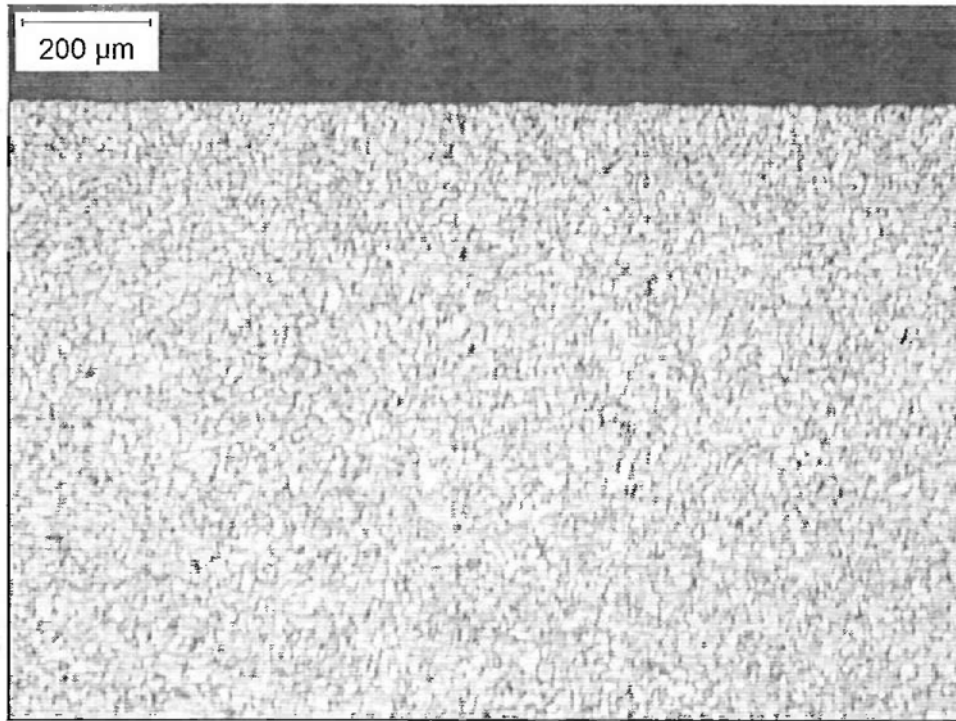
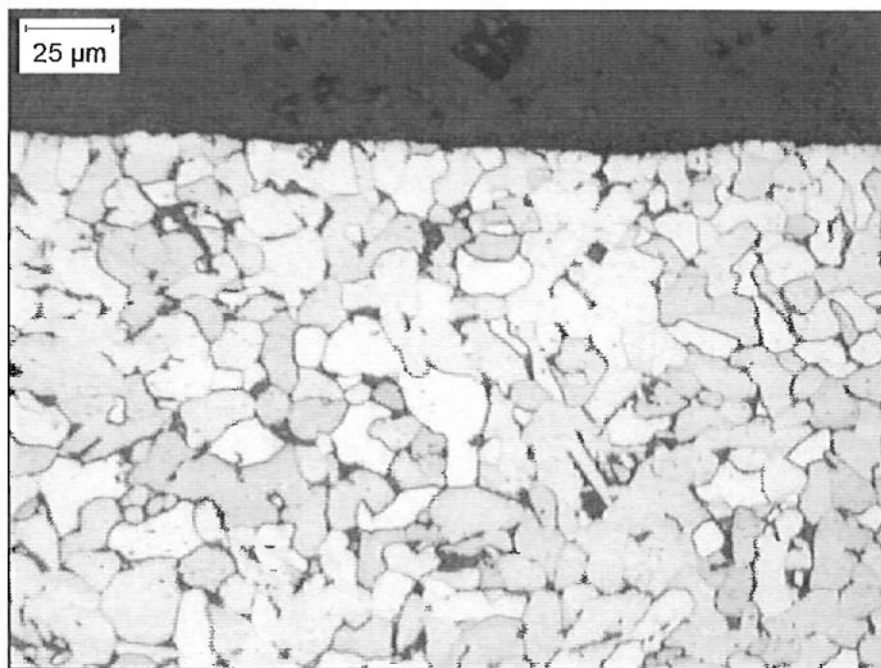
Figure 13. Right, Surface – the microstructure consists of fine ferrite grains (white) with scattered islands of pearlite (dark) – no objectionable features of the microstructure were found – this microstructure is consistent with expectations for the specified low carbon steel

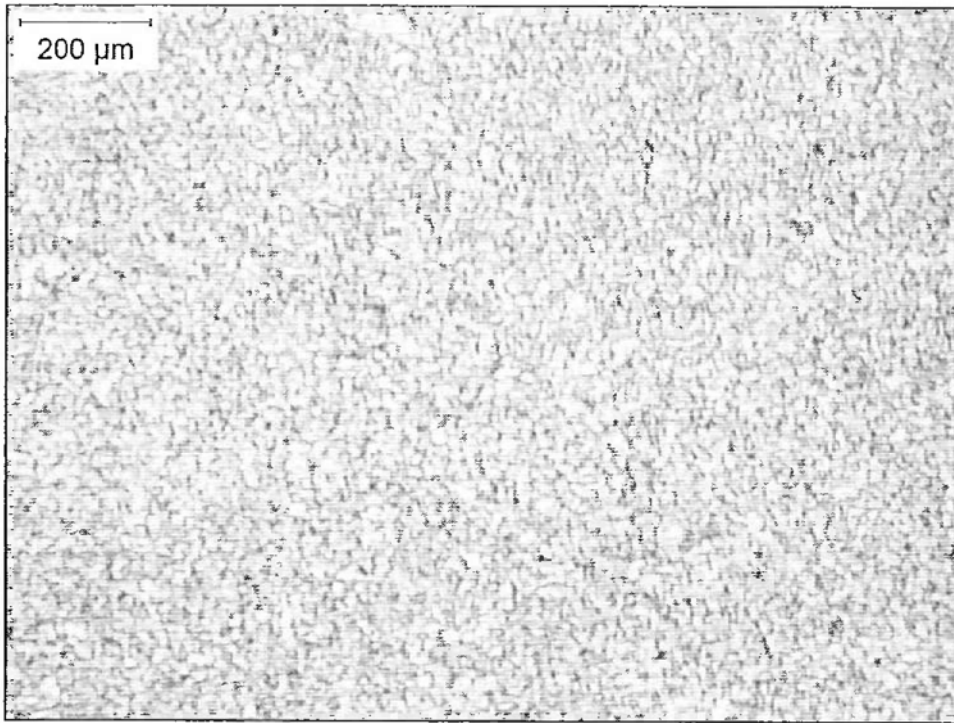
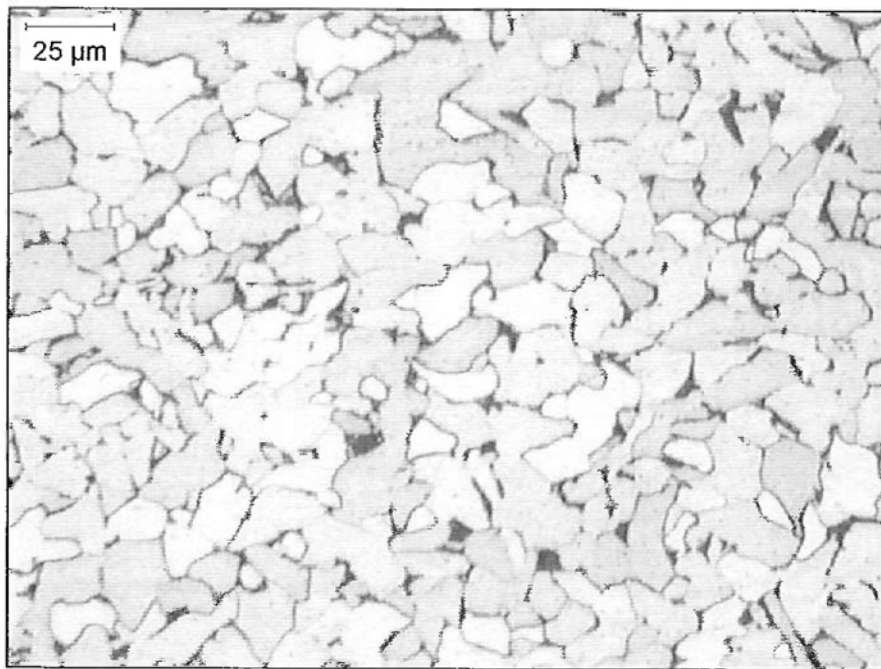
Figure 14. Right, Core – the microstructure consists of fine ferrite grains (white) with scattered islands of pearlite (dark) – no objectionable features of the microstructure were found – this microstructure is consistent with expectations for the specified low carbon steel
