September 2020

Safety Recall W53

Steering Column Wiring Harness

2019 - 2020 (JL) Jeep® Wrangler

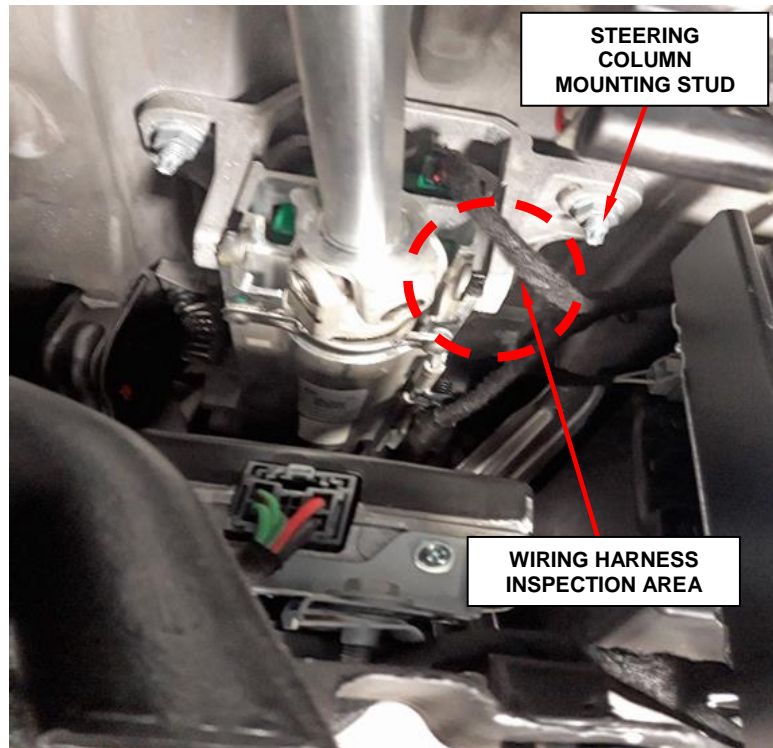
Figure 3 – Steering Column Shaft

The Electronic Steering Lock (ESL) wiring harness on about 31,000 of the above vehicles may come in contact with the steering column shaft while turning. This condition may cause wiring abrasion and over time may damage the wires. If certain wires become damaged, this may lead to loss of motive power and/or power steering assist. A loss of motive power or power assist may increase the risk of a crash without any prior warning.

3. Inspect the Electronic Steering Lock (ESL) module wiring harness (red dashed area) for any wire abrasion or damage (Figure 3).

4. If **there is NO** wiring harness abrasion continue with step 6.
5. If **there is any** wiring harness abrasion on wire harness friction tape or insulation inspect for damaged wires then continue with step 10.
