STAR Case

Symptom/Vehicle Issue: Steering Requires Excessive Effort When Turning At Slow Speeds

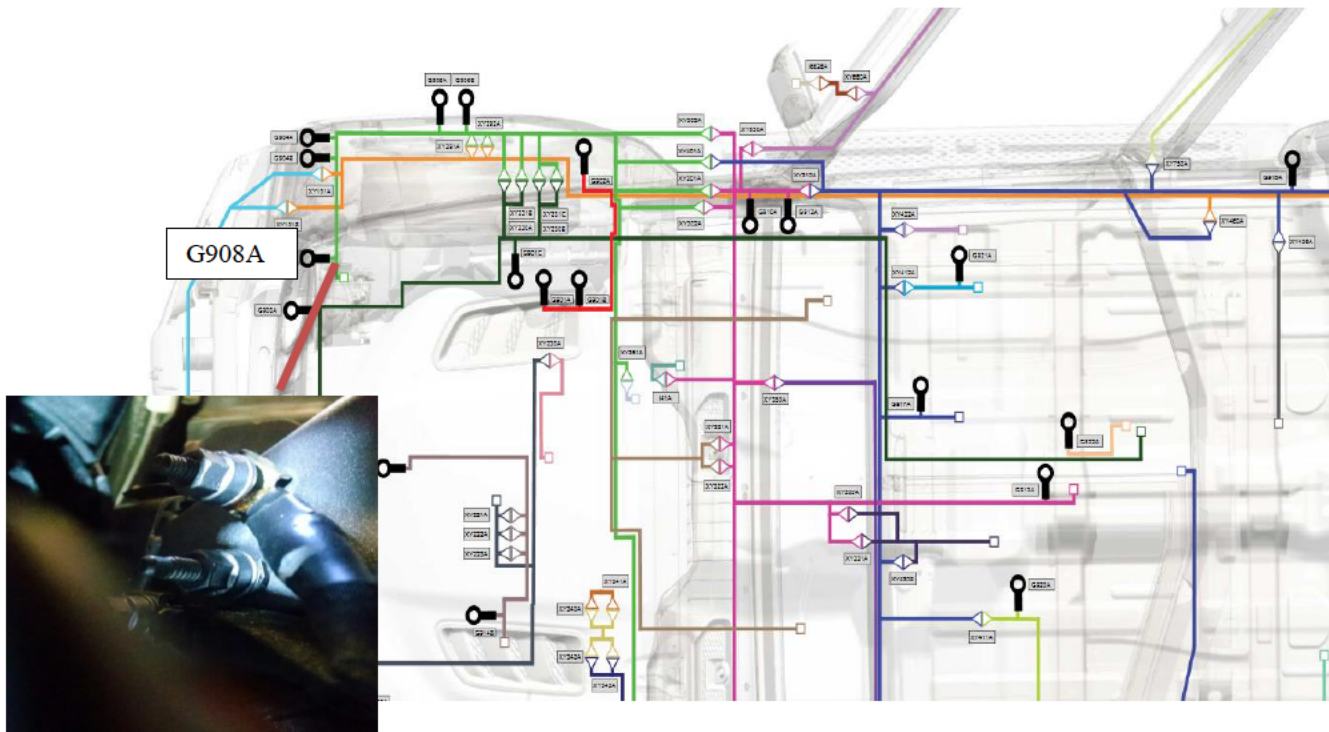
Discussion: Excessive effort required when steering in a parking lot, DTC U0131-00 Lost Communication With Power Steering Control Module "A" may be stored or active. Inspect the G908 ground location, clean and tight as needed to complete.
