STAR ONLINE PUBLICATION

Symptom/Vehicle Issue: U0131-00-LOST COMMUNICATION WITH POWER STEERING CONTROL MODULE "A". Service Electric Power Steering Message On Cluster.

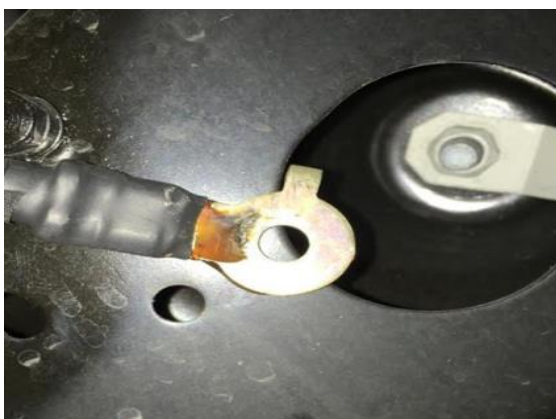
Heat Shrink Glue Interference.

Discussion: As part of diagnostics for U0131-00, connections of the EPS grounds to the frame should be verified. It may be necessary to disassemble, clean both sides of the eyelet and the ground stud location with Emory paper. Also inspect the eyelet for heat shrink glue. Carefully Trim any glue from the contact surfaces with a razor knife. Inspect the ground stud for weld spatter that could prevent a consistent flat electrical connection. Carefully grind or file down the spatter to provide a flat connection point. Refer to the images below.

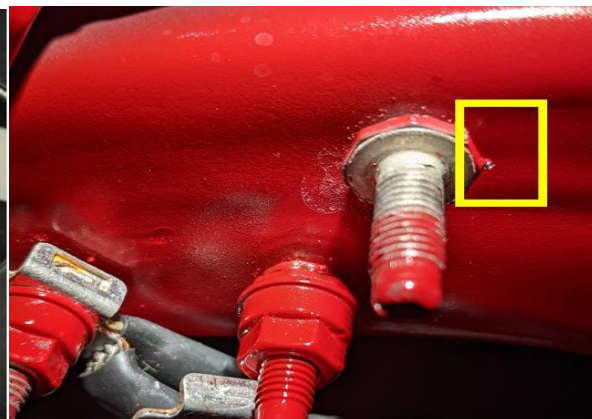
Weld Spatter Causing Poor Eyelet Connection.
