STAR ONLINE PUBLICATION

Symptom/Vehicle Issue: Loss Of Power Steering Assist. U0131 Lost Communication With Electro Hydraulic Power Steering Control Module (EHPS).

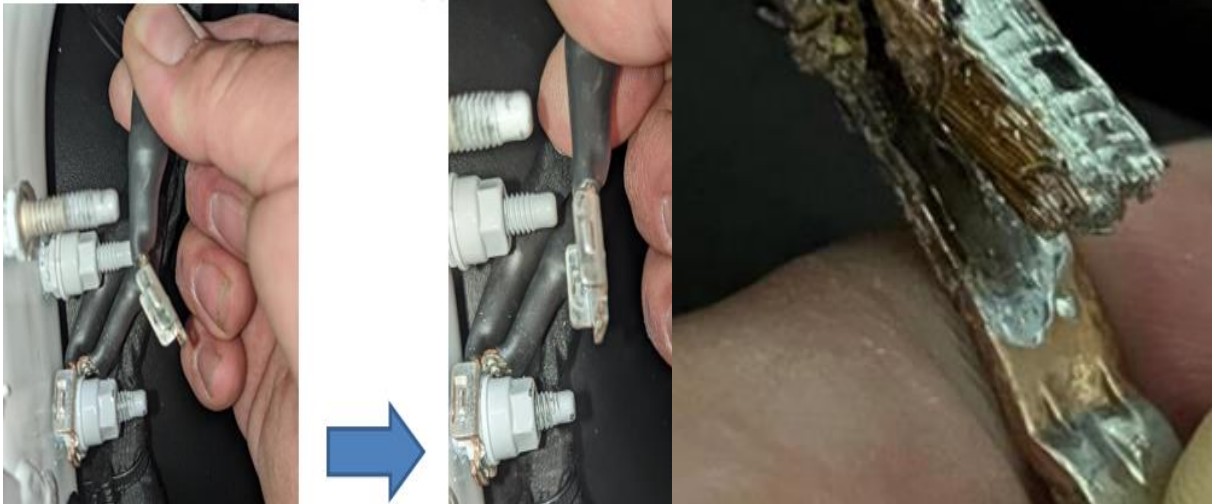
Fig 2.

Diagnosis: Inspect the G908A ground located behind the passenger side headlight. Determine if the ground eyelet is properly secured to the ground wire. Check if the eyelet from the power steering ground is bent. If it is, carefully bend it back straight (Fig. 2).

Next, remove the shrink tubing from the ground cable. Verify the wire is firmly attached and soldered to the eyelet (right image in Fig. 2). Note the shrink wrap may need to be removed to inspect and repair. If it is removed, replace with dual layer glue style shrink wrap.

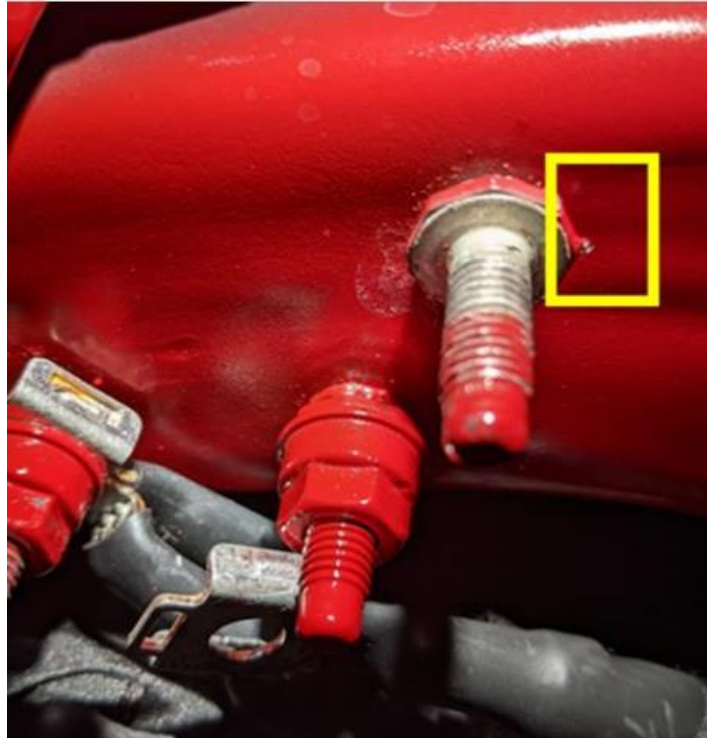
Fig 3. Weld slag to be filed or ground down.

Using a wire brush, file and emery cloth as needed, clean the top weld stud thoroughly from any impurities that can cause the eyelet not to make flat contact (dirt, paint, glue, weld slag). Refer to Fig 3. Reconnect the ground wire and torque to 15 N-m (11 Ft-Lbs.).

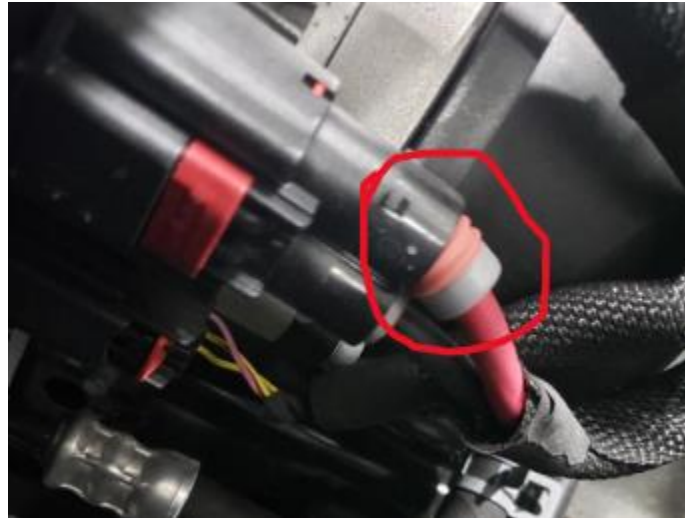
Example Of Pin Push Out.

Using a multimeter verify power and ground at the EHPS C1 connector. C2 connector has pins for CAN communication and Ignition Run Start. Inspect each for problems including pin pushout and harness routing. Repair as needed.
