TO: FCA CORPORATION
INVESTIGATION REPORT FOR JL EHPS PUMP for performance verification
REPORT NUMBER: [REDACTED]
ISSUE DATE: Aug 22th, 2023

SUBJECT: Investigation report JL EHPS Pump for performance verification
EHPS Pump Profile:

Part No.: 68247930AD
Model: 2019 JEEP WRANGLER UNLIMITED SAHARA
Serial No.: [REDACTED]
VIN: [REDACTED]
Vehicle build date: 02/09/2019
Part Mfg Date: 09/22/2018

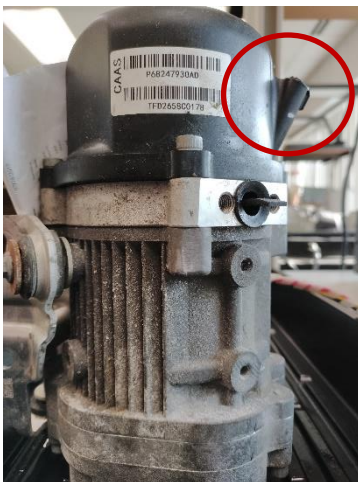
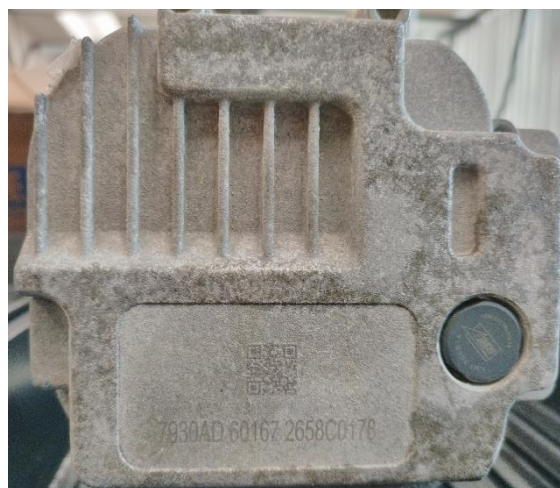
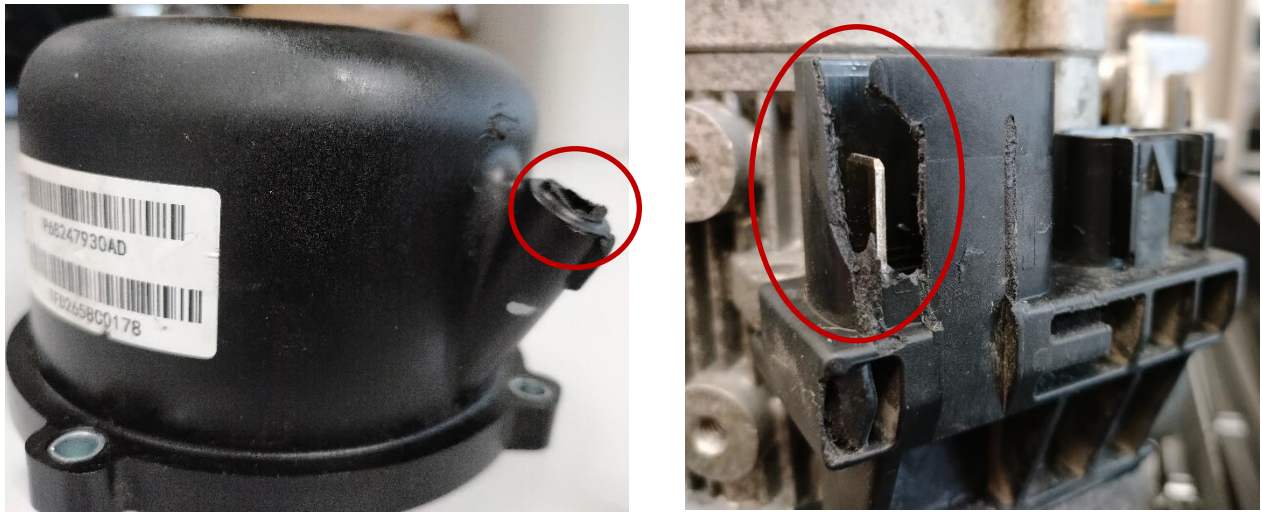
Fig 1. EHPS and Connector, Oil inlet Condition While Receiving

Part Checked	Result	Remarks
1) Reservoir	O.K	Reservoir is O.K
2) Motor Housing	O.K	Motor housing is O.K
3) Controller Cover	O.K	Controller cover is O.K
4) Vent	NOK	Oil inlet is broken
5) Bracket	O.K	Bracket is O.K
6) Connector port	NOK	Power Supply Housing is broken

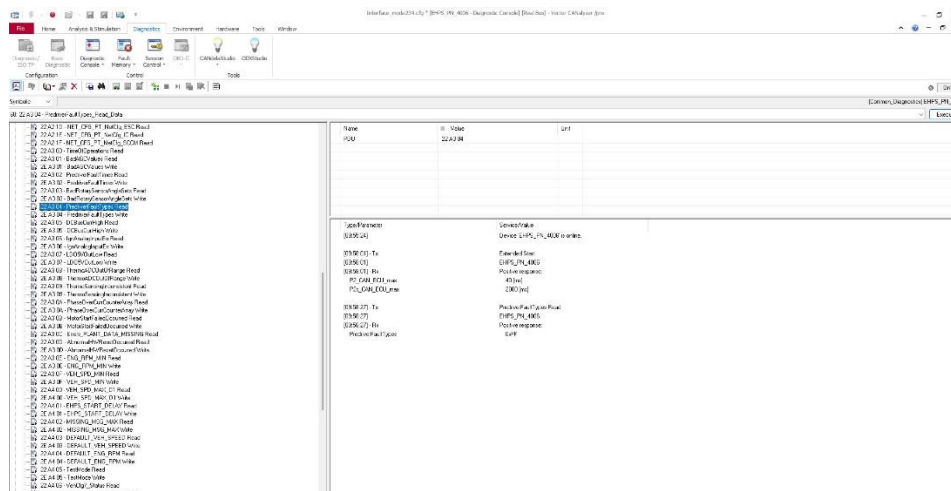
Fig 3. CAN Communication -Pre Driver Read

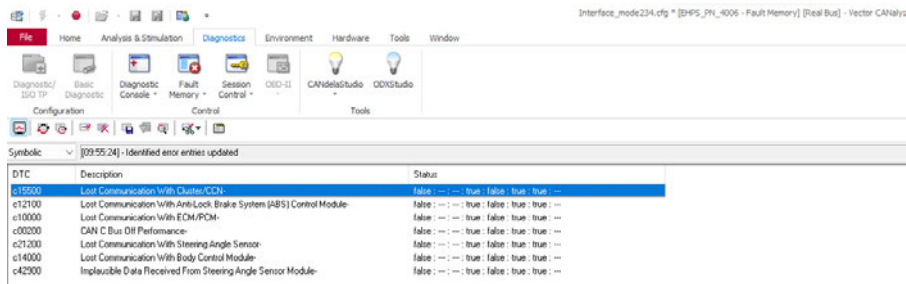
Fig 4. CAN Communication – Confirmed DTC List.

Summary Module lists has CAN Communication failure.

Cluster DTC=C15500	ABS DTC=C12100	ECM/PCM DTC=C1000	CAN C Bus off performance DCT=C0020	Steering angel sensor DTC=C21200	BCM DTC=C1400	Implausible data from Steering Angle Sensor Data DTC =42900
Original Odometer value	7214	7214	7214	7514	7214	7214	7214
Most Recent Odometer Value	7503	7503	7548	7504	754B	724A	7201

RESULT: Based on the table, it indicates there was a problem with CAN bus. The “CAN Bus off “DTC was confirmed, which should be the root cause of CAN Bus Failure.
