# SET 881 Diagnostics

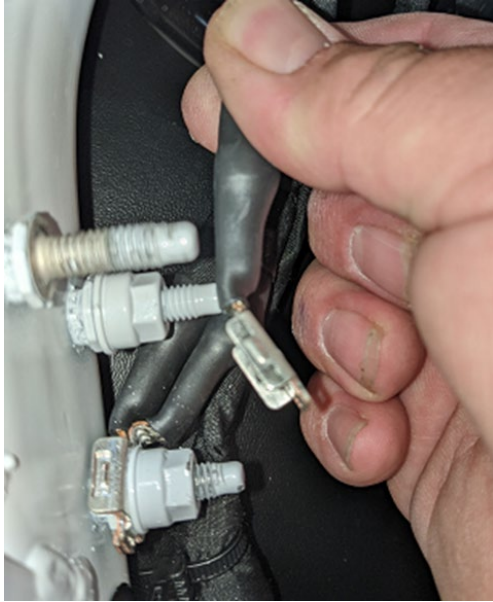
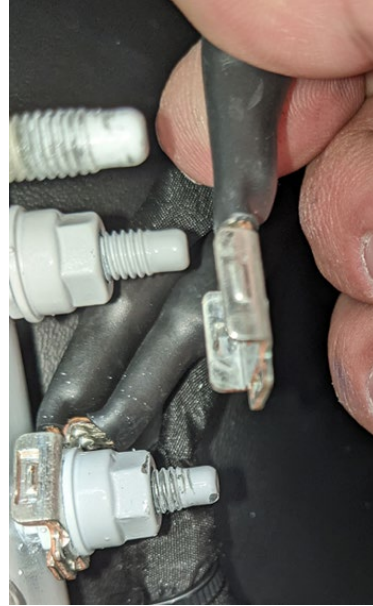
- Check if the eyelet from the power steering ground is bent. If it is, make it straight.

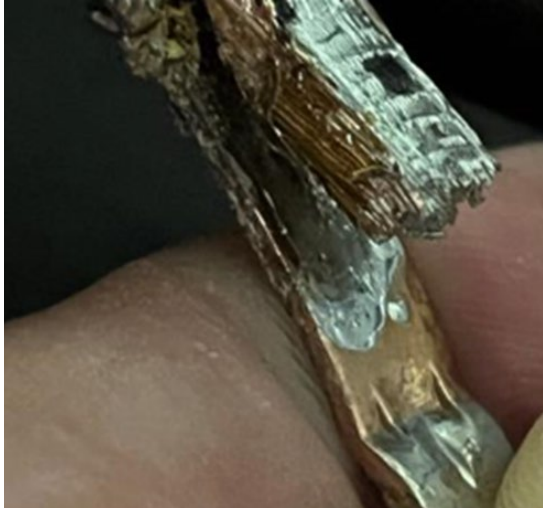
Defective welding

- If the issue persists, remove ground from stud, then remove the shrink tubing from ground and check that the wire is firmly

welded to the eyelet. If the joining is defective, replace the ground wire.

If the components are correctly attached and not separated, replace the heat shrink to ensure the wiring is sealed again.

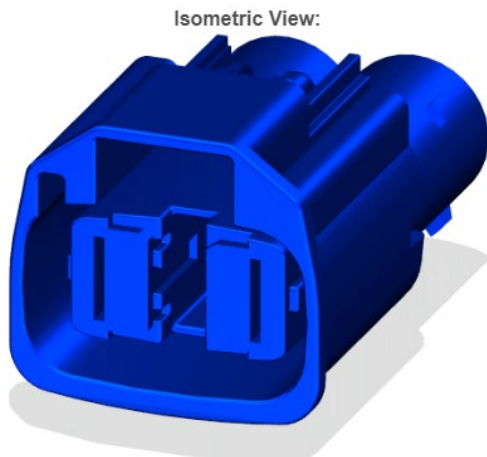
- Verify the connection between pump and wire connectors is firm and steady.
- Check if the wiring harness is pulling the connector, allowing to expose the seal on the wire insertion side. If it is, replace the damaged connector.

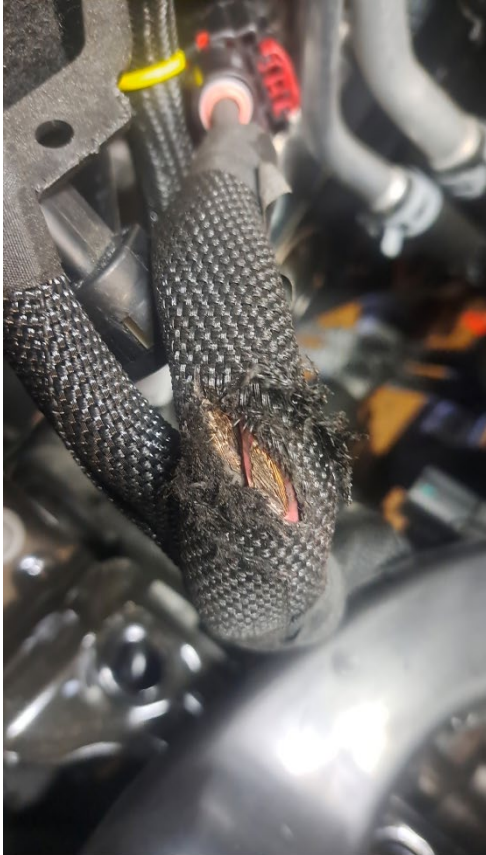
- Inspect the dash wiring harness for damage or wear due to contact to other components.

wiring rubbed by alternator pulley
