# SAFETY RECALL

NORTH AMERICA  
12V Isolator Post

Reference: B0A / NHTSA 23V-753

Remedy available for  
2023 (RU) Chrysler Pacifica

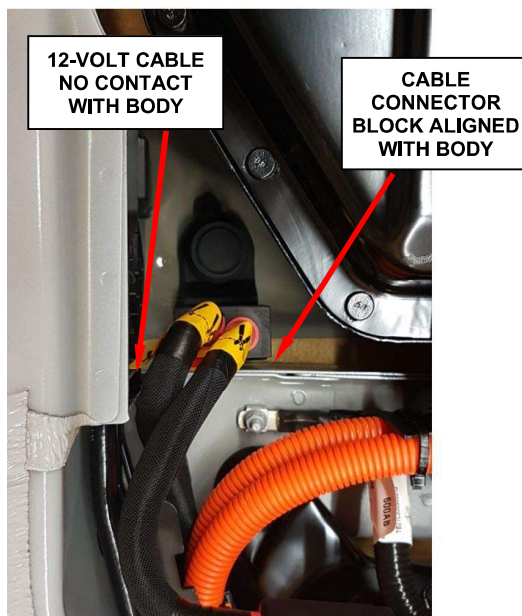
#### Acceptable

- 12-volt cable is NOT contacting the body
- Cable connector block is aligned with body NOT rotated or contacting the body

**NOTE:** The 12-volt cable terminal connector block may rotate during tightening. Ensure the connector block stays stationary during tightening and is properly aligned when fully tightened. Connector block should not be visibly rotated and cables should not be touching any metal surfaces after the terminal nut has been tightened to the proper torque specification (Figure 29).

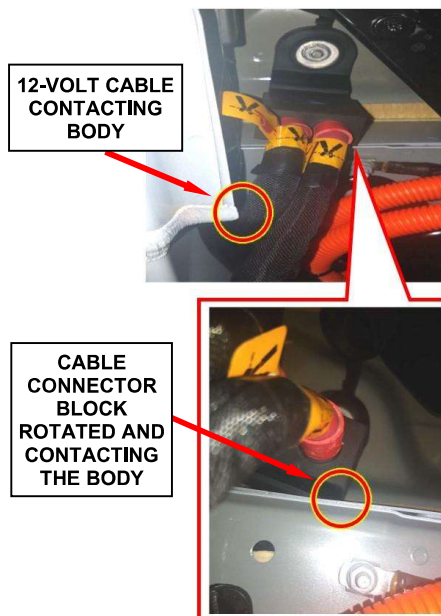
#### Not Acceptable

- 12-volt cable is contacting the body
- Cable connector block is rotated and contacting the body
