**NUMBER:** 25-003-18

**GROUP:** 25 - Emissions Control

**SUBJECT:**

Internal Catalytic Converter Damage

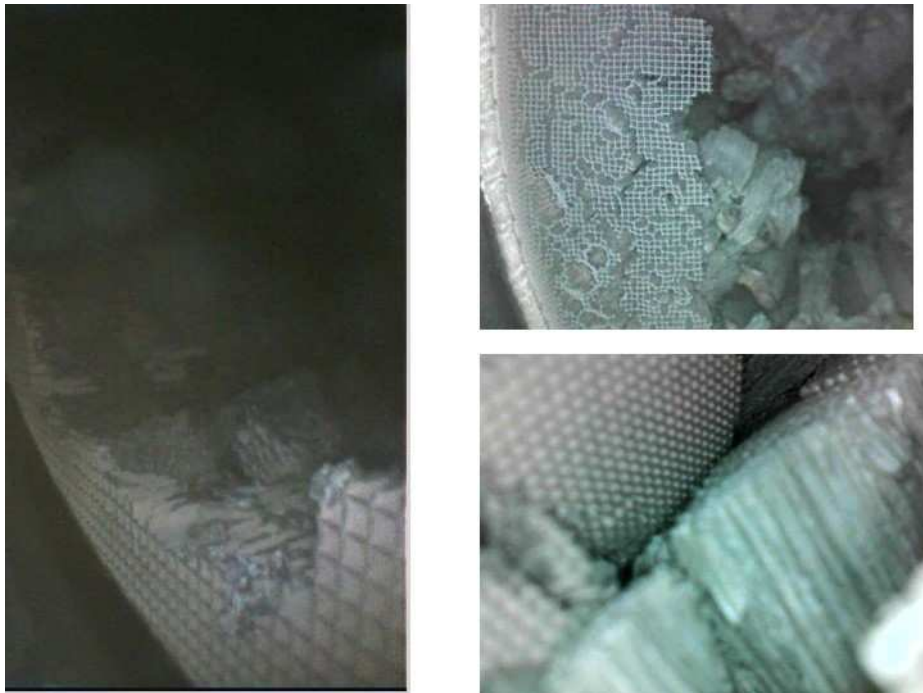
**Fig. 5**  
**Extreme Damaged Substrate**

- d. Look for signs of discoloration, melting, chipping, degradation, or any other anomaly. Inspect the entire face. If there is evidence of over-heating, the converters will need to be replaced, proceed to [Step 1](#) of the Repair Procedure.

- f. Looks for signs of degradation, shifting (change of position; under the right conditions, it is possible for the upper catalyst substrate to be pushed down). If there is evidence of over-heating, the converters will need to be replaced, proceed to [Step 1](#) of the Repair Procedure.

**NOTE:** The damaged substrate will show primarily heavy damage (missing material/large holes). Lighter damage to the substrate will consist of broken matrix walls but may not have progressed to large sections of missing material /holes. If “chains” of broken cell walls are found, the catalysts & O2 sensors need to be replaced. This may be present from viewing at either O2 sensor location.

1. Remove and replace catalytic converters as needed. Refer to the detailed service procedures available in DealerCONNECT> TechCONNECT under: Service Info>11 - Exhaust System/Converter, Catalytic/Removal and Installation>Right>Left.
2. Remove and replace oxygen sensors (O2) as needed. Refer to the detailed service procedures available in DealerCONNECT> TechCONNECT under: Service Info>14 - Fuel System/Fuel Injection, Gas/Sensor, Oxygen/Removal and Installation> Upstream>Downstream.
3. Power up the 12 volt system. Refer to the detailed service procedures available in DealerCONNECT> TechCONNECT under: Service Info>08 - Electrical/Standard Procedure 12 Volt Power Up.
