Request 11

Answer

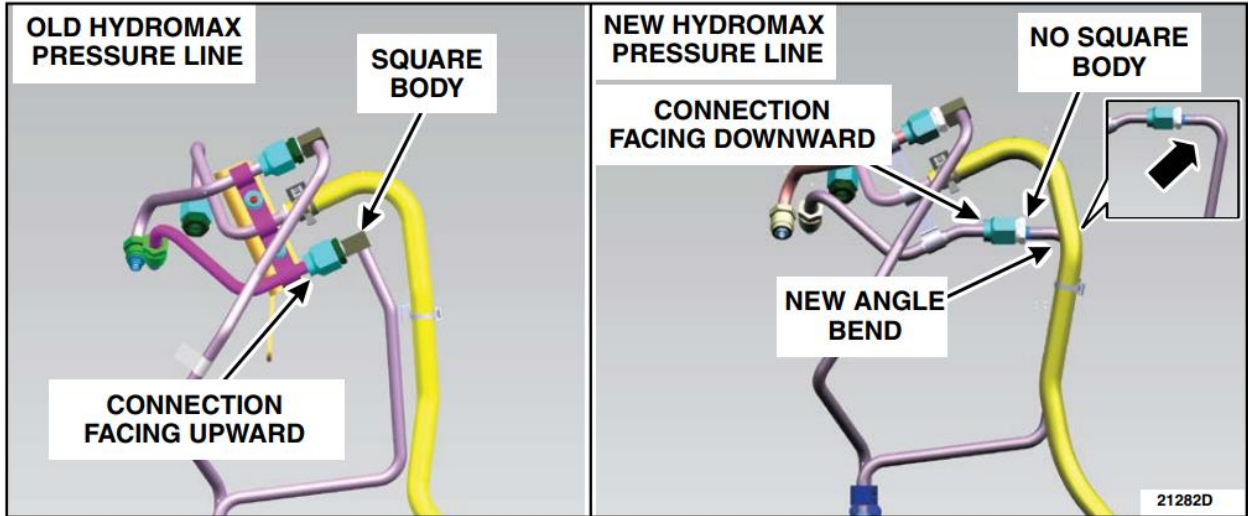
The high-pressure power steering line (also known as "Hydromax Pressure Line") connects to the jumper line of the brake Hydroboost unit with a quick-connect fitting. In response to evidence of line disconnection in the field and ergonomic feedback from assembly plant personnel, Ford Engineering identified that an incomplete connection of the snap-ring in the retention groove can occur due to side loading during installation of the quick-connect fitting in the vehicle assembly plant as a result of ergonomic constraints. On June 21, 2021, the connection interface between the two lines, and the routing of the two lines, was changed to improve the ease of assembly of the parts in the assembly plant and to avoid side loading of the connection between the jumper line and high-pressure power steering line.

Figure 1: Differences in pre/post June 21, 2021 High-Pressure Power Steering Line

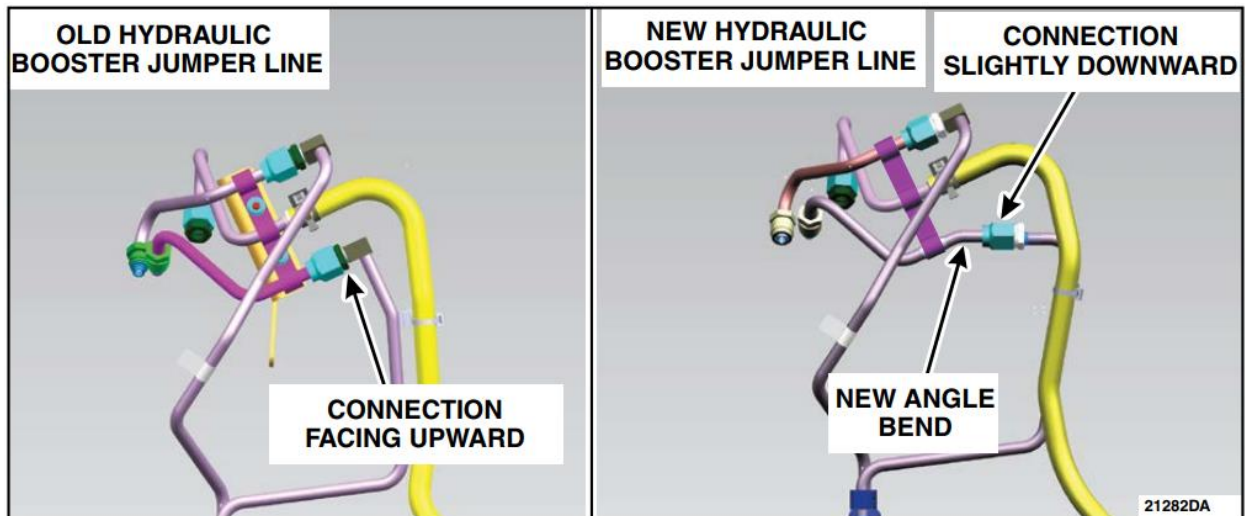
Figure 2: Differences in pre/post June 21, 2021 Jumper Line
