Request 14

Summary

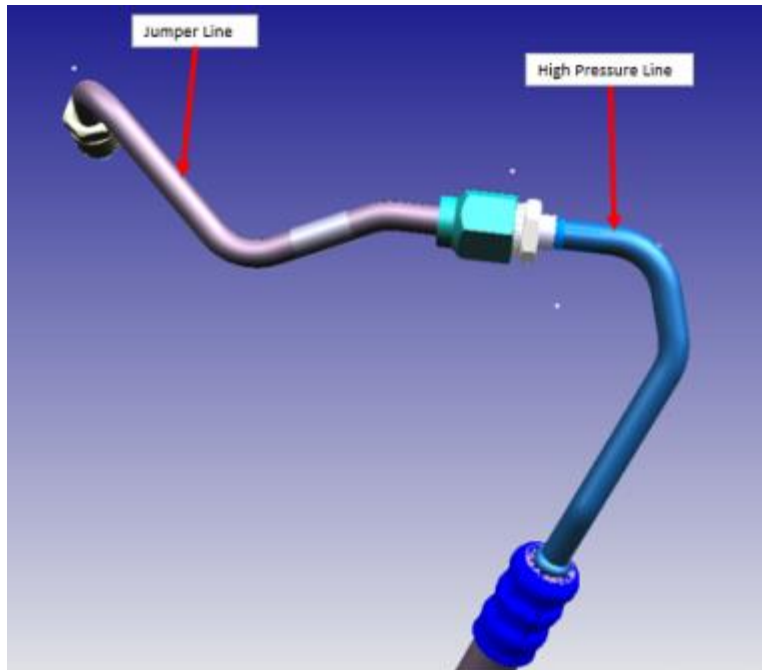
The failure modes are a leak or disconnect at the quick-connect fitting between the high-pressure power steering line and the jumper line, which may result in the customer experiencing loss of power steering and brake assist. The figure below shows a Computer Aided Drawing (CAD) view of the quick-connect fitting, the high-pressure power steering line and the jumper line. Although the high-pressure power steering line is unique between the chassis cab and cutaway vehicle types, the section of the line of interest for the failure mode, which is shown in the figure below, is the same for both E-Series vehicle types. The differences in the high-pressure power steering lines used in the chassis cab and cutaway vehicle types is immaterial for the failure mode and the alleged defect.

Figure 1: Isolated CAD Image Showing the High Pressure Power Steering Line to Jumper Line Connection Area
