RQ24-008 Supplemental IR Request 10 Leak Path Details

October 25, 2024

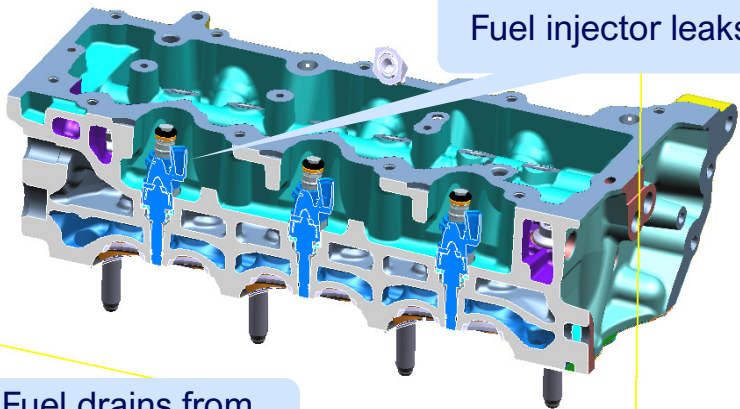
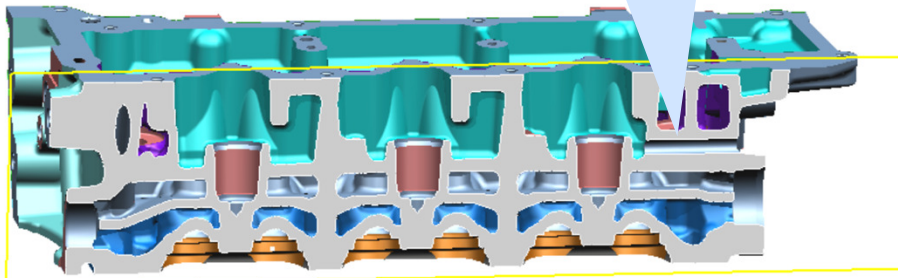
Fuel Path From Cracked Injector

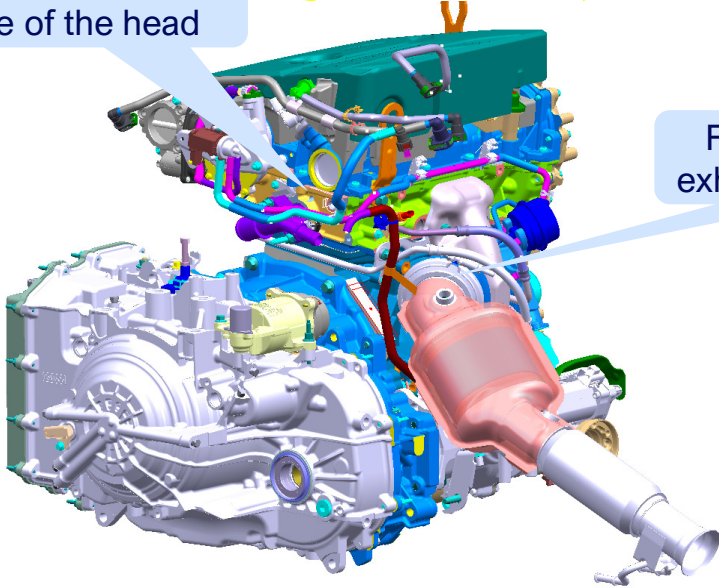
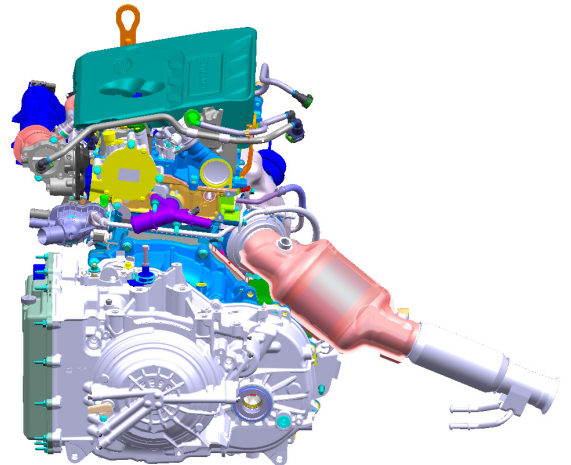
Fuel drains from side of the head

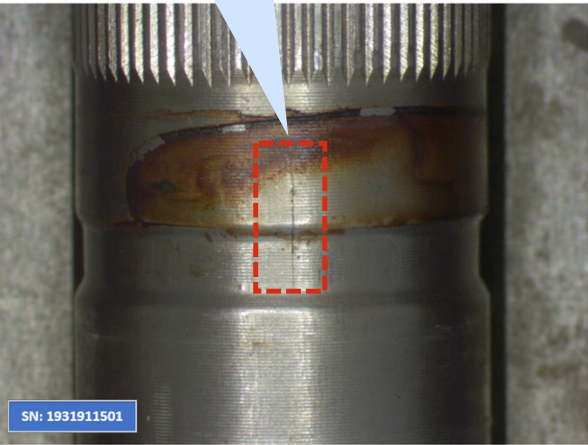
Crack in valve body

High pressure fuel leaks out of crack in valve body

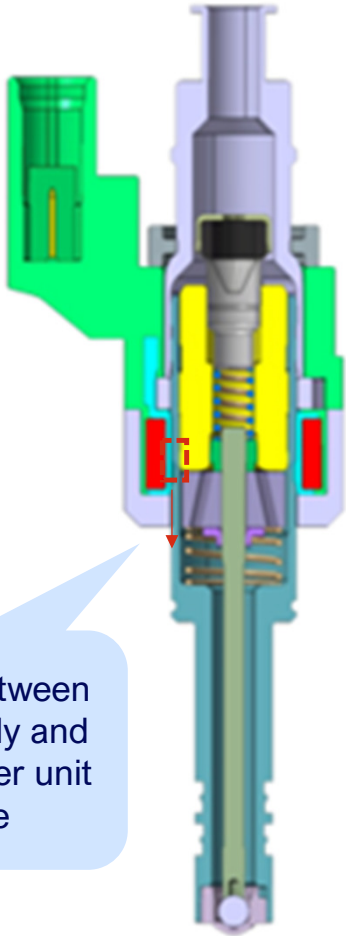
Fuel leaks between the valve body and modular power unit interface

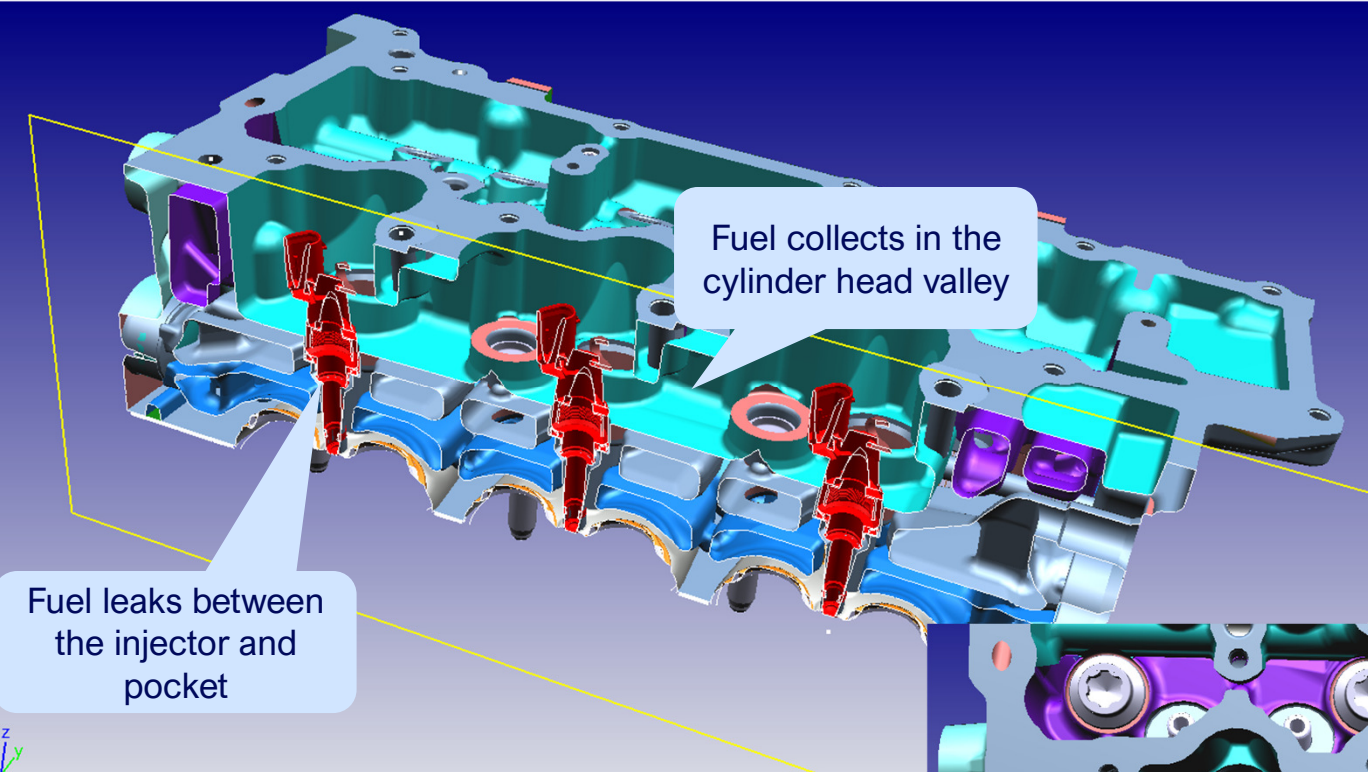
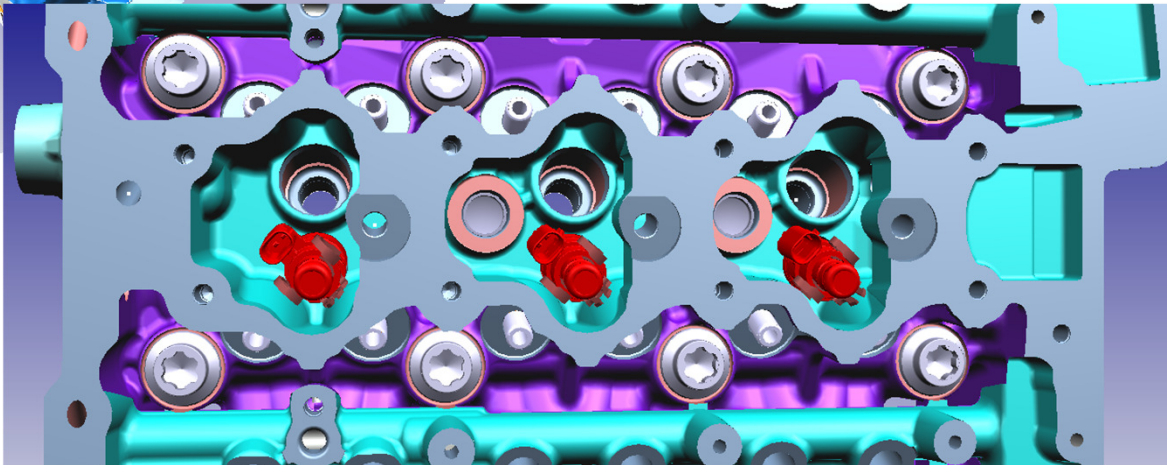
Fuel Path Into Valley

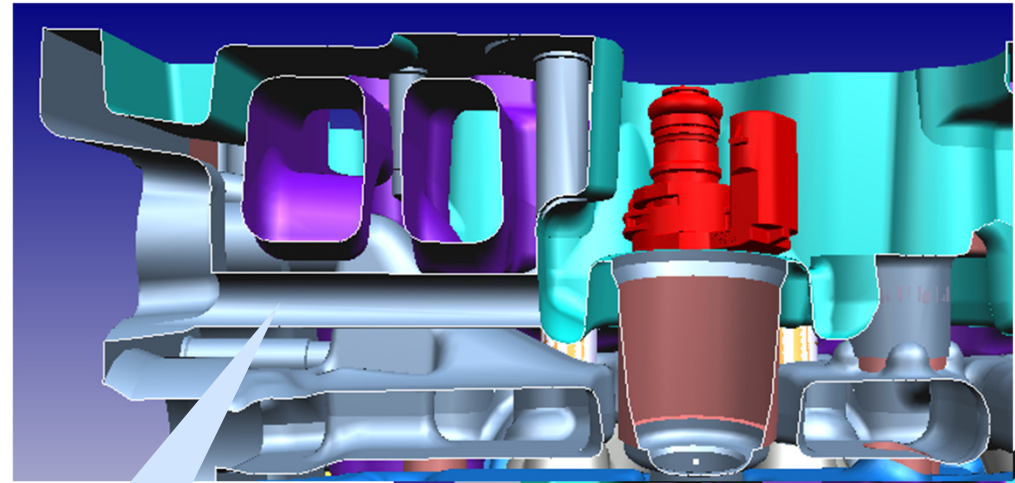
Fuel Path From Valley to Drain Hole

Cylinder head drain

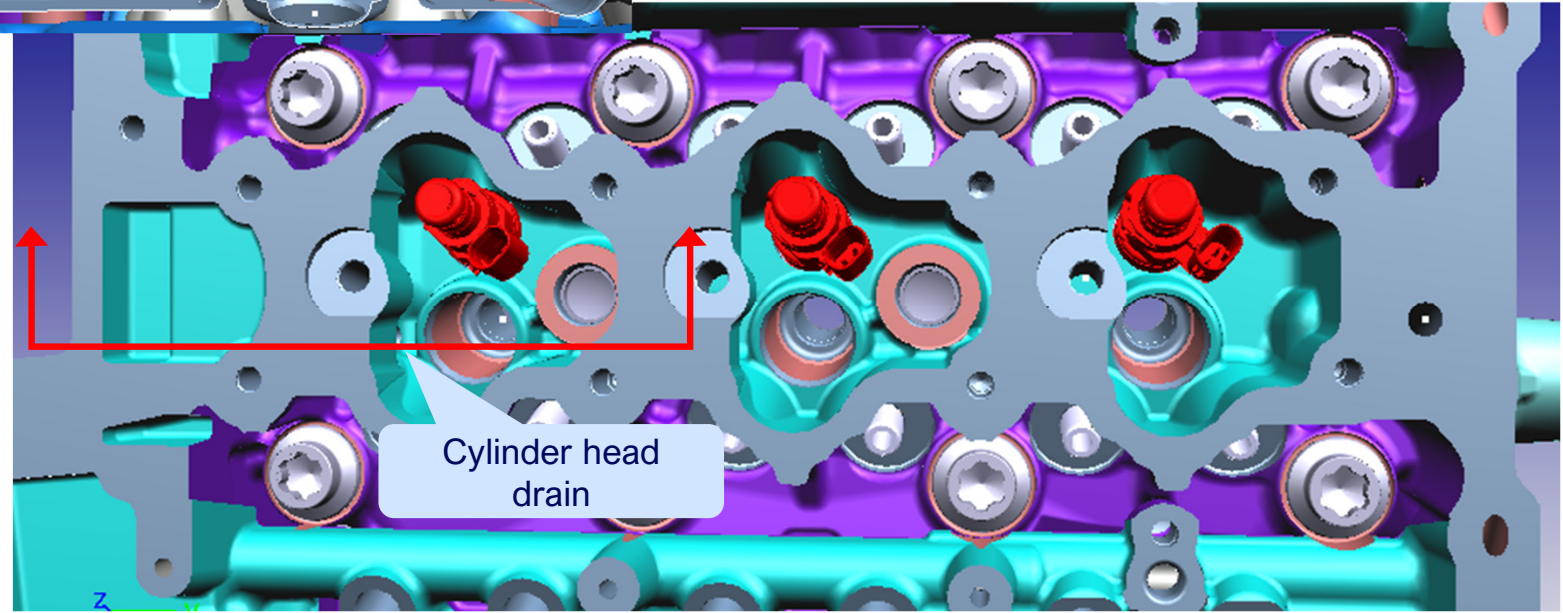
Cylinder head drain
