# Loss of CAN seen in durability testing

# Part 1 – Clip missing on Transmission Harness

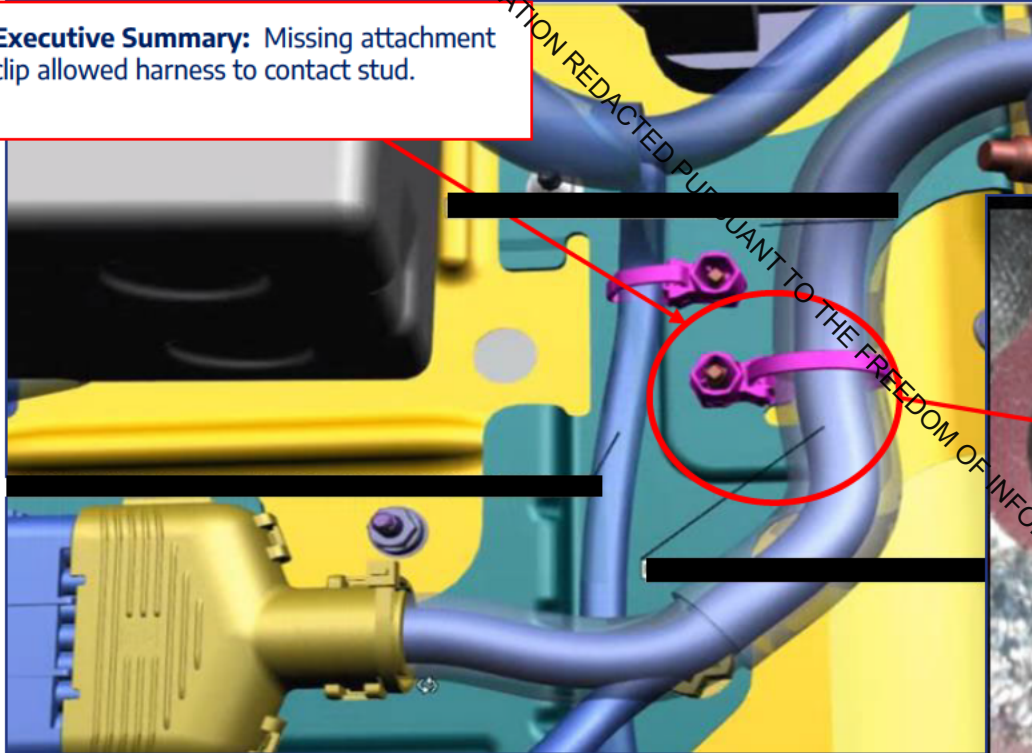
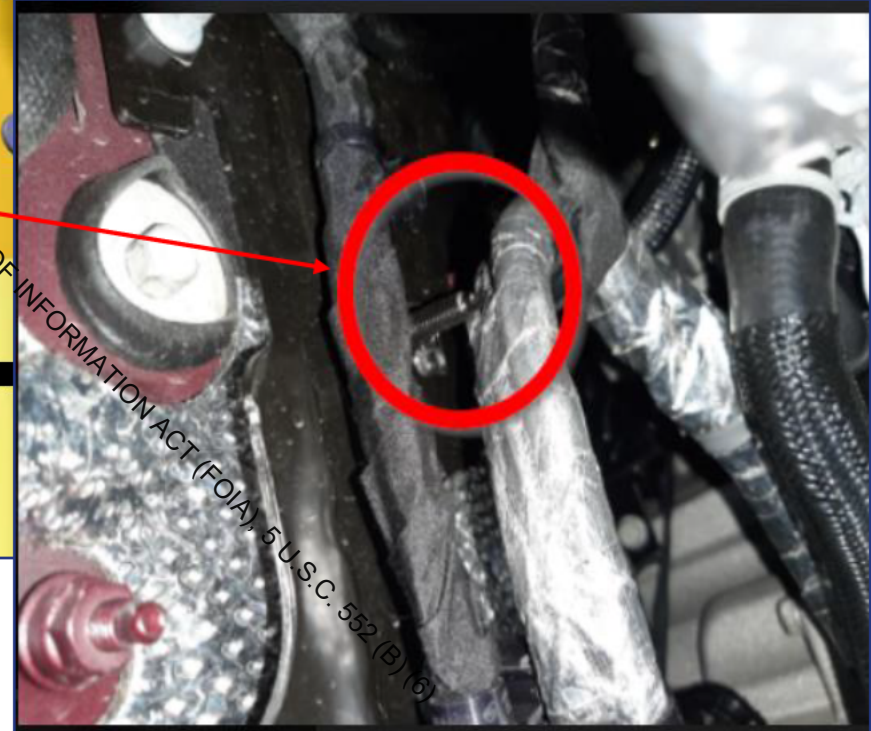
**Executive Summary:** Missing attachment clip allowed harness to contact stud.

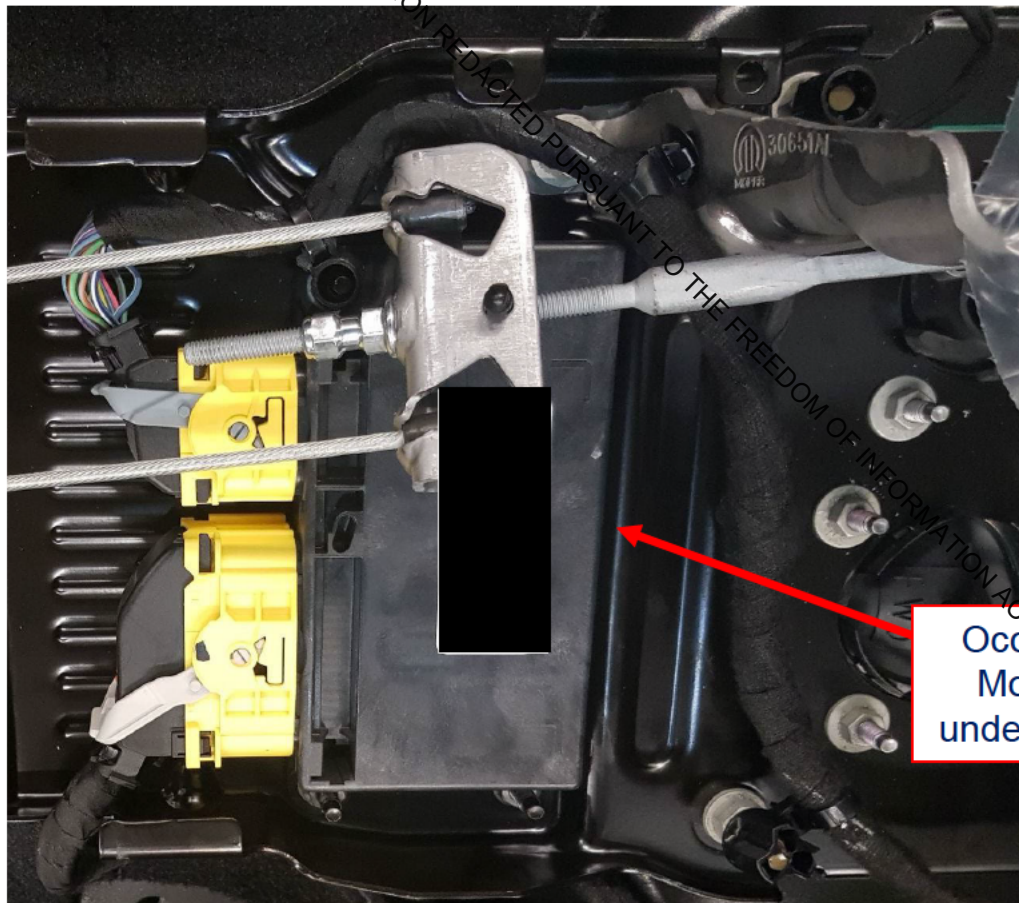
## Damage Location

# Part 2 - ORC Takeout Damage

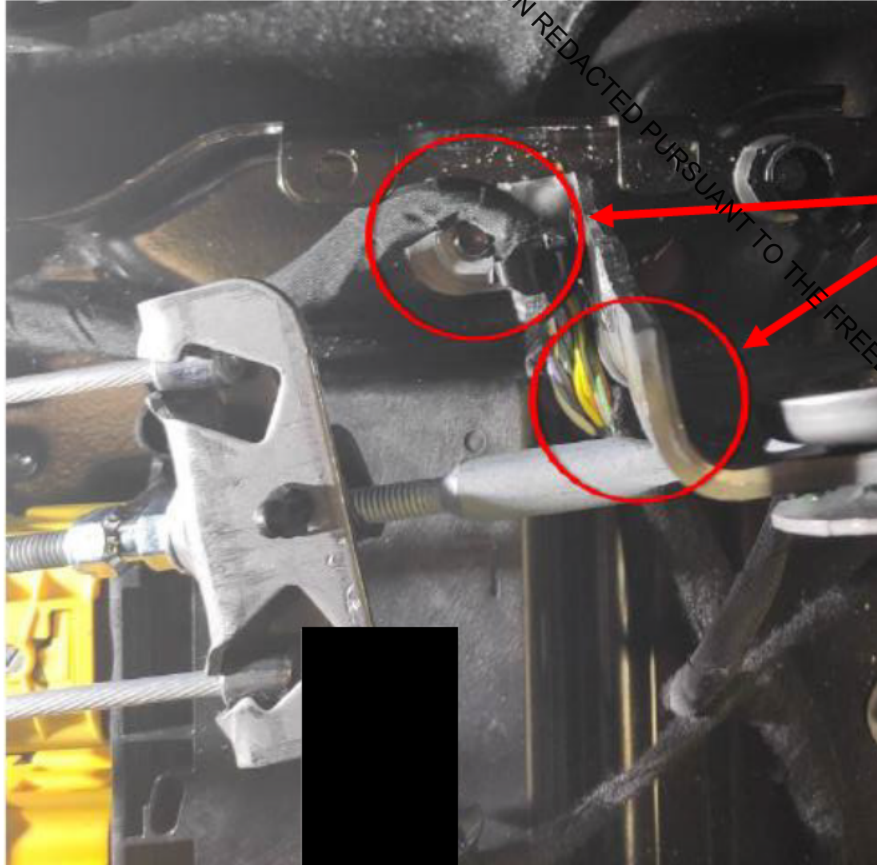
Occupant Restraint  
Module (Located  
under Center Console)

Wiring near ORC  
was damaged.

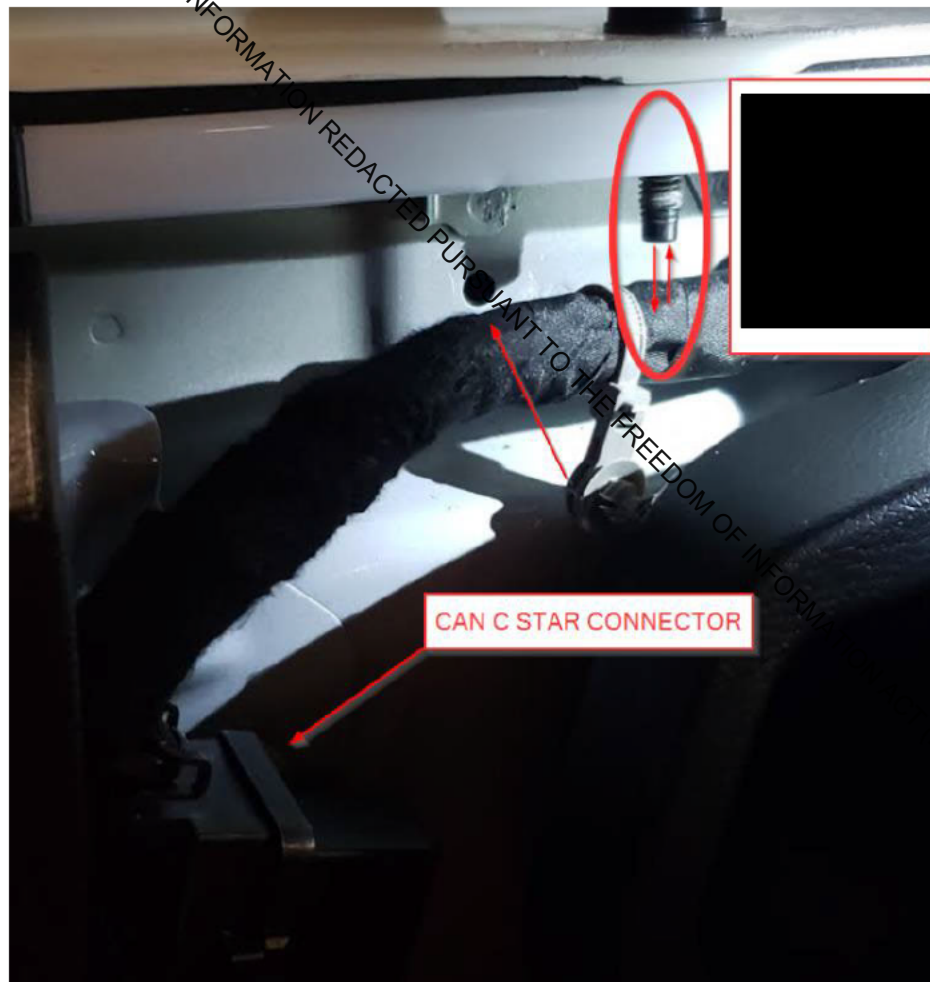
# Part 3- Harness contact with Hardtop bolts
