# Loss of CAN seen in durability testing

# Part 1 – Clip missing on Transmission Harness

# Part 2 - ORC Takeout Damage

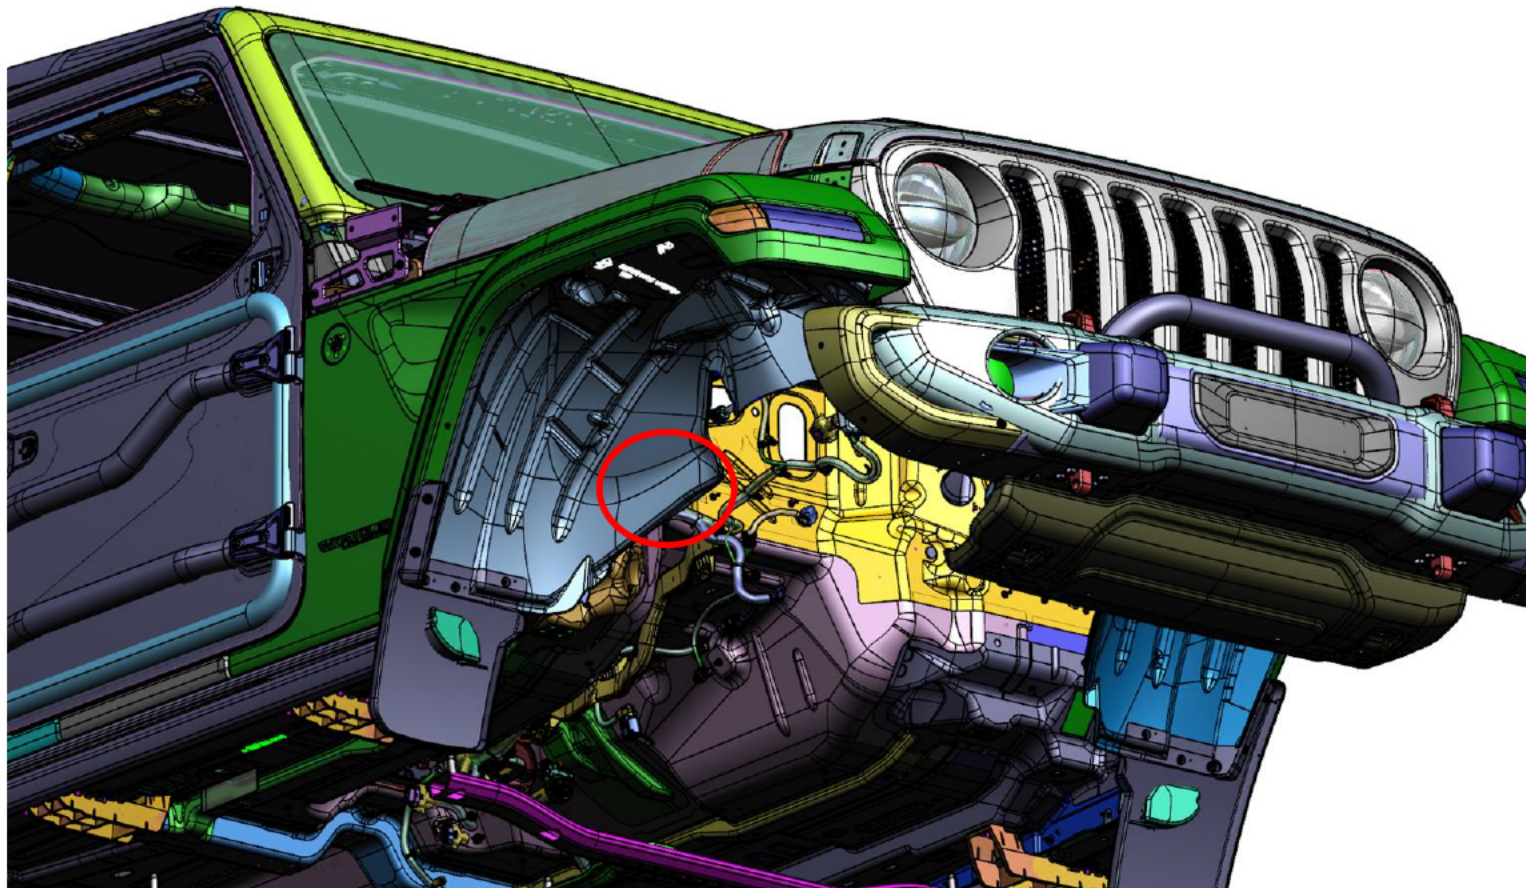
## Missing Clip Location

**Executive Summary:** Missing attachment clip allowed harness to contact stud.
