FORD MOTOR COMPANY (FORD) RESPONSE TO RQ24014-1 Request 10Request 10

Furnish Ford's assessment of the alleged defect in the subject vehicles, including:

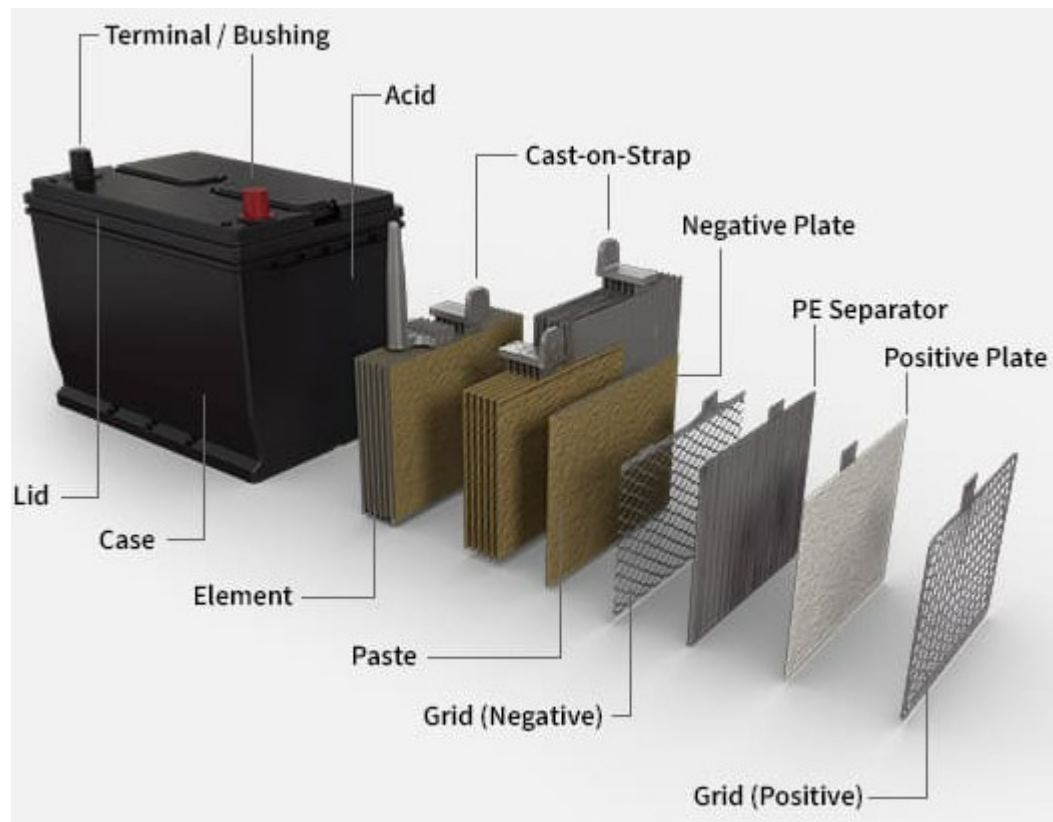
Ford has determined that the cause of the failures described in the VOQs is traceable to supplier manufacturing defects for batteries used in a portion of the vehicles included in safety recall 24S24, and which the BCM sometimes cannot detect. The tear-down and evaluation of several 12-volt batteries that had experienced the subject failure in the field revealed heavy cracking of the internal Cast On Strap (COS) and failed intercell welds. These types of failures are indicative of a supplier quality issue. Manufacturing defects plus long exposures to high heat environments increase the likelihood of these types of sudden failures.

Figure 1. Generic Example of Enhanced Flooded Battery
