CQIS DETAIL REPORT

CQIS Report Number: S1VPV010 Program Type: MX Orig Rpt #:  
Report Source: VO - FOM - CUST SERV TECH/QLTY Report Date: 01/22/2025

VEHICLE: 2023 MAVERICK, FWD, SUP CRW, PICKUP VIN [REDACTED]  
Engine : 2.0L TIVCT GTDI T/C 240PS GAS Odometer: 12,168 MILES  
Operating Environ: WCC :  
Vehicle Use : Rsp. Act:  
SYMPTOM: 4 41 Z 00 START/RUN/MOVE RUNNING  
NOT LISTED UNKNOWN (CODE NOT AVAILABLE)  
Additional Symptom: se apago  
Other Veh. With Concern: Severity Rating - Customer: Engineering:

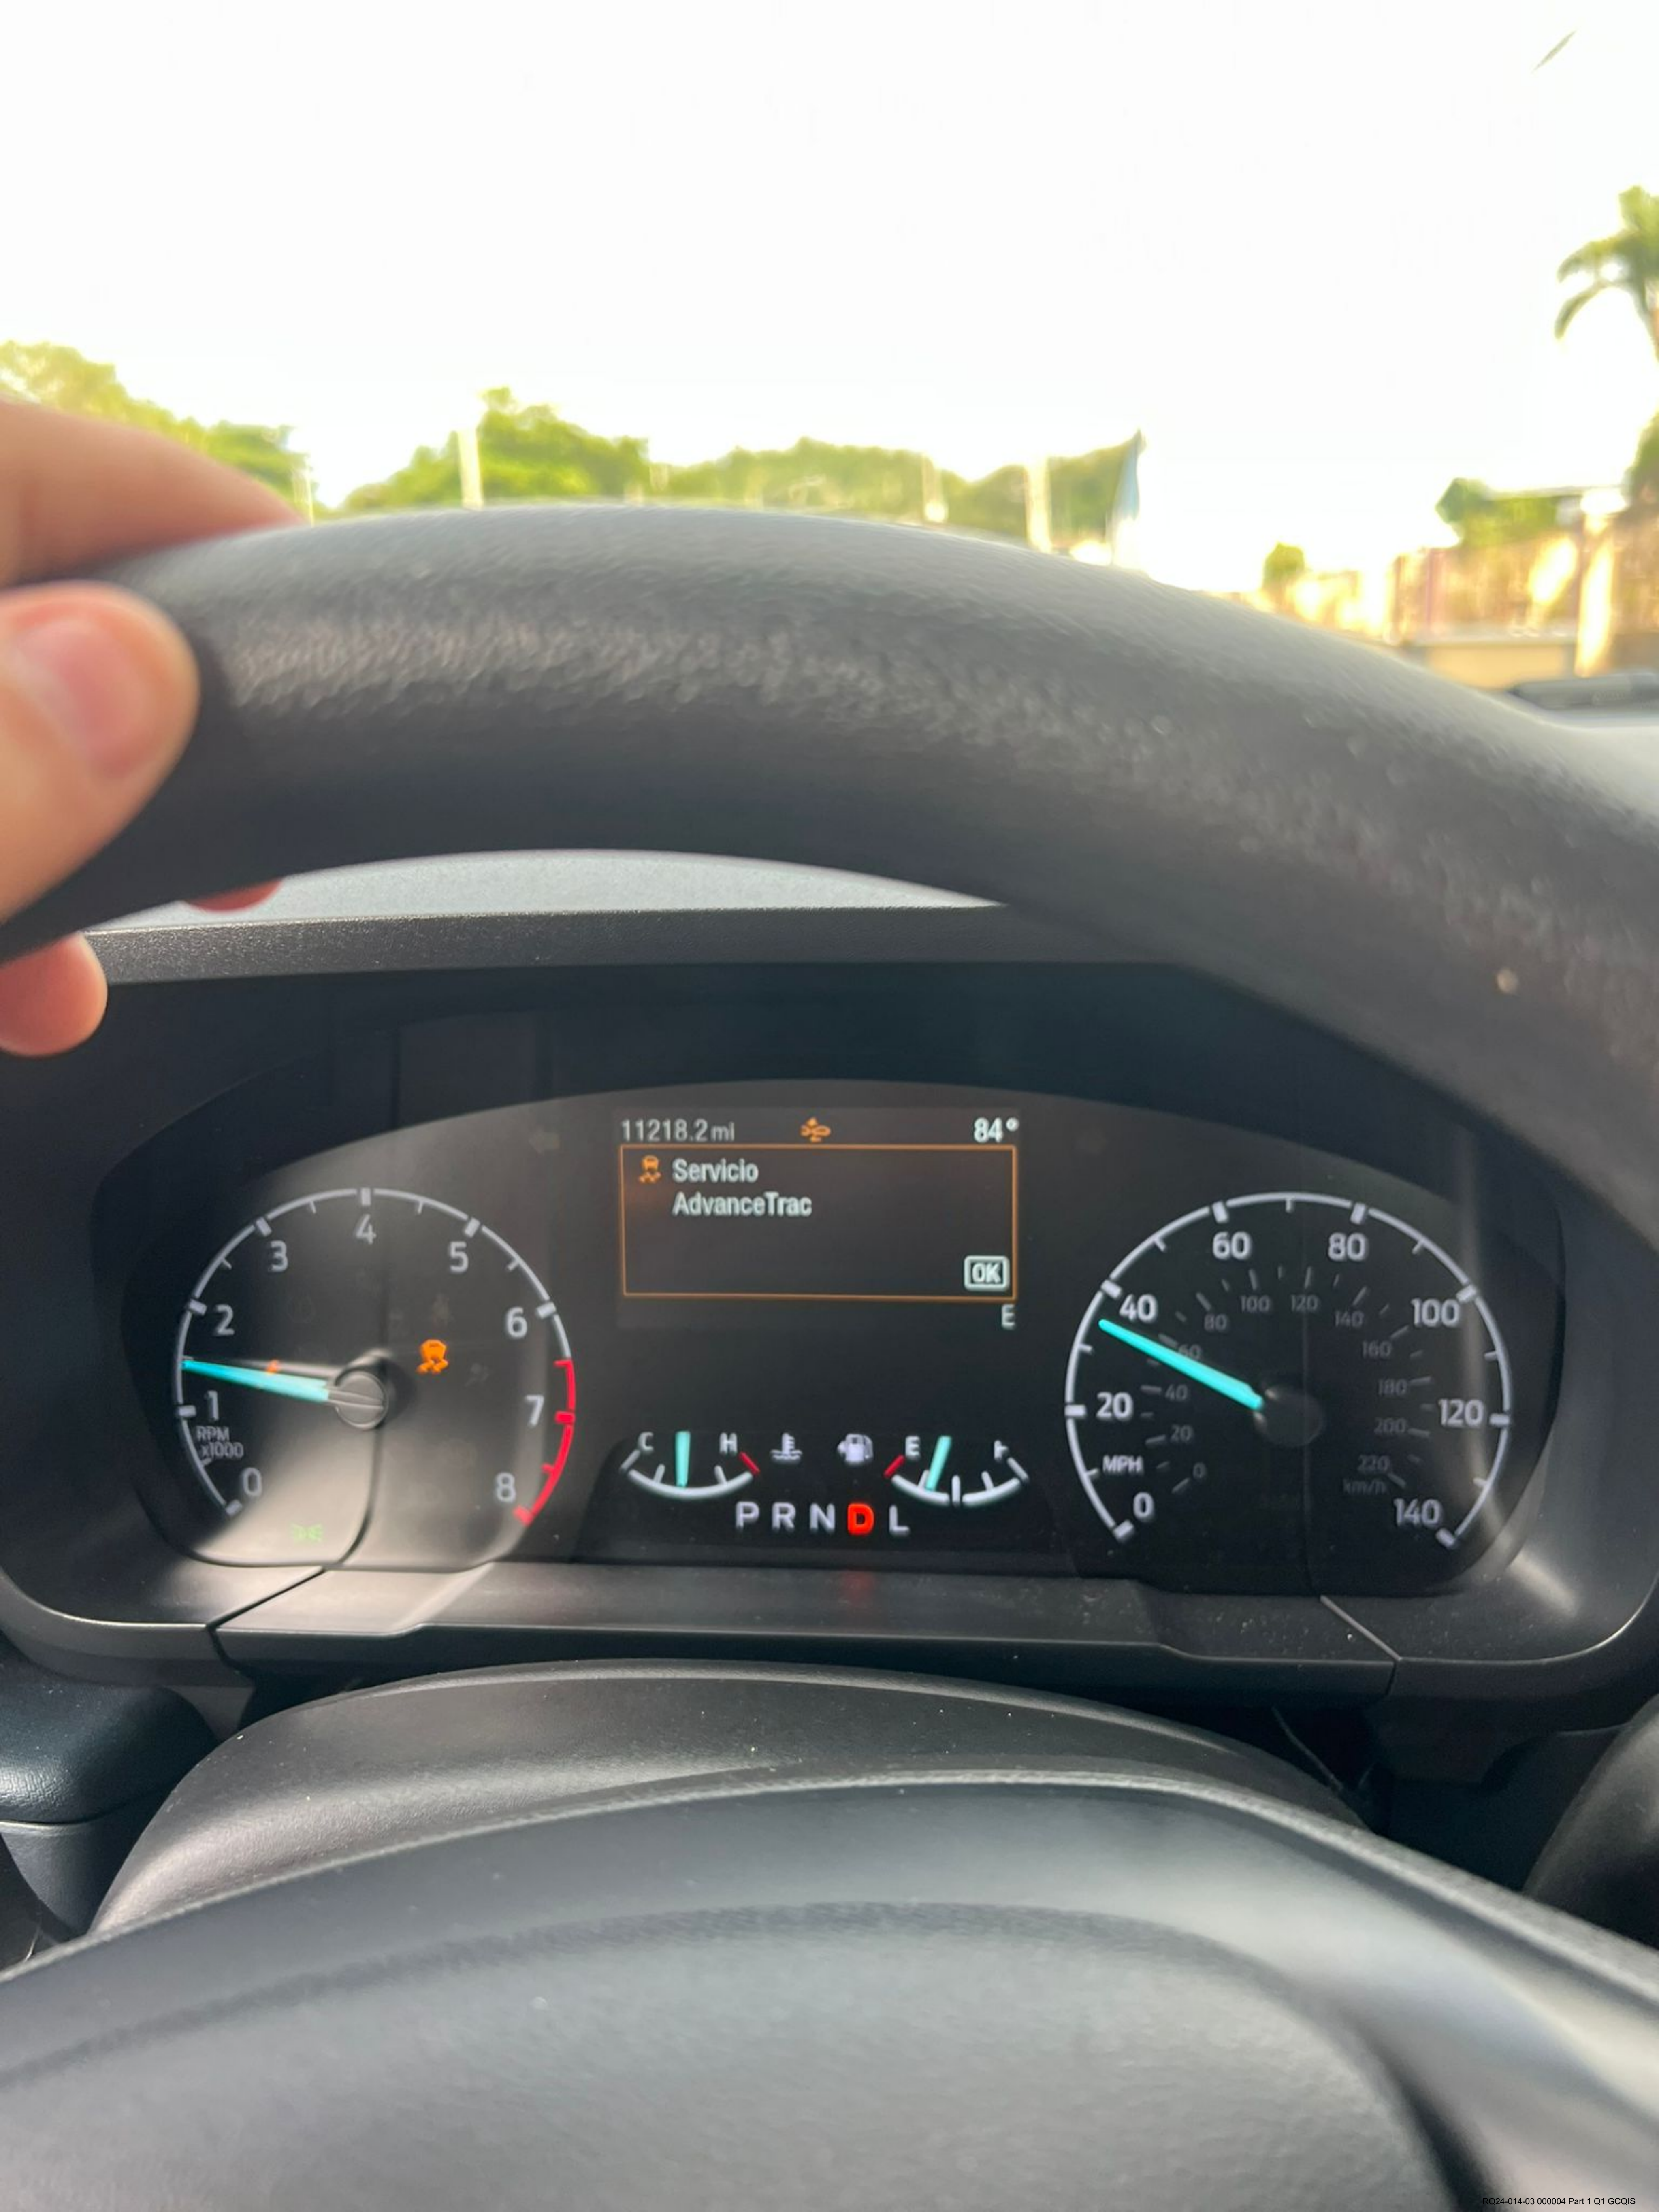
11218.2 mi 84°

Servicio AdvanceTrac

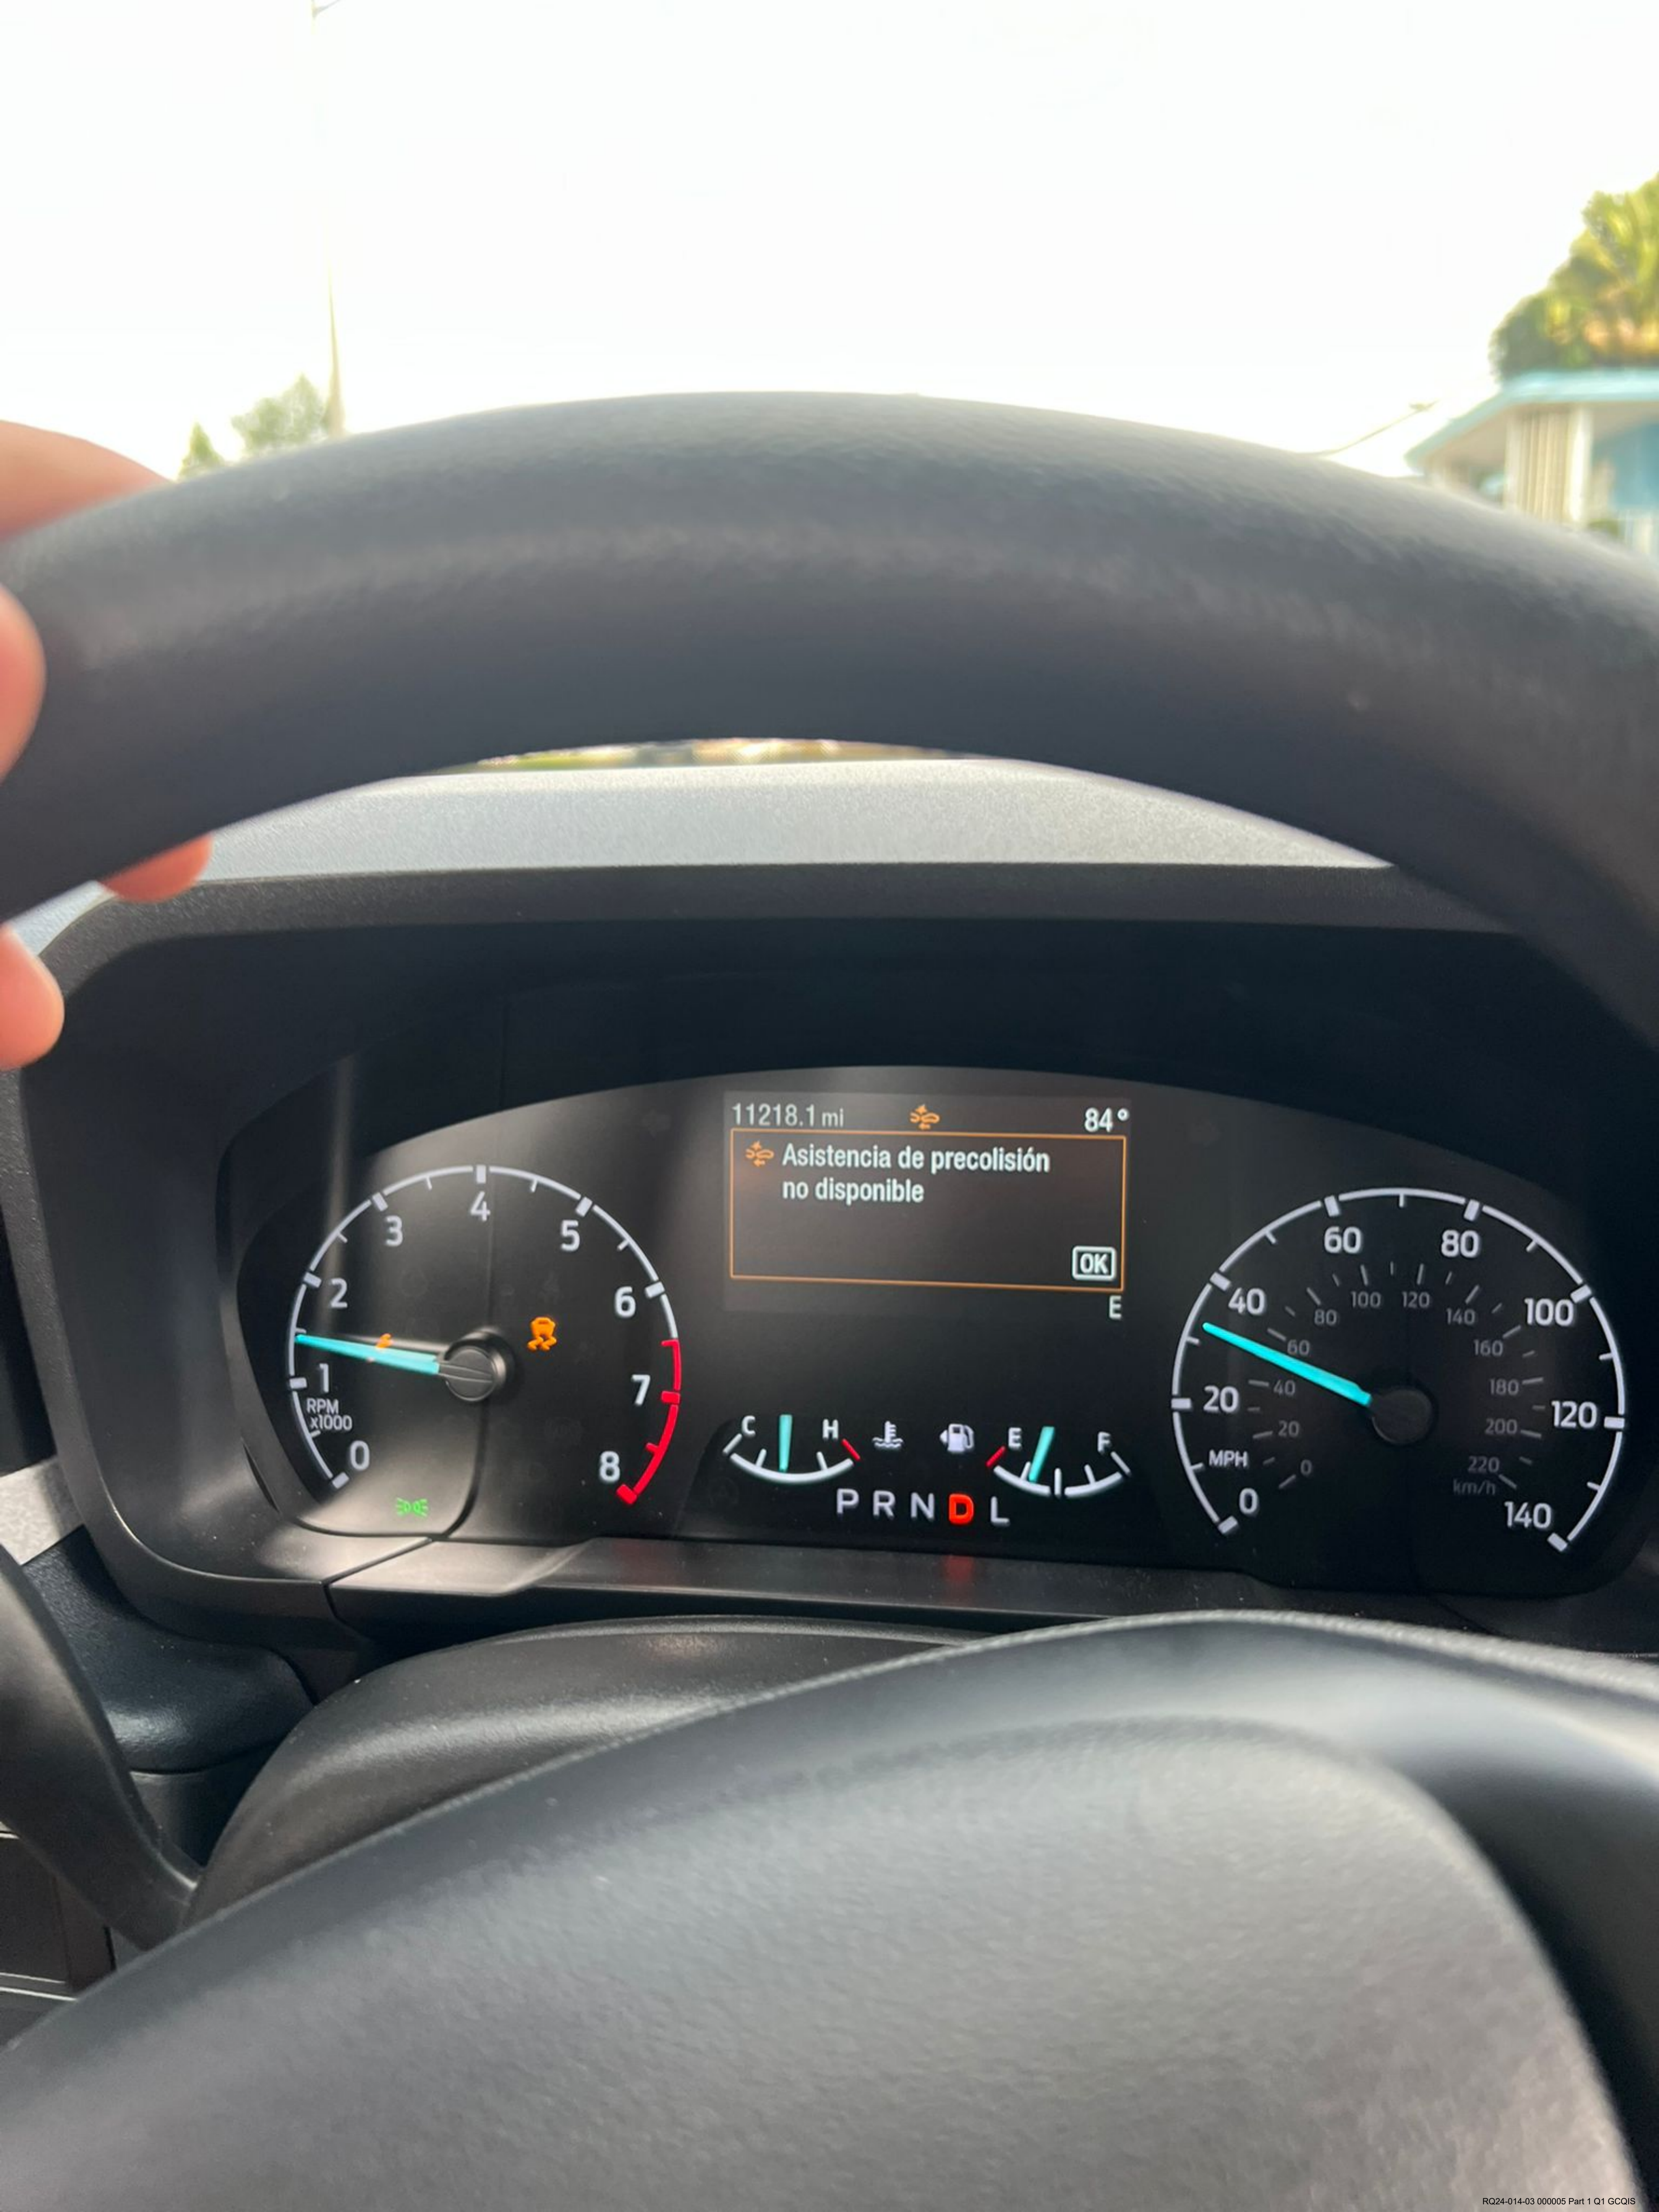
Asistencia de precolisión  
no disponible

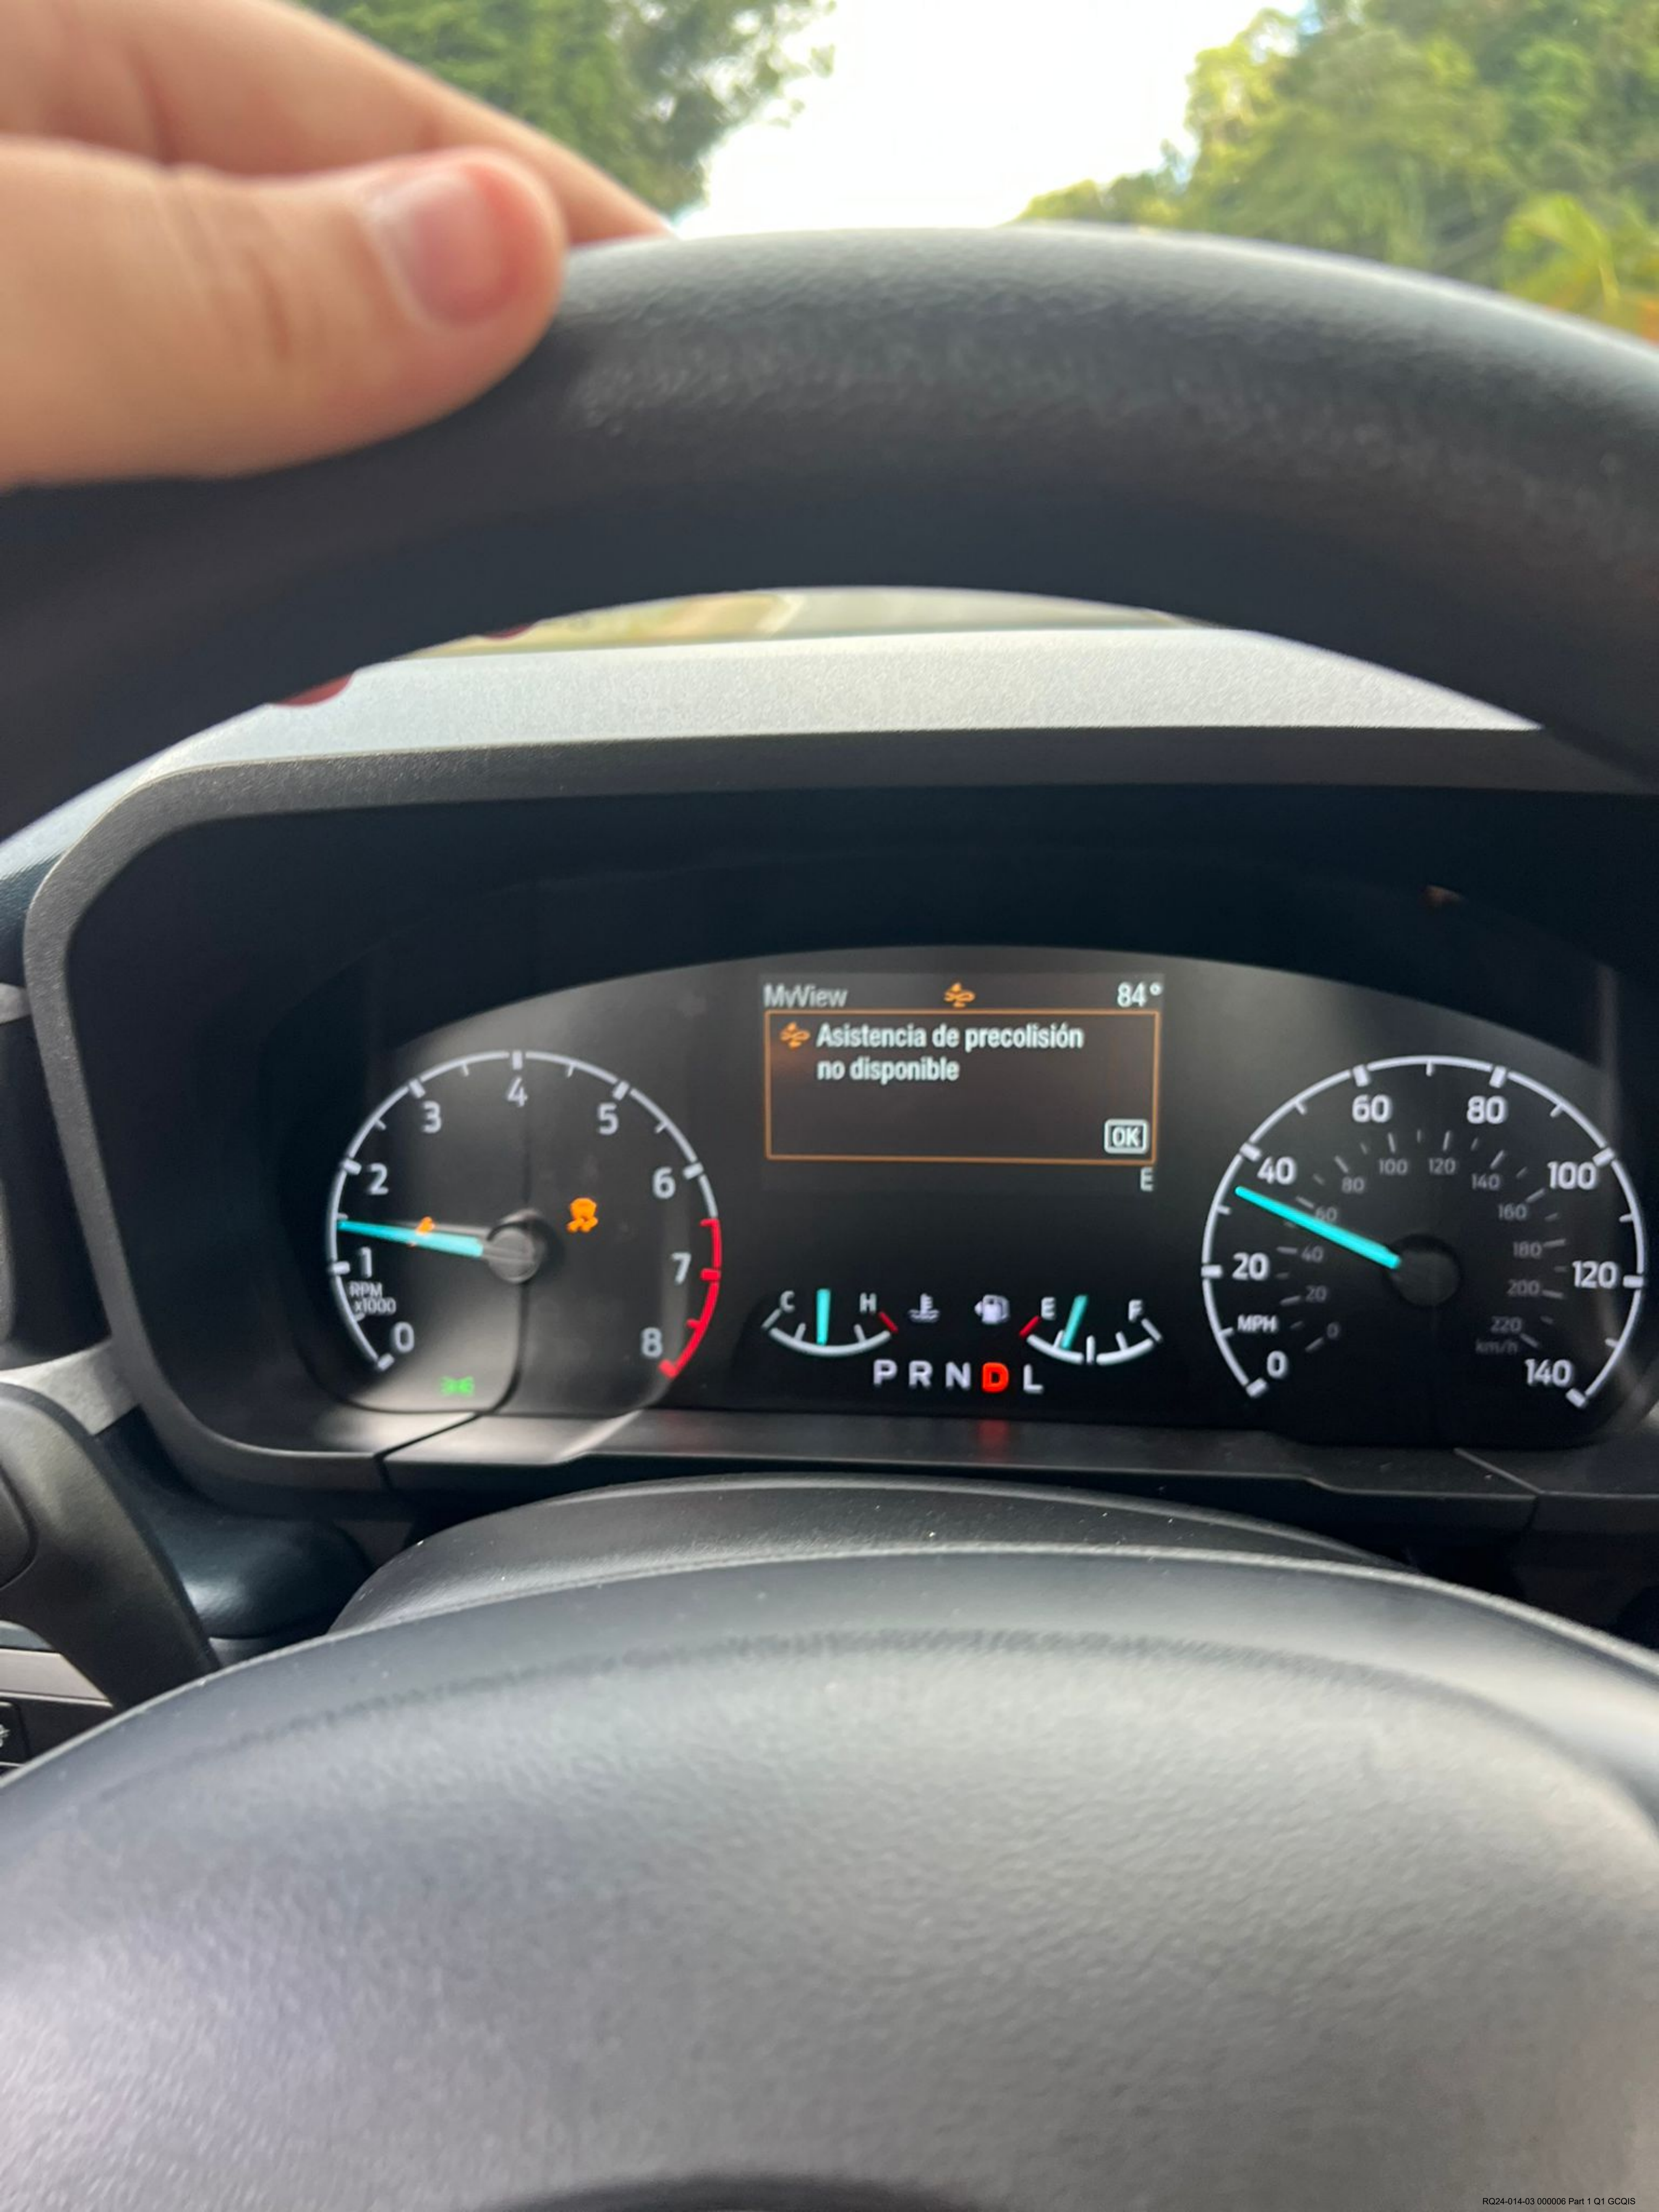
Asistencia de precolisión  
no disponible

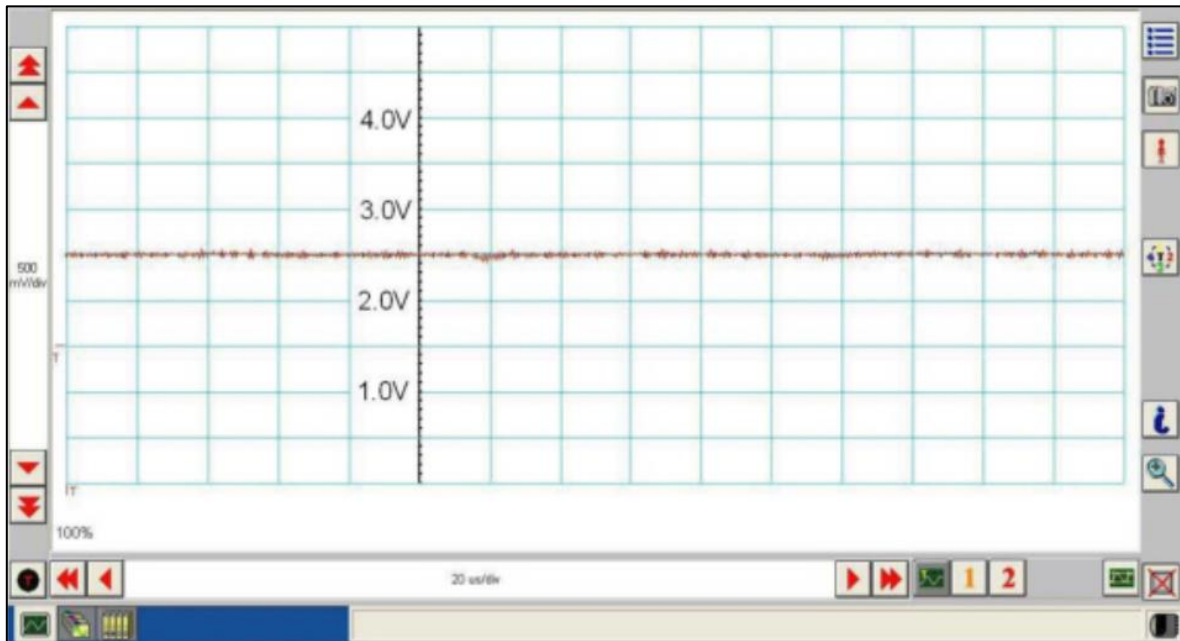
### Circuitos de red CAN en cortocircuito entre sí

En caso de que los circuitos (+) y (-) de datos presenten un cortocircuito entre sí, la señal permanece en el voltaje básico (2.5V) continuamente y se pierden todas las capacidades de comunicación.

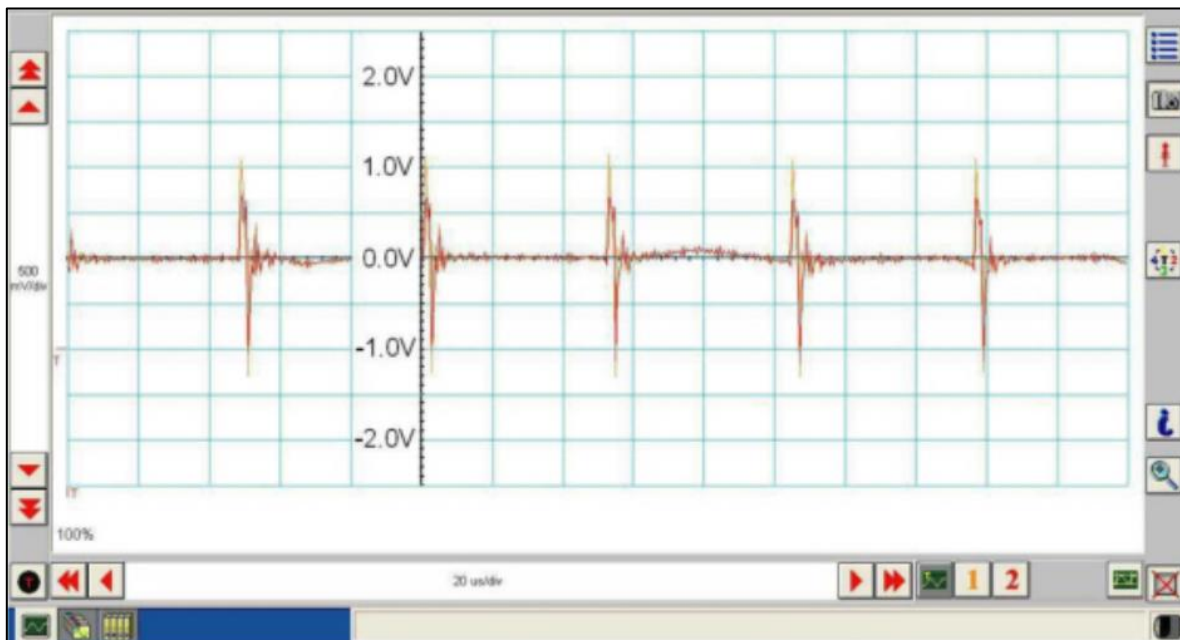
### Cortocircuito a tierra en el circuito (+) de la CAN

En caso de que el circuito (+) de datos presente un cortocircuito a tierra, el voltaje tanto del circuito (+) como del circuito (-) de datos pasa al nivel bajo (0V), y se pierden todas las capacidades de comunicación.

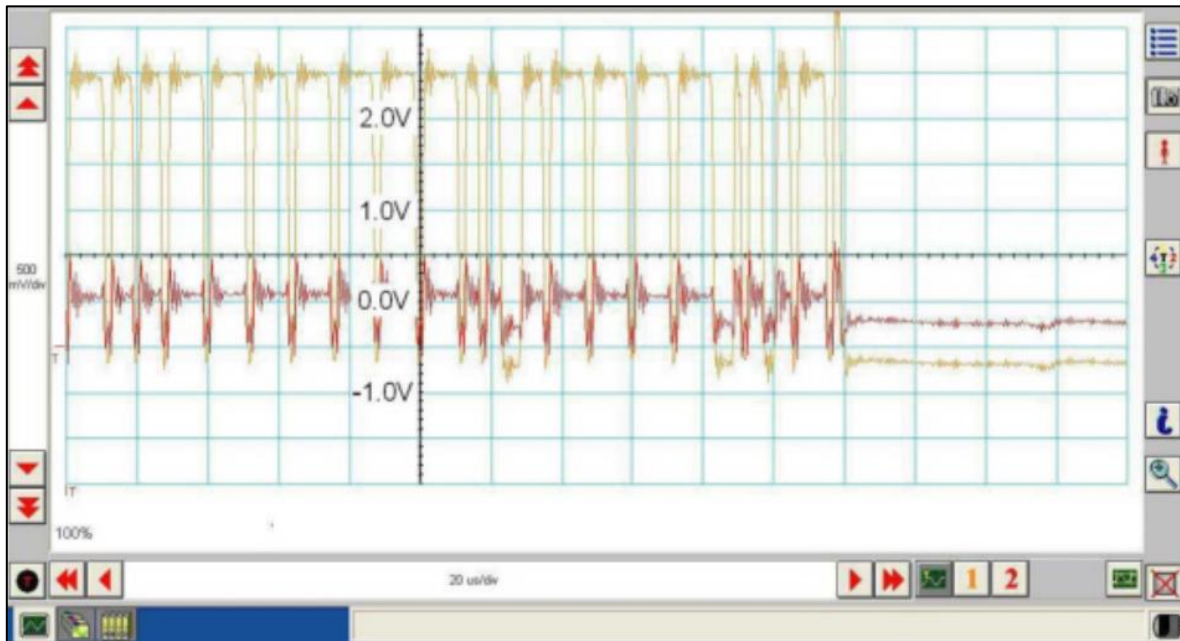
### Cortocircuito a tierra en el circuito (-) de la CAN

En caso de que el circuito (-) de datos presente un cortocircuito a tierra, el voltaje en el circuito (-) pasa al nivel bajo (0V) y el voltaje en el circuito (+) alcanza un voltaje de pico casi normal (3.0V) durante la comunicación, pero se reduce a 0V en lugar de al voltaje básico normal (2.5V). La comunicación puede continuar, pero a un nivel reducido.

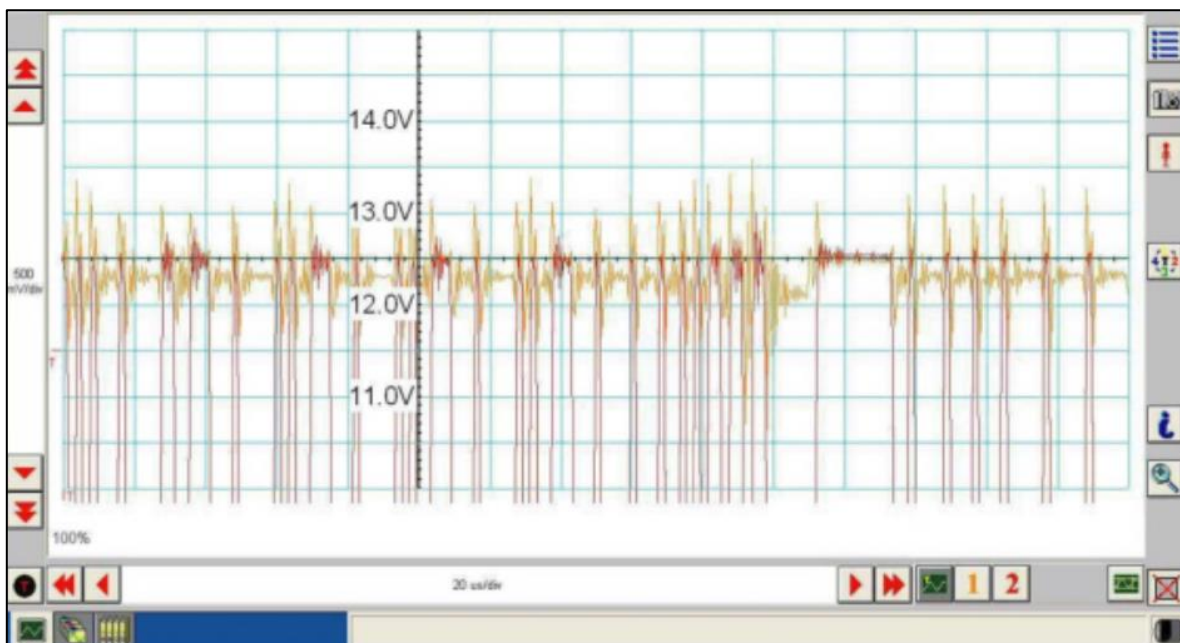
### Cortocircuito a voltaje de la batería en el circuito (+) de la CAN

En caso de que el circuito (+) de datos presente un cortocircuito a voltaje de la batería, se ocasiona un voltaje alto (12V) en el circuito de datos (+) y se ocasiona un voltaje anormalmente alto (mayor de 5V) en el circuito de datos (-) durante la comunicación, y se alcanza el voltaje de la batería (12V) para el voltaje pico. La comunicación puede continuar, pero a un nivel reducido.

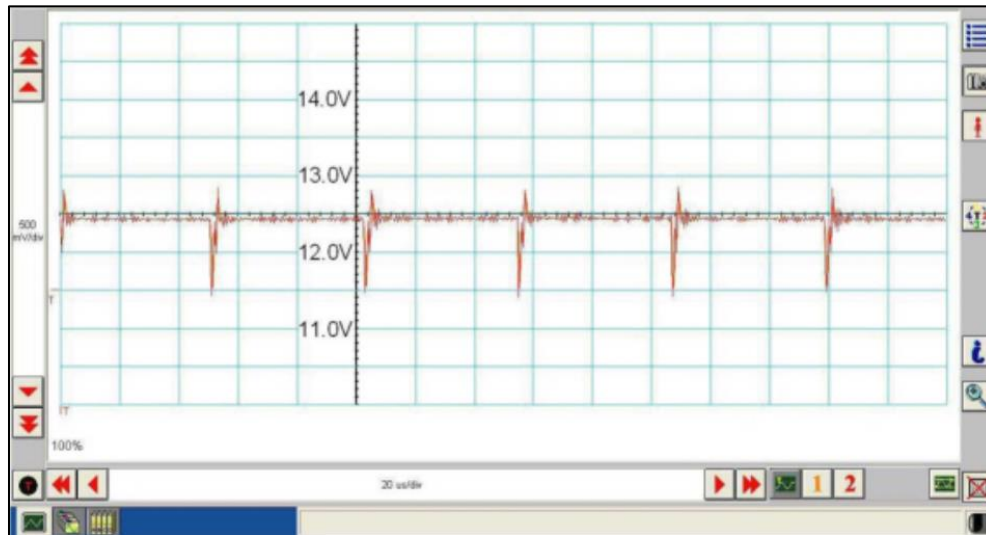
### Cortocircuito a voltaje de la batería en el circuito (-) de la CAN

En caso de que el circuito de datos (-) presente un corto a voltaje de la batería, se ocasiona un voltaje alto (12V) tanto en el circuito de datos (+) como en el circuito de datos (-) y se pierden todas las capacidades de comunicación.

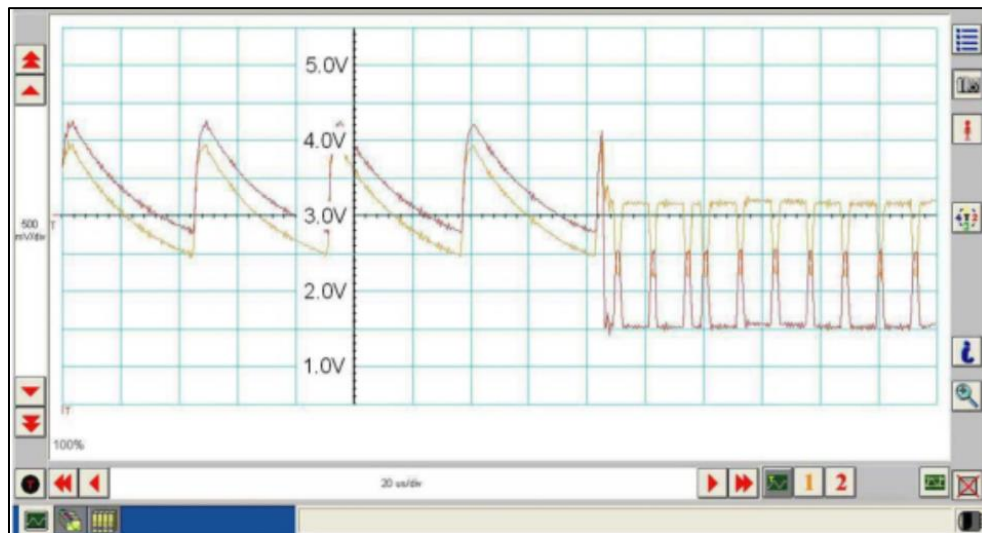
### Corrupción de la señal en circuito de CAN

Las oscilaciones rítmicas, los picos inductivos y las interferencias aleatorias pueden corromper las comunicaciones de red. La fuente de corrupción de la señal podrían ser las interferencias eléctricas externas, como motores eléctricos o solenoides, o en interferencias internas generadas por un módulo en la red. En algunos casos, una apertura ya sea en el circuito de datos (+) o en el circuito de datos (-) a un módulo de la red podría ocasionar que el módulo emita interferencias en el circuito que sigue conectado. La marca mostrada es un ejemplo de un patrón de "diente de sierra" transmitido desde un módulo con un circuito de red abierto.

Podría haber otros tipos de corrupción presentes cuando un módulo se energiza y desenergiza intermitentemente. El módulo, al ser energizado, podría iniciar la comunicación fuera de sincronía con otros módulos de la red, lo que causa fallos de comunicación momentáneos.
