TECHNICAL SERVICE BULLETIN

Water Leaking On Right Front Floor During Or After A/C Use - Built On 31-Aug-2018 And Through 02-Feb-2020

20-2170

Ford 2018-2020 Expedition
2018-2020 F-150
2018-2020 F-Super Duty
Lincoln 2018-2020 Navigator

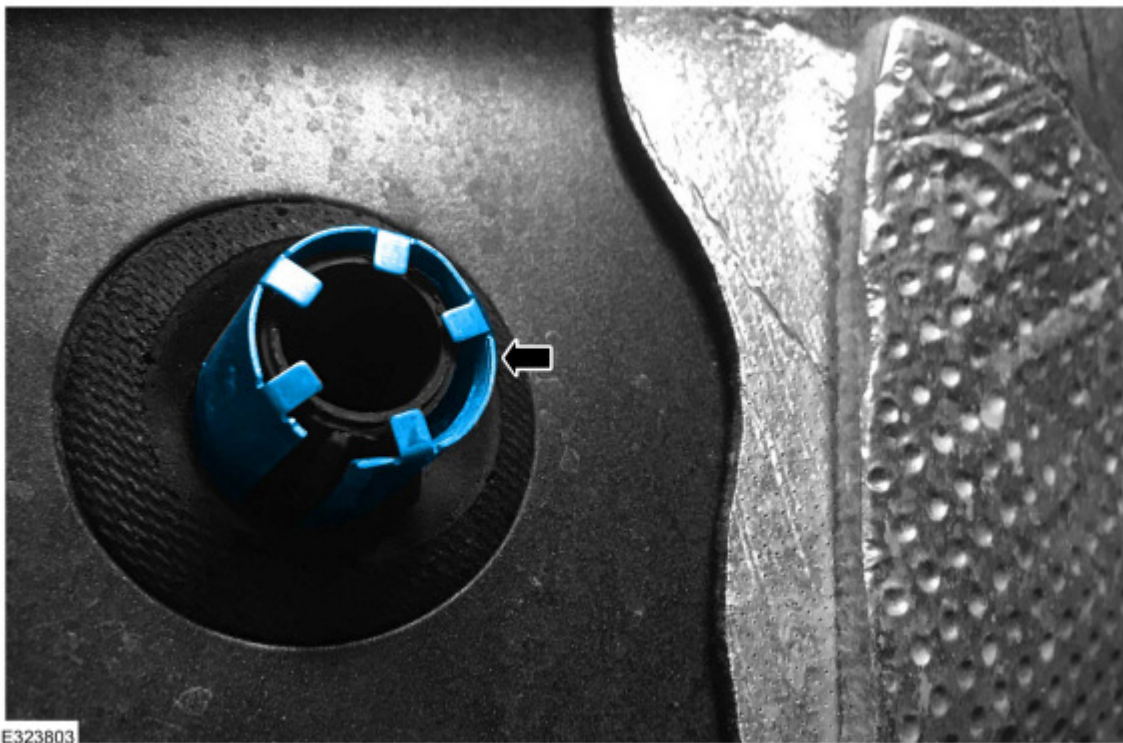
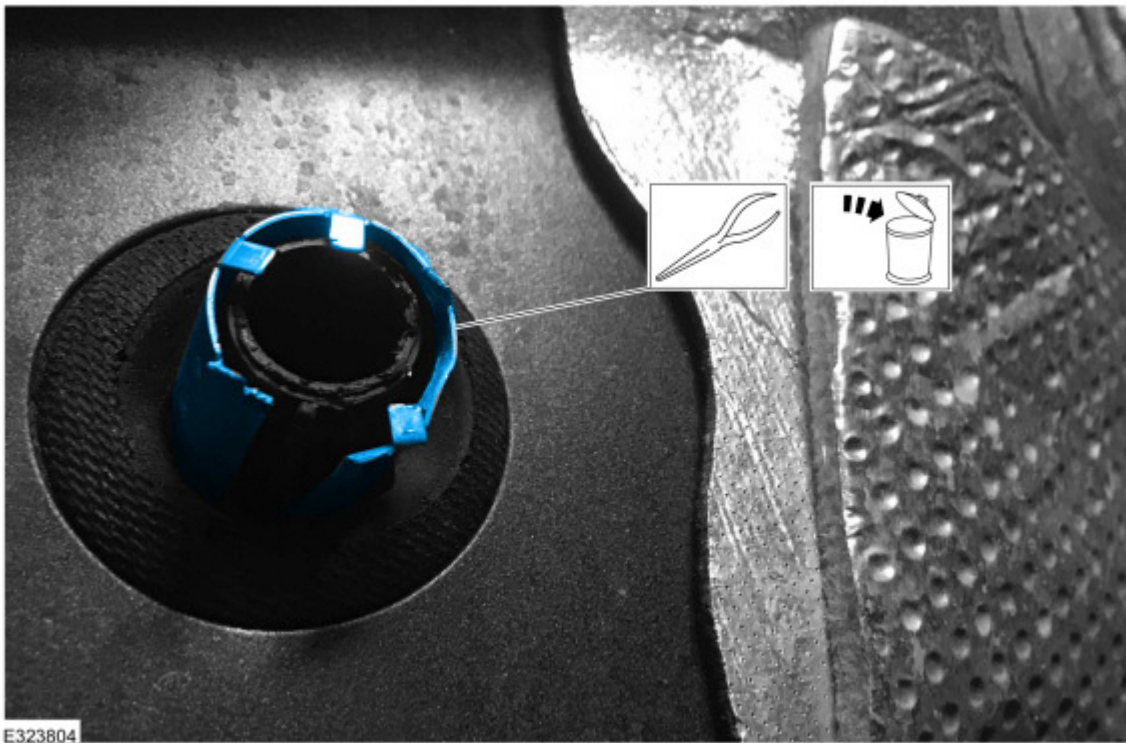
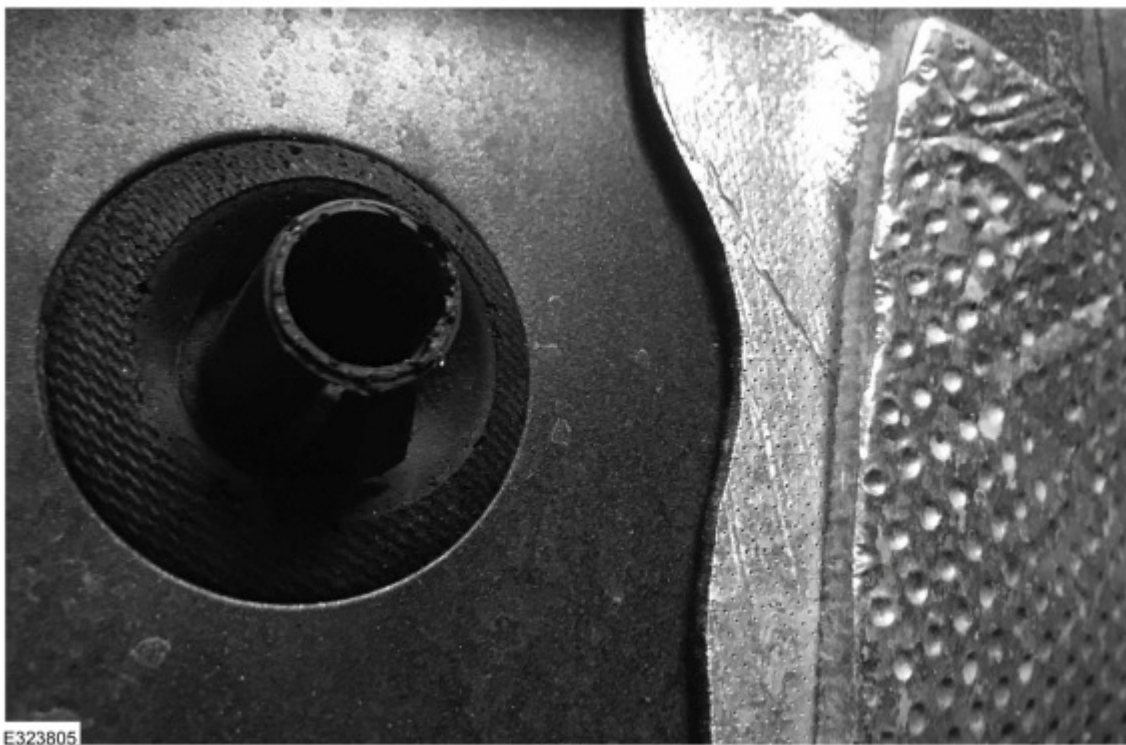
Issue: Some 2018-2020 F-150/Expedition/Navigator/F-Super Duty vehicles built on 31-Aug-2018 and through 02-Feb-2020 may exhibit a water leak on the right front floor during and/or after the air conditioning (A/C) is used. This may be due to condensation from the evaporator drain tube entering the vehicle through the drain tube seal. To correct the condition, follow the Service Procedure steps to install an elbow on the evaporator drain tube to direct the condensation away from the seal.

1. Raise the vehicle and remove the right front tire.
2. Remove the right front fender splash shield. Refer to the Workshop Manual (WSM), Section 501-02.
3. Using needle nose pliers or equivalent, remove and discard the metal shield from the evaporator drain tube by bending the tabs away from the tube. (Figures 1-3)
