TECHNICAL SERVICE BULLETIN

20-2170

Water Leaking On Right Front Floor During Or After A/C Use - Built On 31-Aug-2018 And Through 02-Feb-2020

14 May 2020

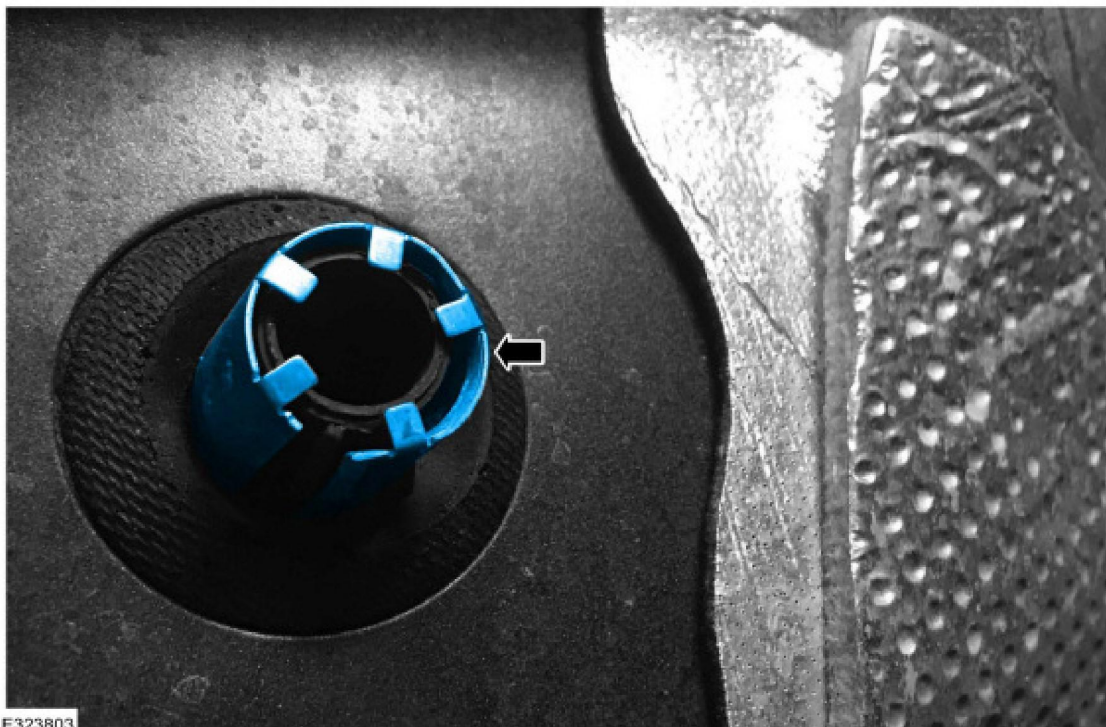
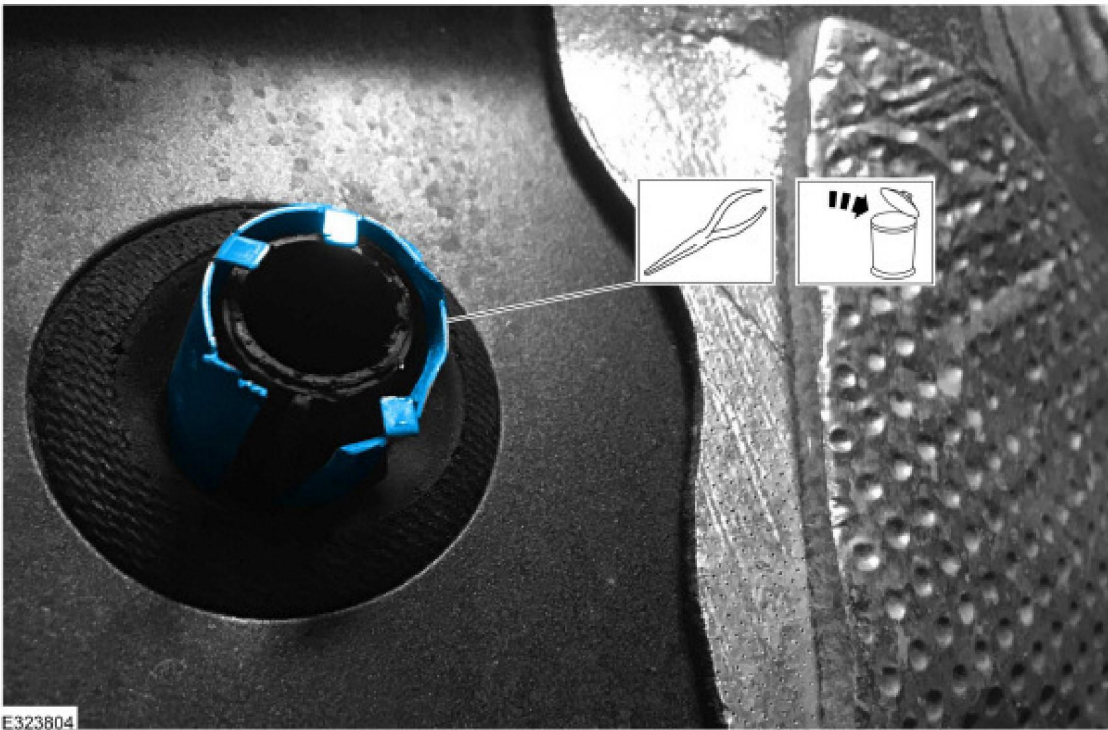
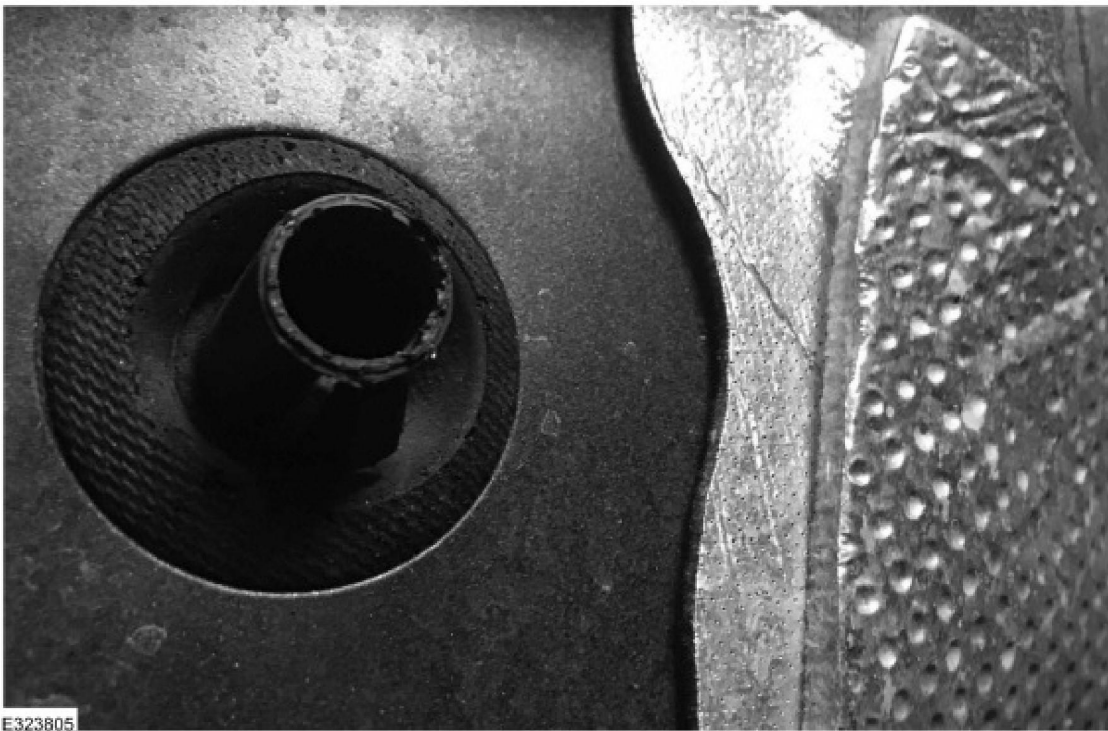
Issue: Some 2018-2020 F-150/Expedition/Navigator/F-Super Duty vehicles built on 31-Aug-2018 and through 02-Feb-2020 may exhibit a water leak on the right front floor during and/or after the air conditioning (A/C) is used. This may be due to condensation from the evaporator drain tube entering the vehicle through the drain tube seal. To correct the condition, follow the Service Procedure steps to install an elbow on the evaporator drain tube to direct the condensation away from the seal.

1. Raise the vehicle and remove the right front tire.
2. Remove the right front fender splash shield. Refer to the Workshop Manual (WSM), Section 501-02.
3. Using needle nose pliers or equivalent, remove and discard the metal shield from the evaporator drain tube by bending the tabs away from the tube. (Figures 1-3)
