**FORD Warranty Review**  
**Secondary Filters - Base Part 9150**

# Warranty Analysis Investigation

- [REDACTED] requested Sogefi [REDACTED] analyze and review 5 samples, Ford base Part Sogefi X [REDACTED] 33 Fine Filter.
- [REDACTED] has been reported with a leak. [REDACTED]

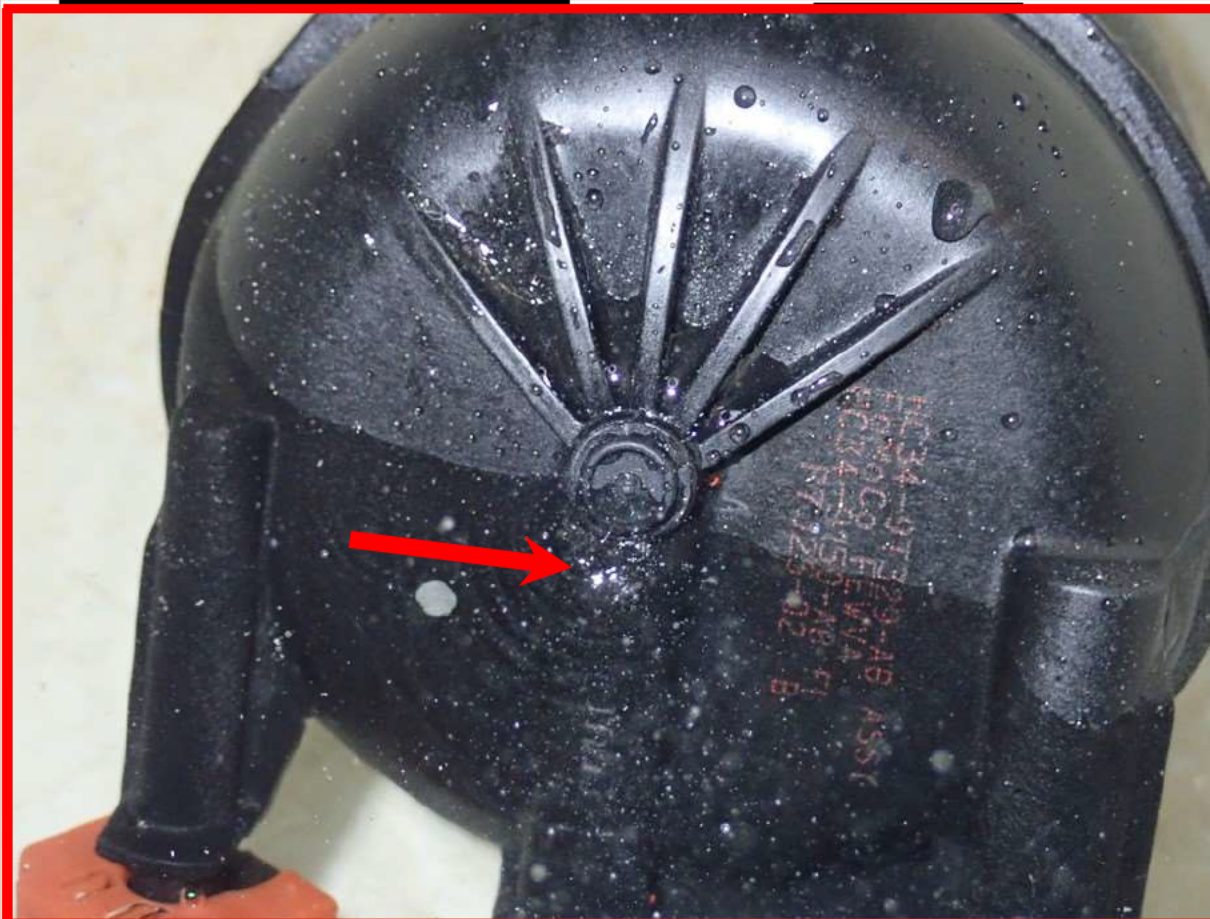
The filter was tested with air pressure and underwater. The leak source was located in the top cover, at the base of the outlet port.

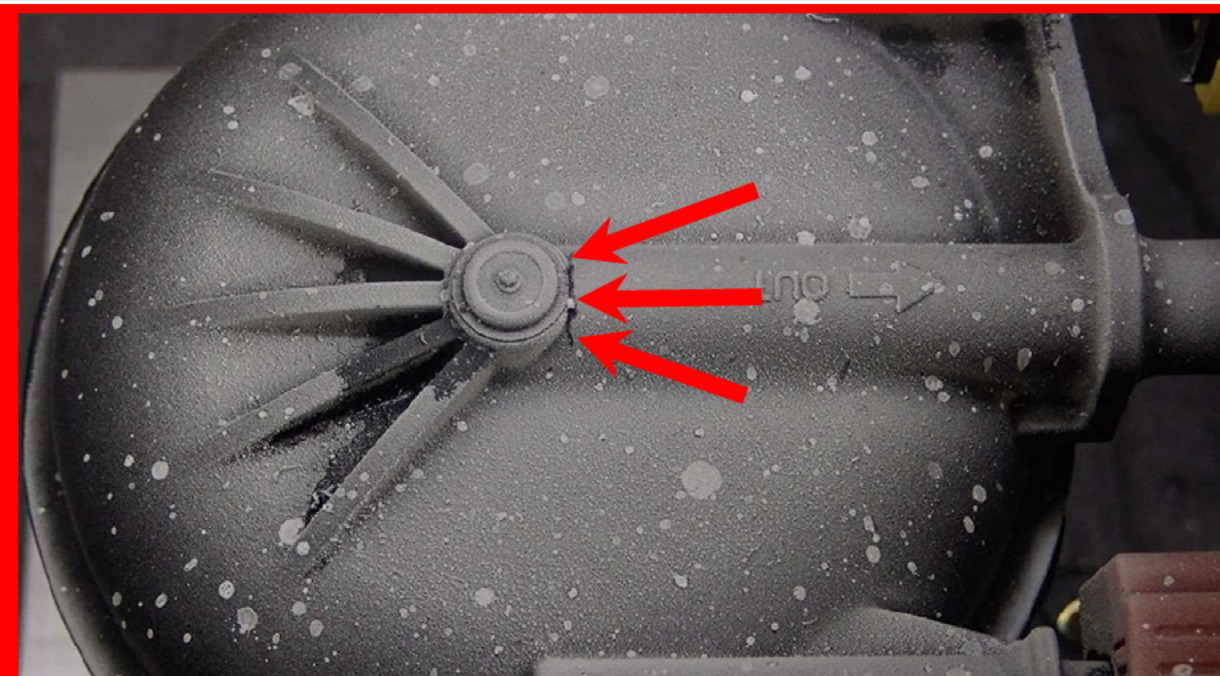
- To get a better view of the leak source, white powder was sprayed over the cap.
- The filter was then pressurized with air.
- **The air exposed the leak area. There is a fracture in the top cover, at the base of the outlet port.**

| # | Vehicle | MY | Prichard Mfg. Date | Top Cover Cavity | Leak Test Results<br>NG | Leak Test Results<br>OK | Comments |
|---|---|---|---|---|---|---|---|
| 1 | VIN UNKNOWN | UNKNOWN | P7J2502 B<br>Aug 25 <sup>th</sup> , 2017 | Cav1 - 07/2017<br>(Mold Date) | Leak @ Fracture in the top<br>cover | --- | Fracture at the base of the outlet port.<br>Filter is very saturated with contamination. Filter is<br>collapsed. |

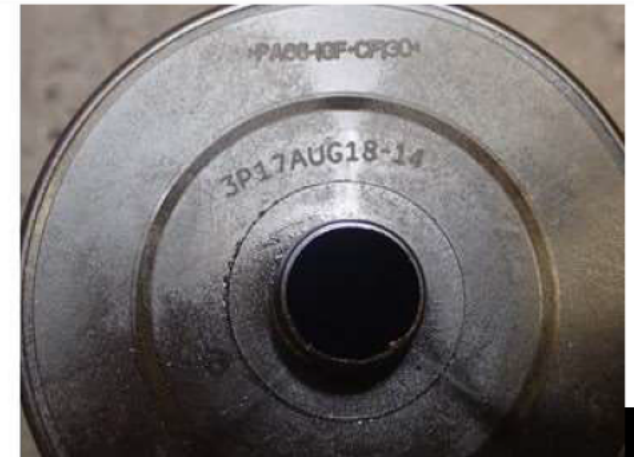
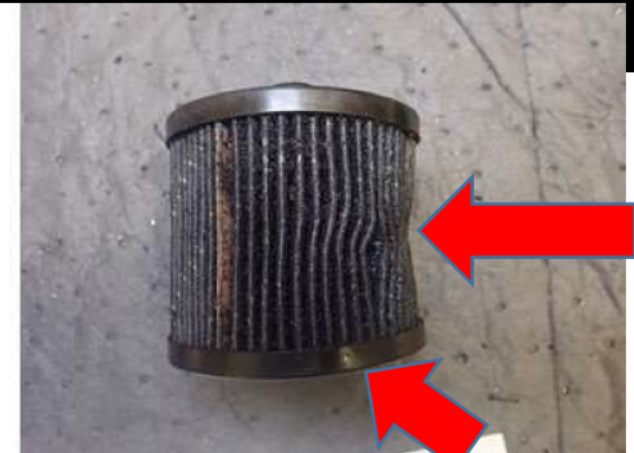
Visual inspection of the filter; There are some pleats that are collapsed, also the bottom end cap of the filter is deformed. We believe this was due to High Pressure Drop causing the filter to collapse.

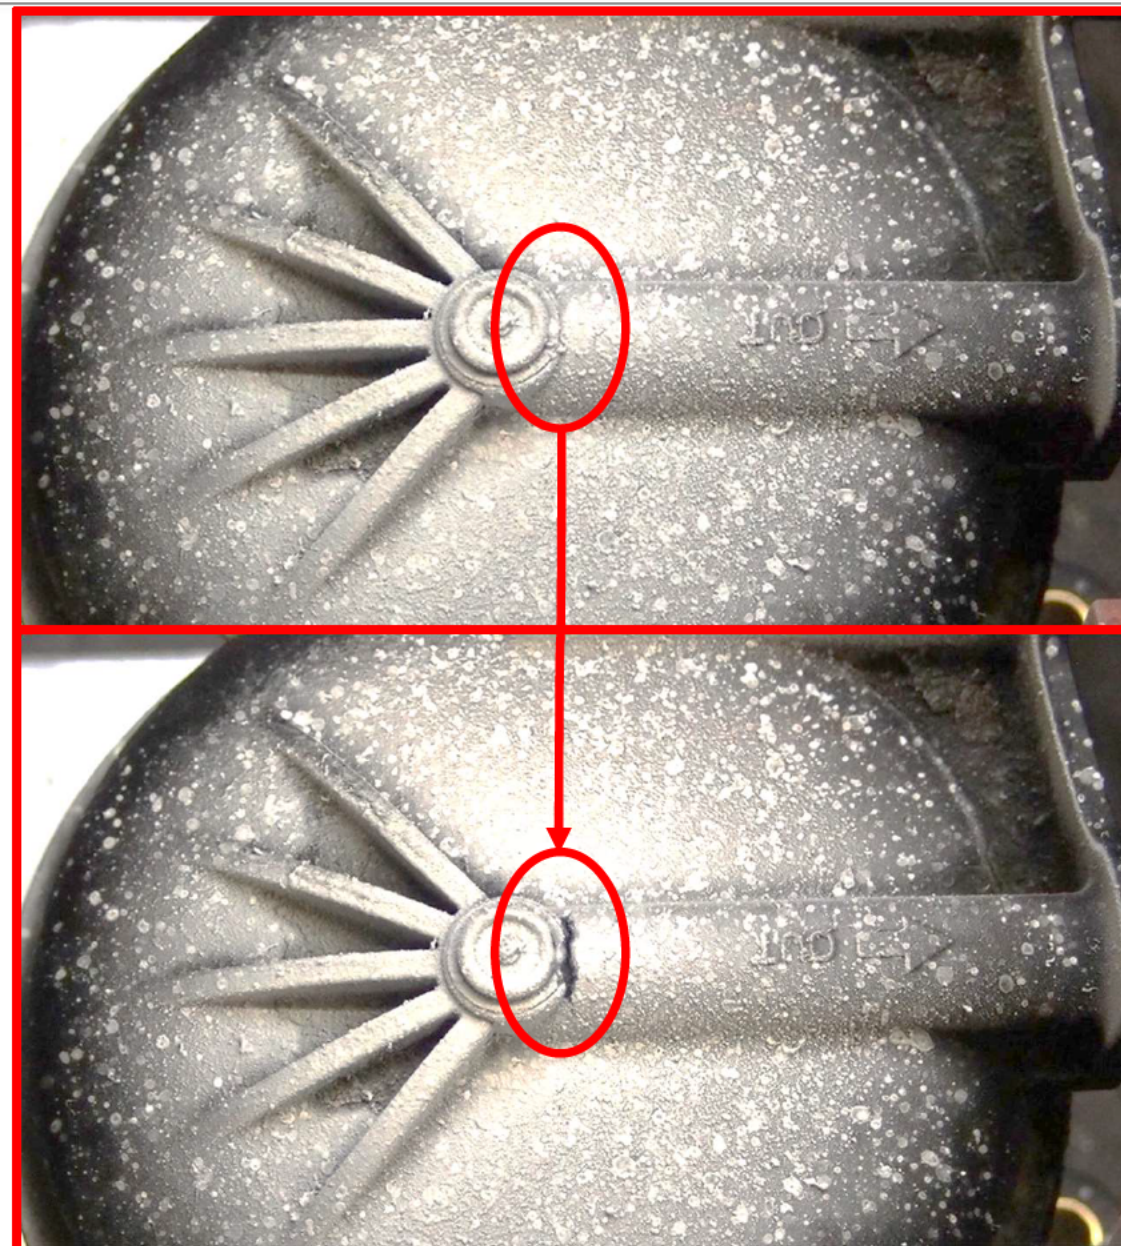
- [REDACTED] of the leak [REDACTED]
- [REDACTED]
- The air exposed the leak area. There is a fracture in the top cover, at [REDACTED] the outlet port.

| # | Vehicle | MY | Prichard Mfg. Date | Top Cover Cavity | Leak Test Results<br>NG | Leak Test Results<br>OK | Comments |
|---|---|---|---|---|---|---|---|
| 2 | [REDACTED] F2017 F350 | 2017 | P7J23-10 B<br>Aug 23 <sup>rd</sup> , 2017 | Cav1 - 07/2017<br>(Mold Date) | Leak @ Fracture in the top<br>cover | --- | Fracture at the base of the outlet port.<br>Filter is very saturated with contamination. Filter is<br>collapsed. |

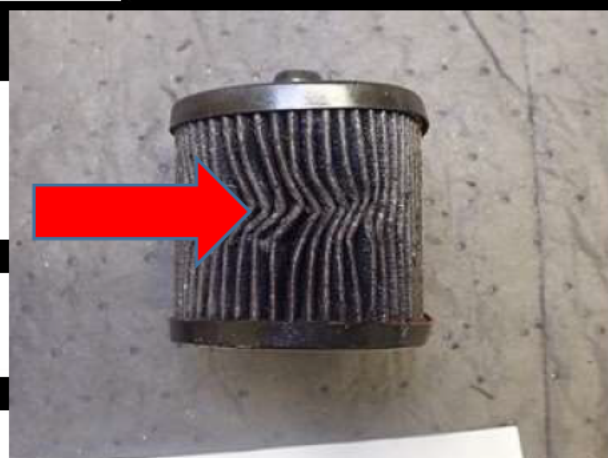
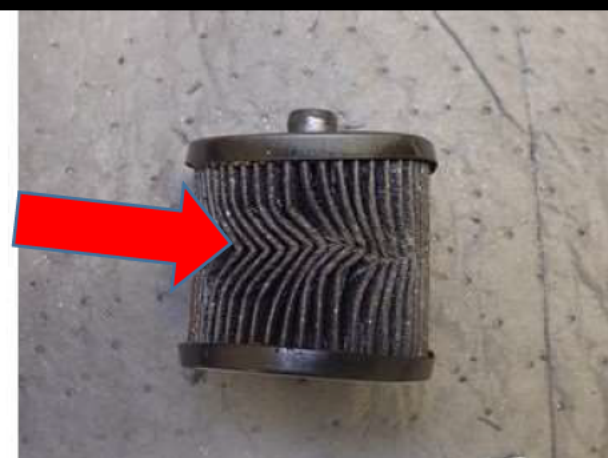
Visual inspection of the filter; There are some pleats that are collapsed, also the bottom end cap of the filter is deformed. We believe this was due to High Pressure Drop causing the filter to collapse.

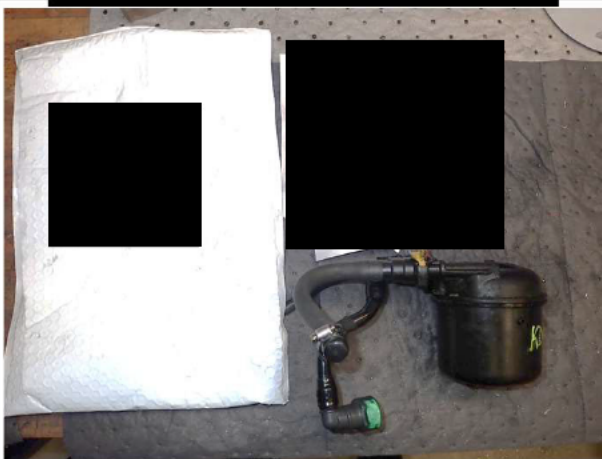
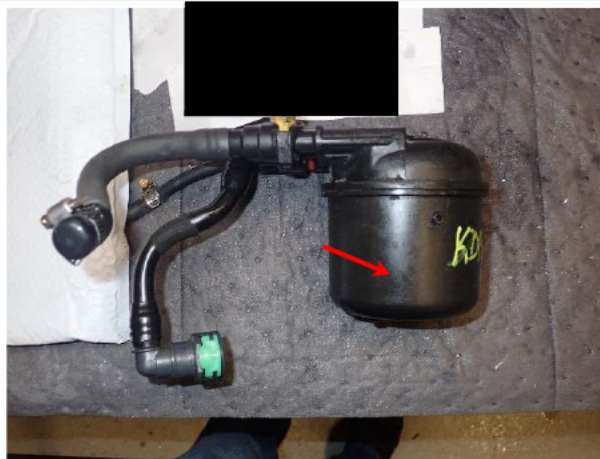
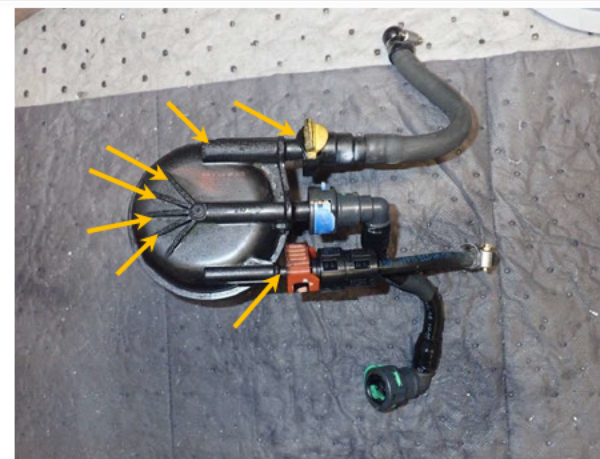
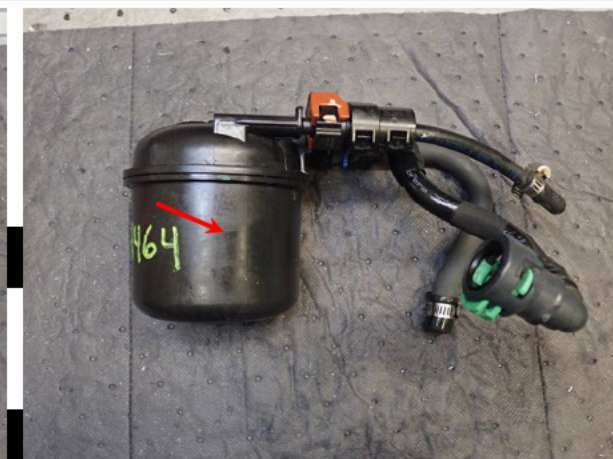
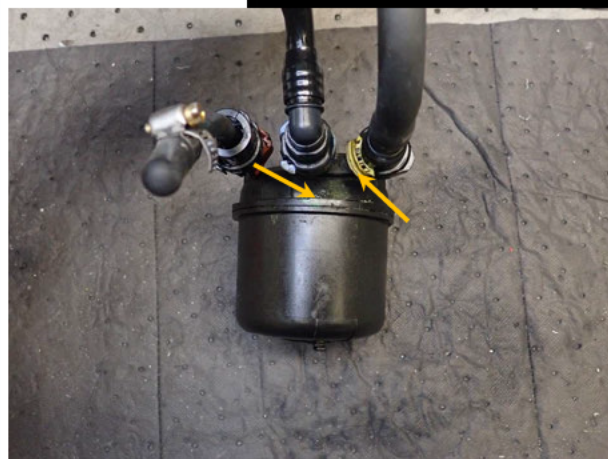
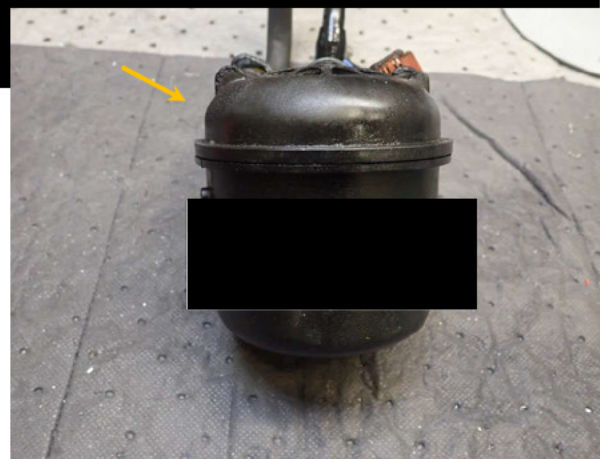
Secondary Filter was visually inspected, some minor scratches and multiple molten plastic areas were found.

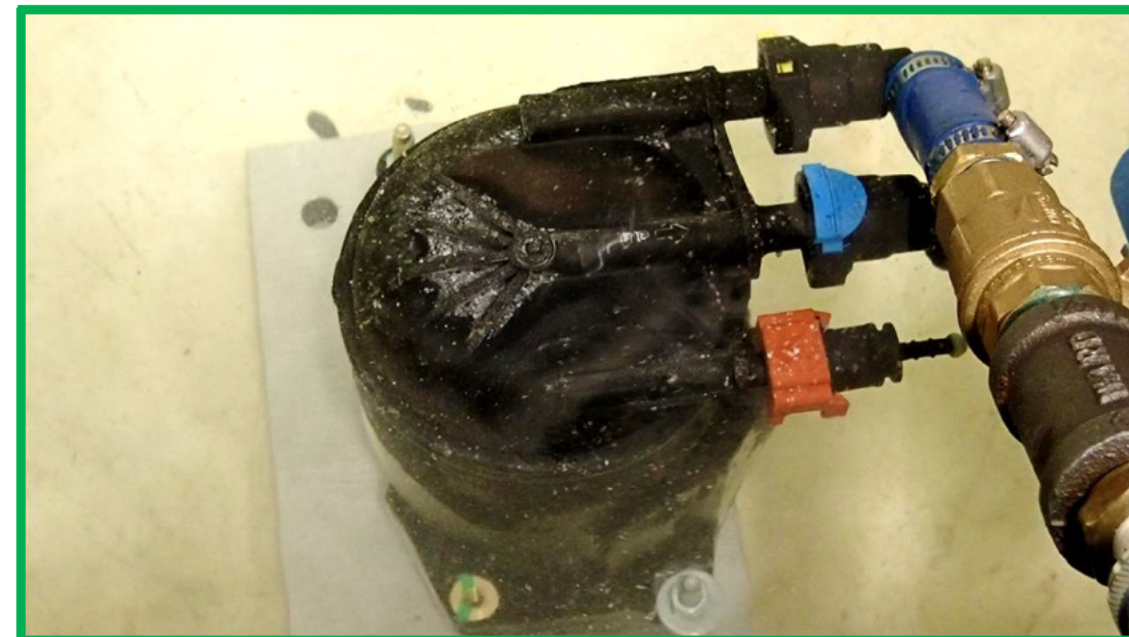
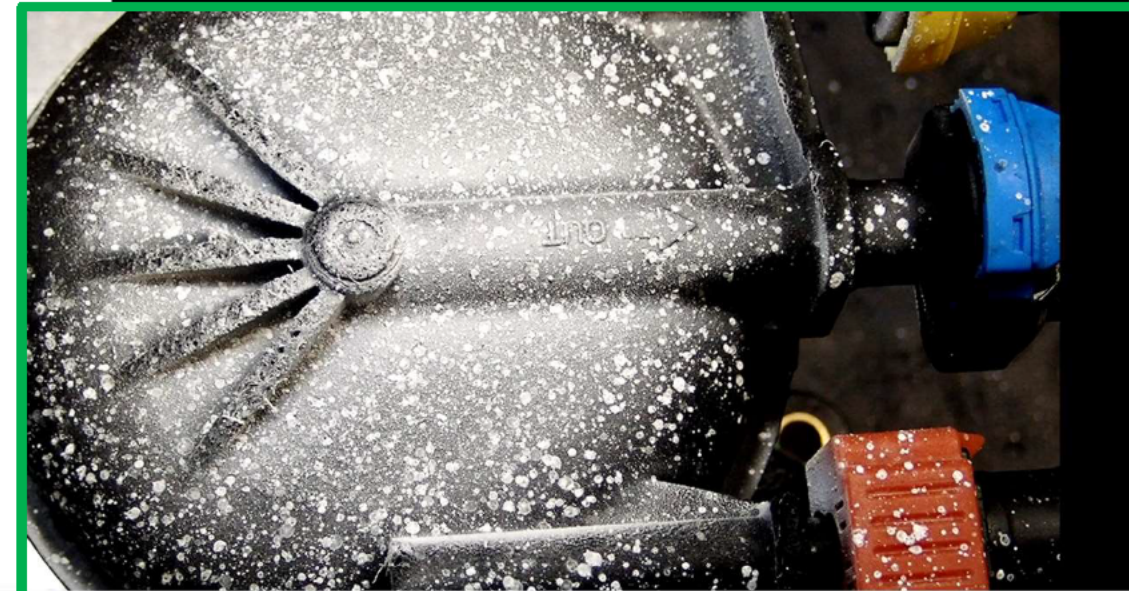
- [REDACTED] air pressure and underwater.
- To get a [REDACTED] over [REDACTED]
- The filter was then pressu [REDACTED]
- The air did NOT expose any leaks.

| # | Vehicle | MY | Prichard Mfg. Date | Top Cover Cavity | Leak Test Results<br>NG | Leak Test Results<br>OK | Comments |
|---|---|---|---|---|---|---|---|
| 3 | [REDACTED]<br>MEDIUM DUTY<br>(F650/F750) 6.7L | 2019 | UNREADABLE /<br>ILLEGIBLE. | Cav1 - 07/2019<br>(Mold Date) | --- | <b>DID NOT LEAK</b> | Filter with low contamination. Filter is not collapsed. |

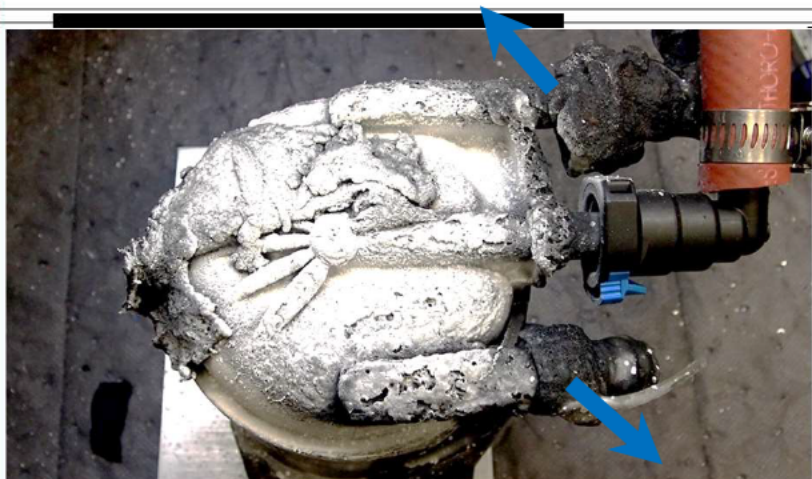
[REDACTED] et a better view, white powder was sprayed over the cap.

• The filter was then pressurized with air.

- The air did NOT expose any leaks on the cover. There are multiple leak areas in the ports.

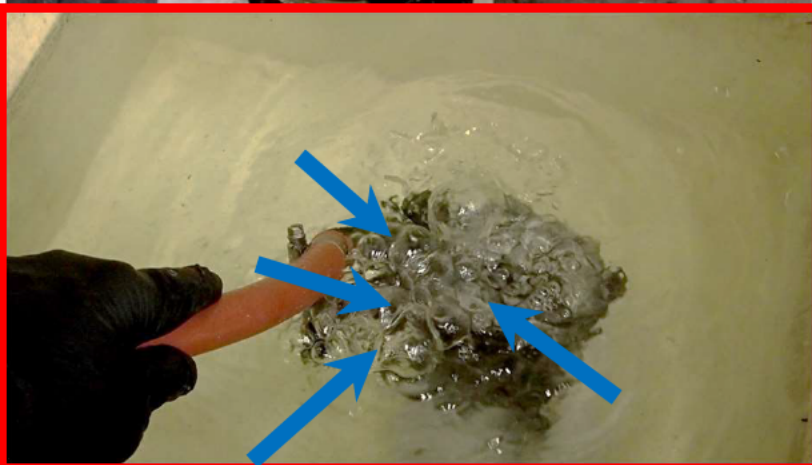
[REDACTED] tested with [REDACTED]  
[REDACTED] areas in the [REDACTED]

- To obtain a better seal, the molten connectors were milled on the [REDACTED] new fuel connectors were placed.

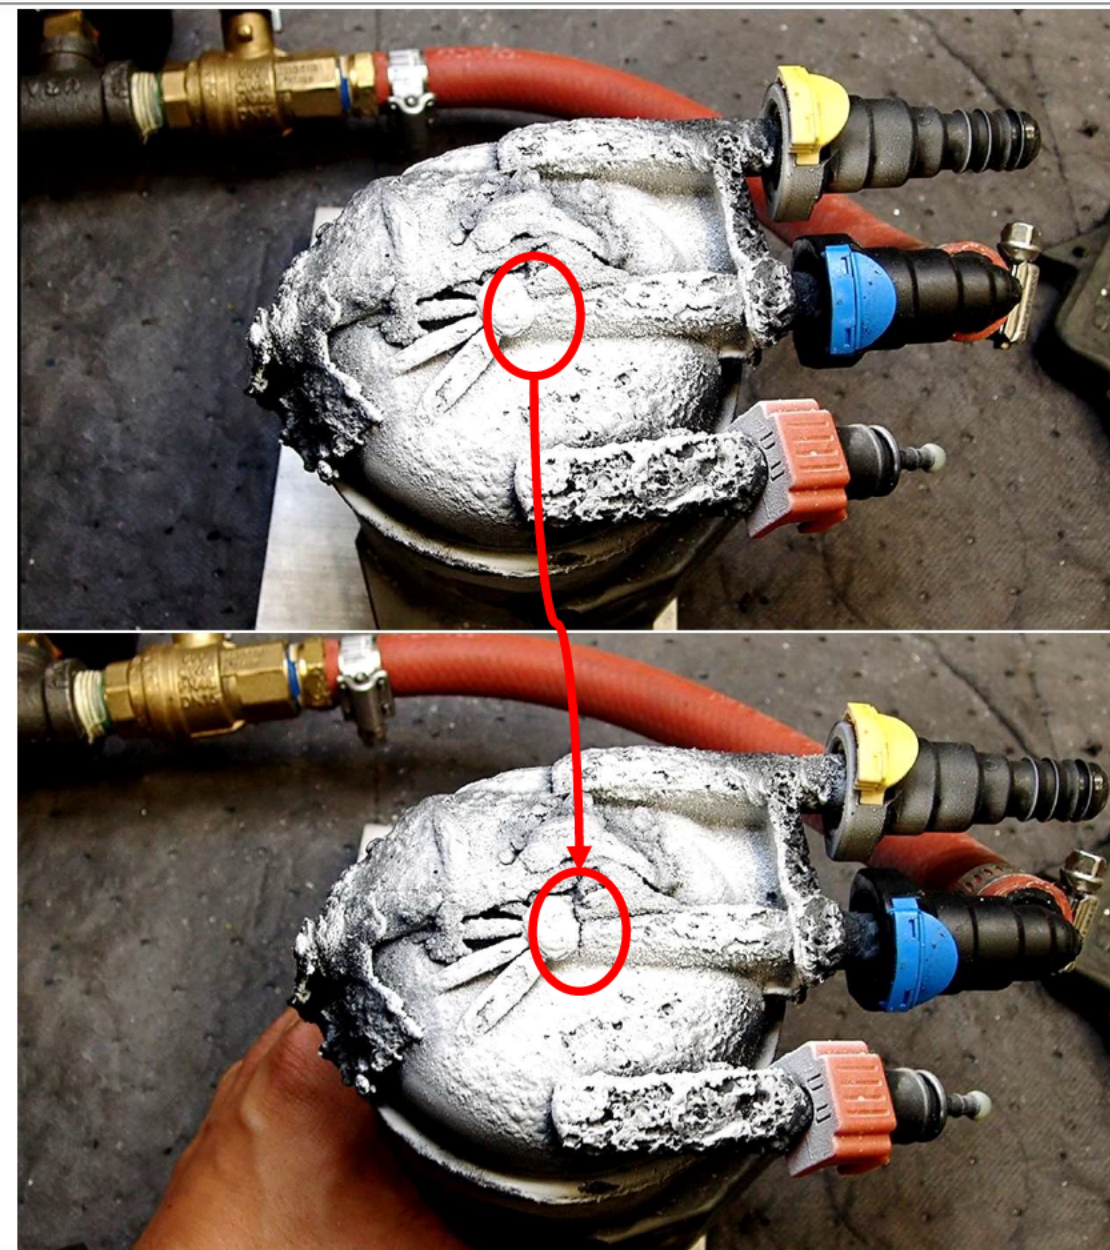
- [REDACTED], white powder is sprayed
- [REDACTED] pressed with [REDACTED]
- [REDACTED] break area. There is a fracture [REDACTED] the base of the [REDACTED]

| # | Vehicle | MY | Prichard Mfg. Date | Top Cover Cavity | Leak Test Results<br>NG | Leak Test Results<br>OK | Comments |
|---|---|---|---|---|---|---|---|
| 4 | [REDACTED]<br>F250 6.7L | 2019 | UNREADABLE /<br>ILLEGIBLE. | Cav1 - 02/2019<br>(Mold Date) | Leak @ Fracture in the top<br>cover | --- | Fracture at the base of the outlet port.<br>Filter is very saturated with contamination. Filter is<br>collapsed. |

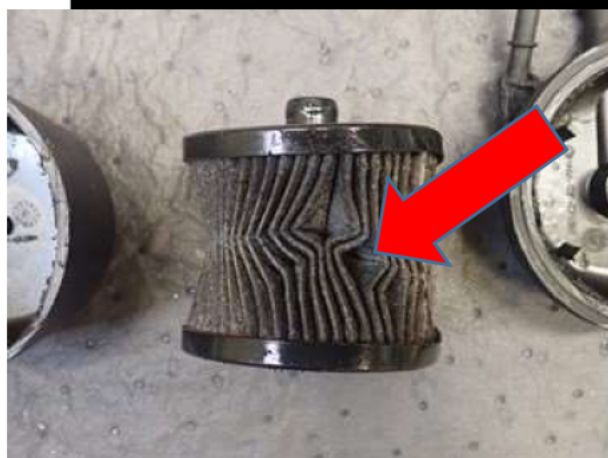
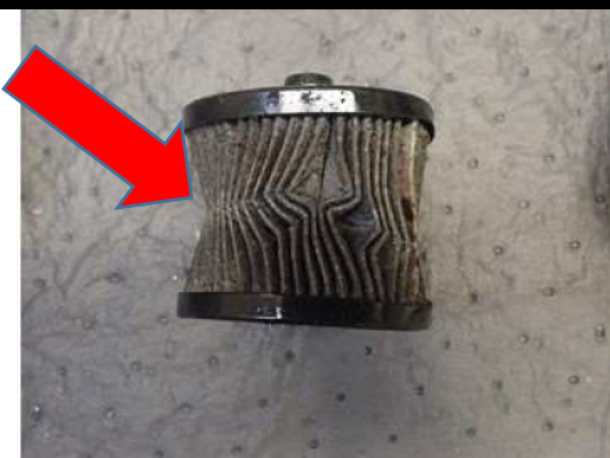
Visual inspection of the filter; There are some pleats that are collapsed, also the bottom end cap of the filter is deformed. We believe this was due to High Pressure Drop causing the filter to collapse.

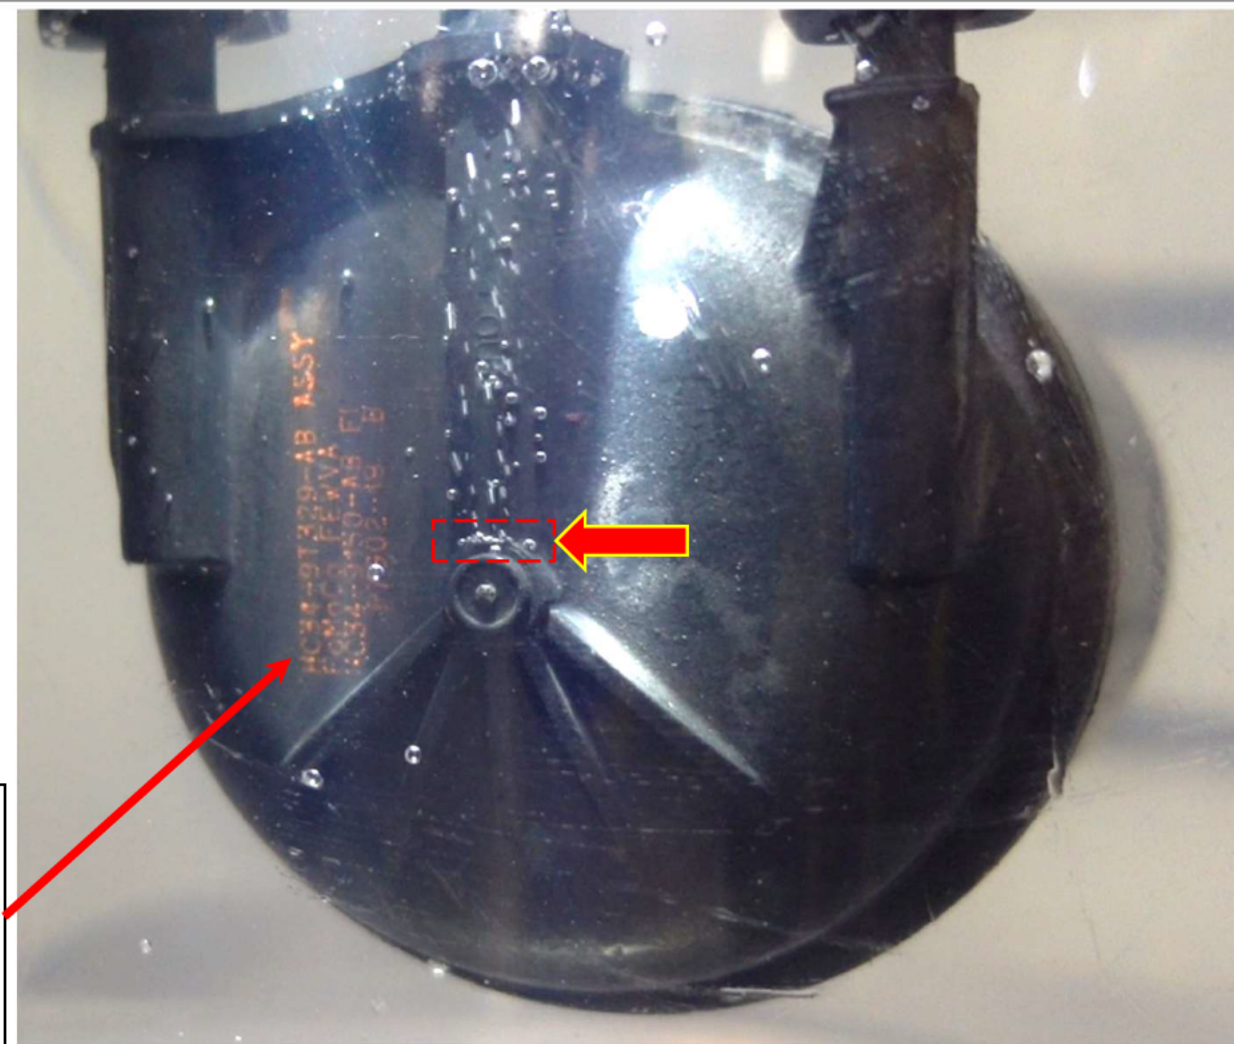
- [REDACTED] ent report [REDACTED] Ford on [REDACTED]
- [REDACTED] air leak underwater.
- [REDACTED] the air leak is co [REDACTED]  
[REDACTED]  
the bas [REDACTED]

| # | Vehicle | MY | Prichard Mfg. Date | Top Cover Cavity | Leak Test Results<br>NG | Leak Test Results<br>OK | Comments |
|---|---|---|---|---|---|---|---|
| 5 | VIN UNKNOWN | UNKNOWN | P7G02-19 B<br>June 2 <sup>nd</sup> , 2017 | Cav1 - <b>Sample @<br/>Ford</b> (Mold Date?) | Leak @ Fracture in the top<br>cover<br><b>Sample @ Ford</b> | --- | Fracture at the base of the outlet port. |

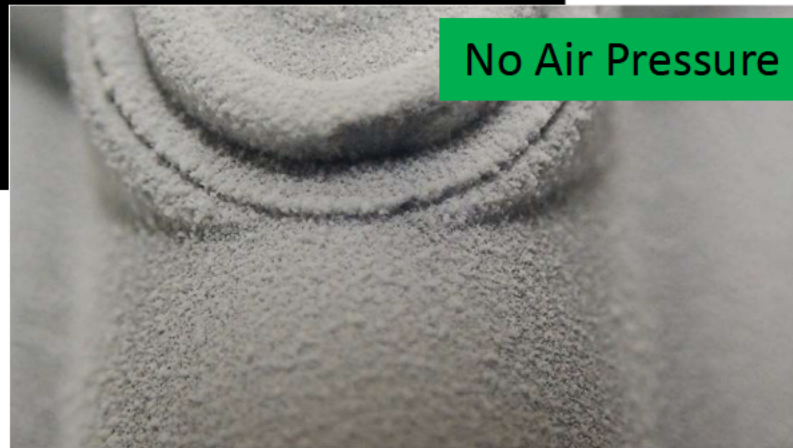
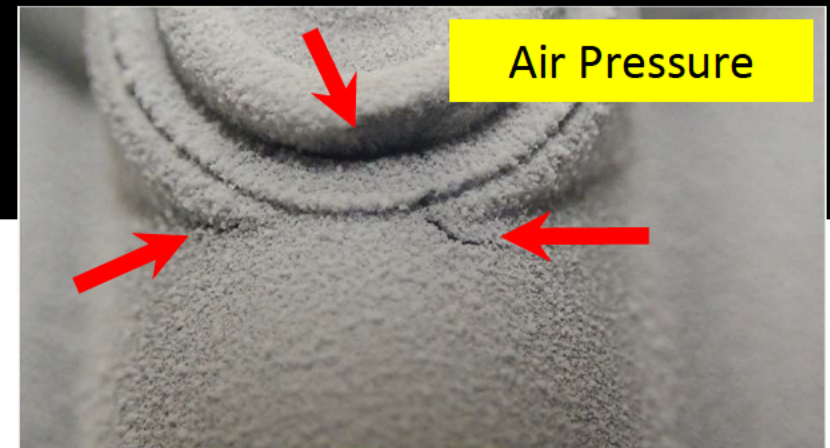
To get a better view of the leak source, white powder was sprayed [REDACTED] the cap.

The [REDACTED]  
with air [REDACTED]  
un [REDACTED]  
source was located in  
the top cover, at the  
base of the outlet port.

- The filter was then pressurized with air.
- **The air exposed the leak area. There is a fracture in the top cover, at the base of the outlet port.**

| # | Vehicle | MY | Prichard Mfg. Date | Top Cover Cavity | Leak Test Results<br>NG | Leak Test Results<br>OK | Comments |
|---|---|---|---|---|---|---|---|
| 6 | [REDACTED]<br>- F250 SERIES | 2021 | P0M14-18D<br>Nov 14 <sup>th</sup> , 2020 | Cav1; 10/2020<br>(Mold Date) | Leak @ Fracture in the top<br>cover | --- | Fracture at the base of the outlet port.<br>Filter with low contamination. Filter is not collapsed.<br><b>Claim did not come from a THERMAL EVENT.</b> |

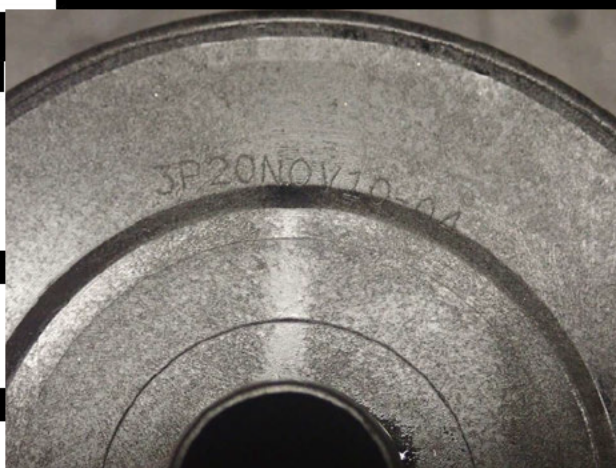
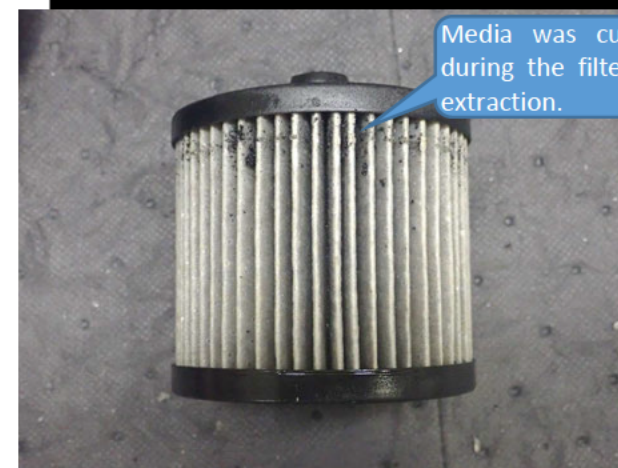
The Filter has a manufacturing date of 3P20NOV10-04. Visual inspection of the filter; Low contamination saturation, due to low miles.

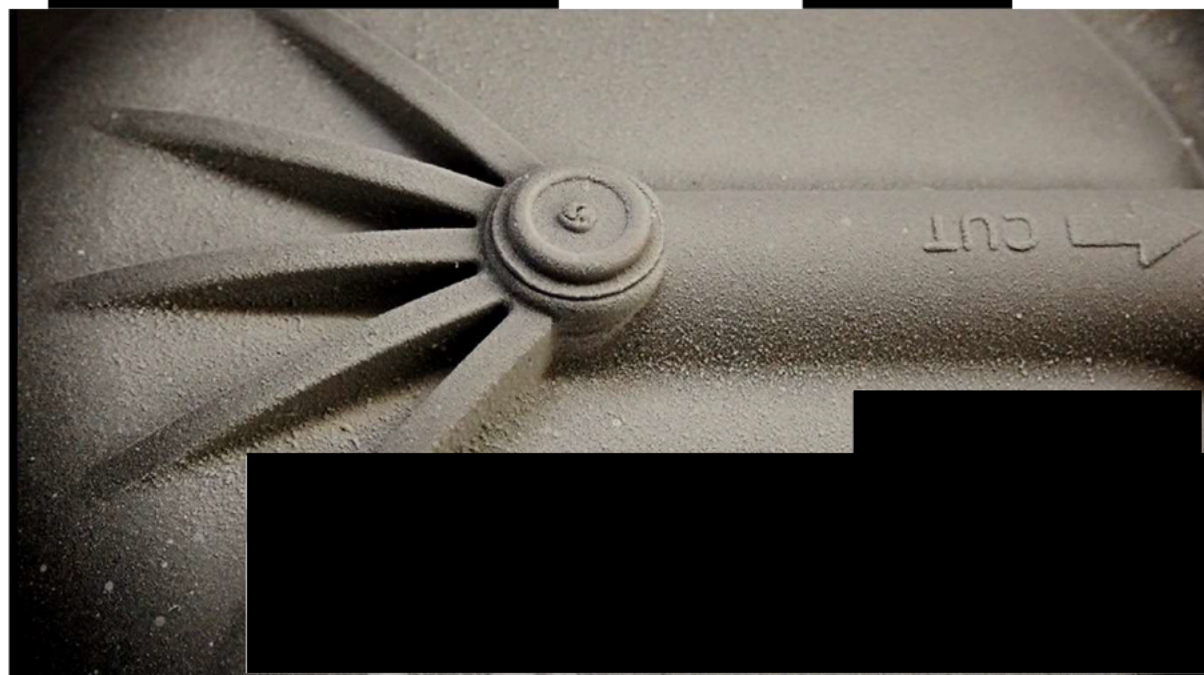
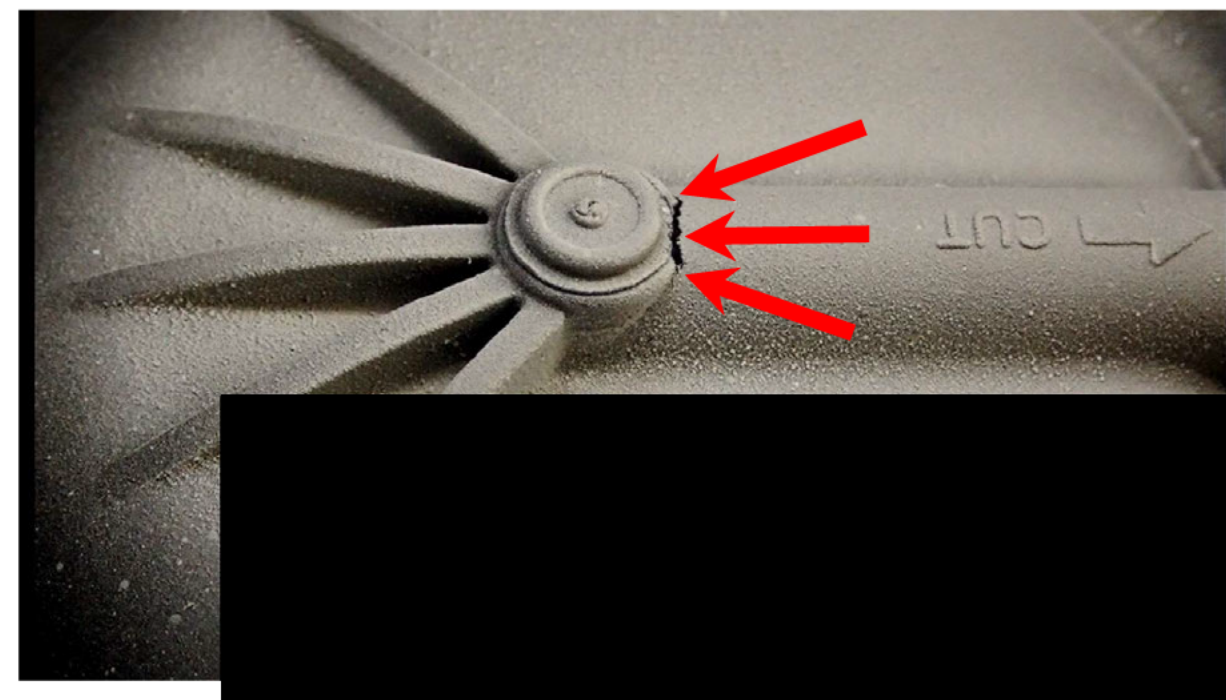
- To get a better view of the [REDACTED] powder was sprayed over the cap.
- [REDACTED]
- The filter was then pressurized with air. (80Psi ~ 5.5Bar)
- [REDACTED]
- The air exposed the leak area. There is a fracture in the top cover, at the base of the outlet port.

| # | Vehicle | MY | Prichard Mfg. Date | Top Cover Cavity | Leak Test Results<br>NG | Leak Test Results<br>OK | Comments |
|---|---|---|---|---|---|---|---|
| 7 | [REDACTED]<br>MY2021 – F450 | 2021 | P7M26-19 A<br>[Nov 26 <sup>th</sup> , 2017] | <b>CAV2</b><br>08/2017 | Leak @ Fracture in the top<br>cover | --- | Fracture at the base of the outlet port.<br>Filter is very saturated with contamination. Filter is<br>collapsed.<br><b>Claim did not come from a THERMAL EVENT.</b> |

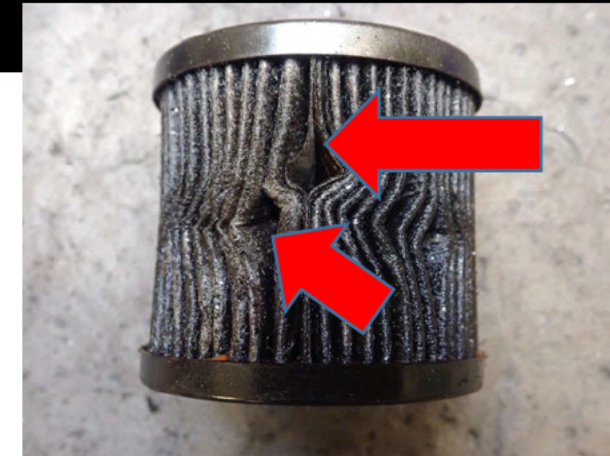
Visual inspection of the filter; There are some pleats that are collapsed, also the bottom end cap of the filter is deformed. We believe this was due to High Pressure Drop causing the filter to collapse.
