## RE: [EXTERNAL]Photographs of 2019 Malibu Inflator Fragments

When you have a moment, could you forward any photographs you have of the fragment(s) of the airbag inflator found in the 2019 Malibu you inspected today?

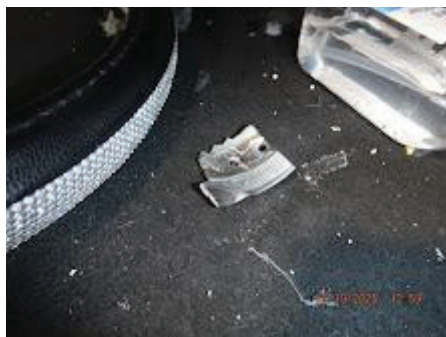
**DSCF0034.JPG**  
4069K

I have attached a photograph of the fragment that was found in the vehicle, matching your description. I made contact with the Michigan Secretary of State office that can help track down the salvage inspection report for when the vehicle was rebuilt. If they can find me the report, they're going to send it to me. Please let me know how else I can help.
