## RE: DTN research

Division Chief  
Office of Defects Investigation

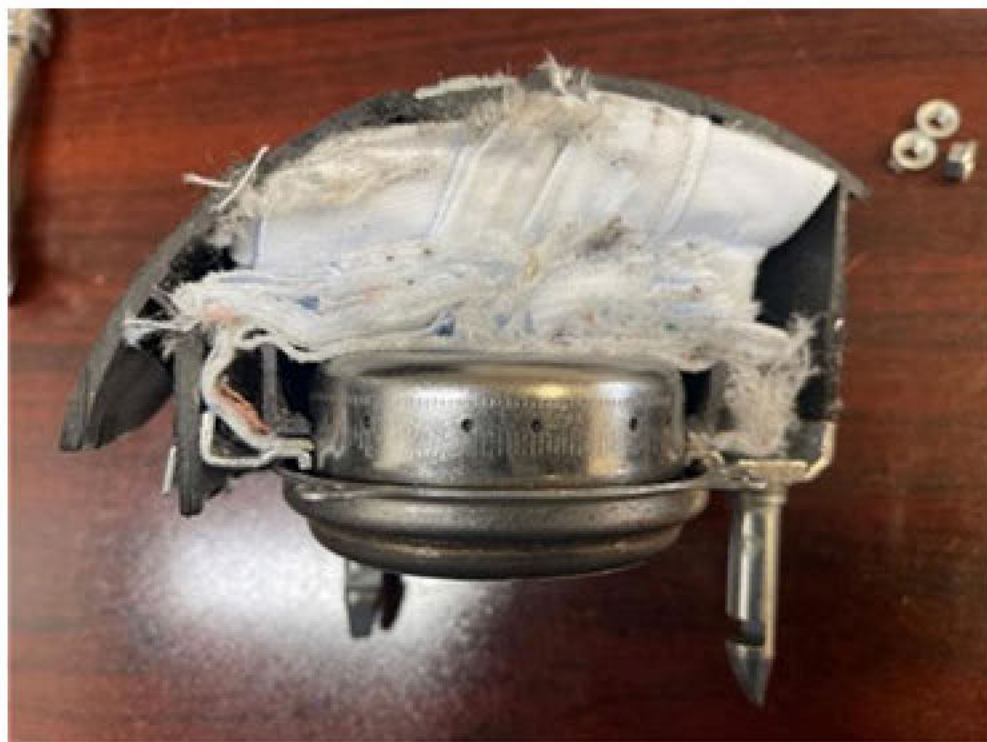
With that background the static deployment testing performed on the DTN60B inflators has no bearing on the DTN field rupture investigation because of the significant differences between the DTN60B and DTN60DB inflators (See attachment). So, I would assume that NHTSA's concern that the DTN60B inflators were deployed without the entire module or cushion is based on their thinking we were deploying the DTN60DB? My first response to their suggestion that we should deploy with the entire module because the module might be impeding gas flow is that its not possible. The photo below is an exemplar 2022 Malibu module that has been cut in half to expose the area where the inflator cap sits. As you can see the gas exhaust ports are in the open space where the cushion resides. This is typical of all driver inflators.
