April 10, 2026

Version 1

**Safety Recall: 2018–22 Odyssey SRS Software Update****APPLIES TO**

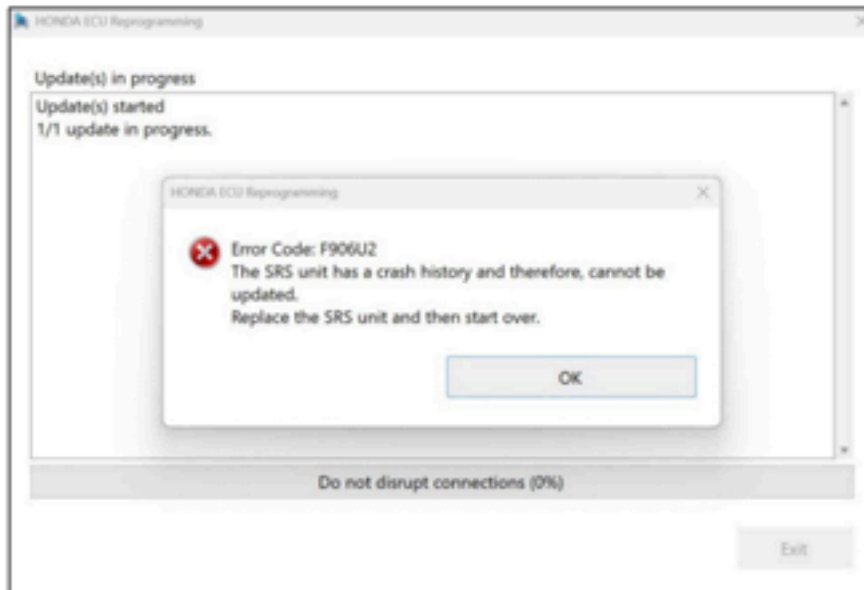
- If the SRS unit cannot be updated and displays the following error message, proceed to **REPAIR PROCEDURE B**.
- A clear photo documenting the HDS screen failure **will be required** for warranty processing.

1. Order a new SRS control unit through normal parts ordering.
2. Remove and replace the [SRS Control Unit](#).
