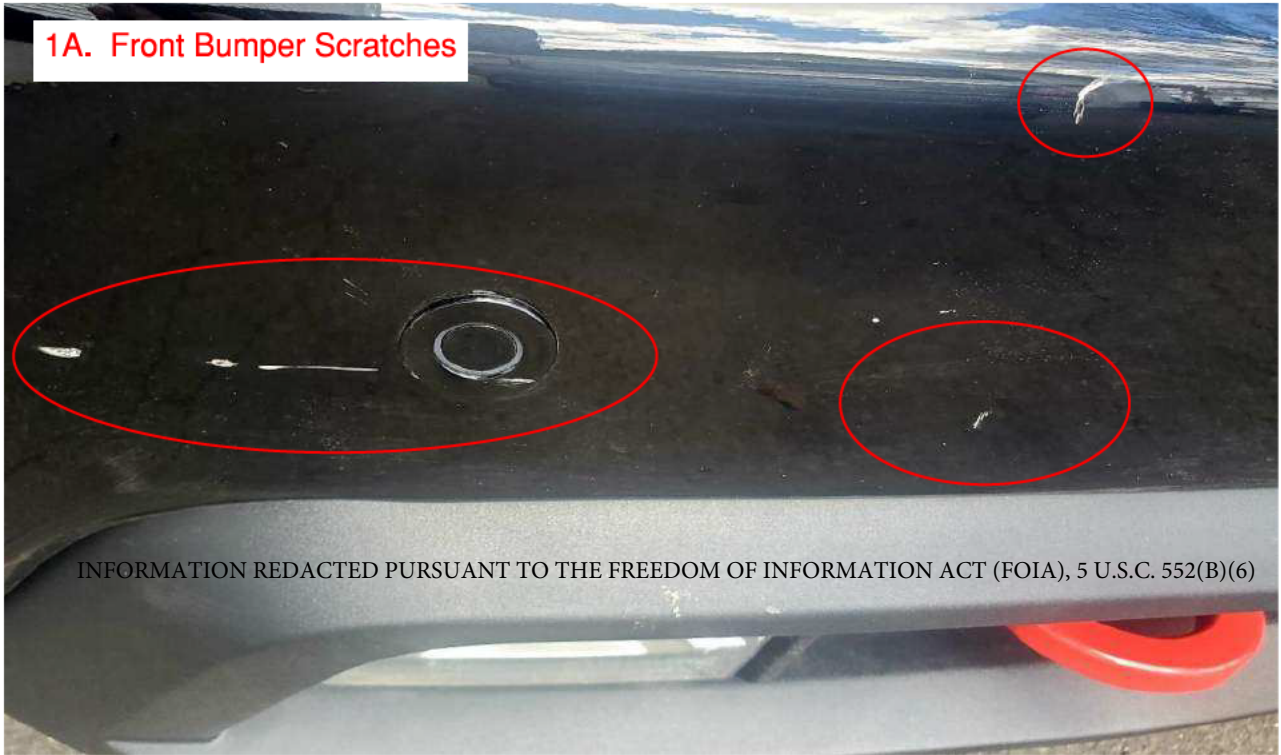
1A. Front Bumper Scratches

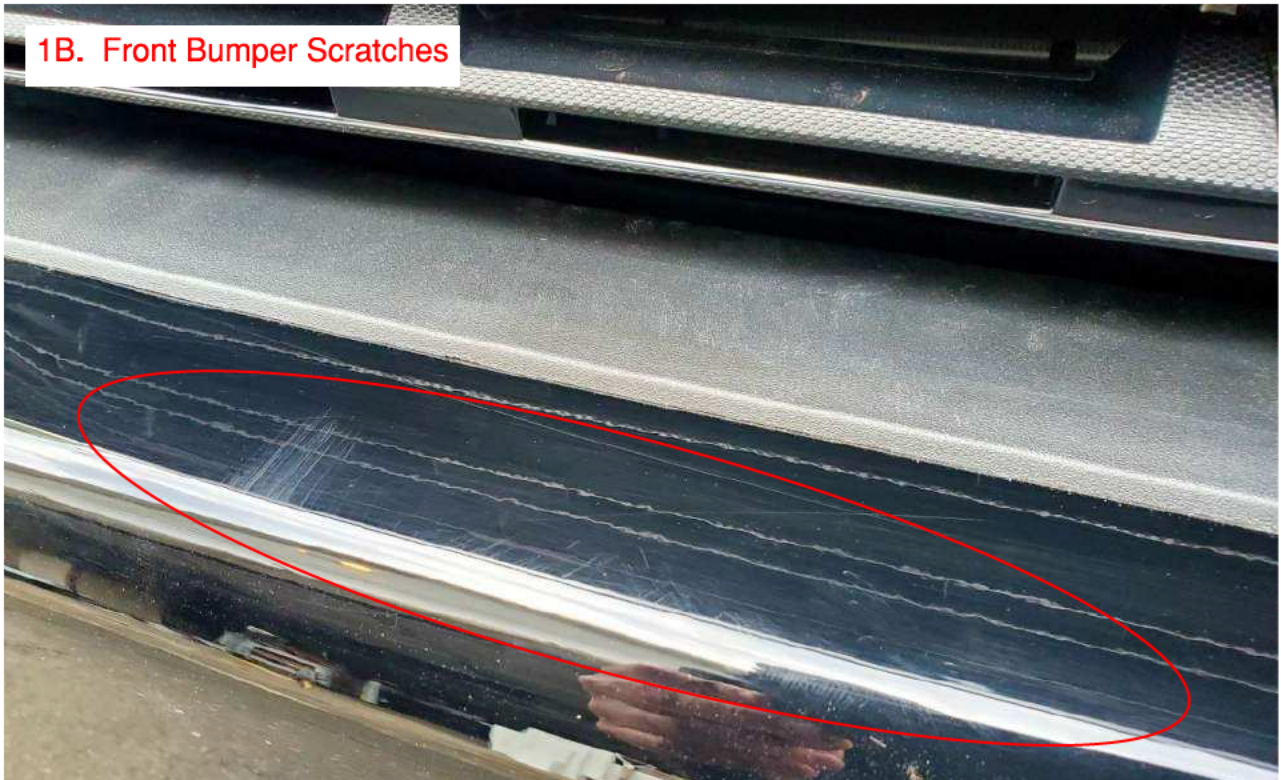
1B. Front Bumper Scratches

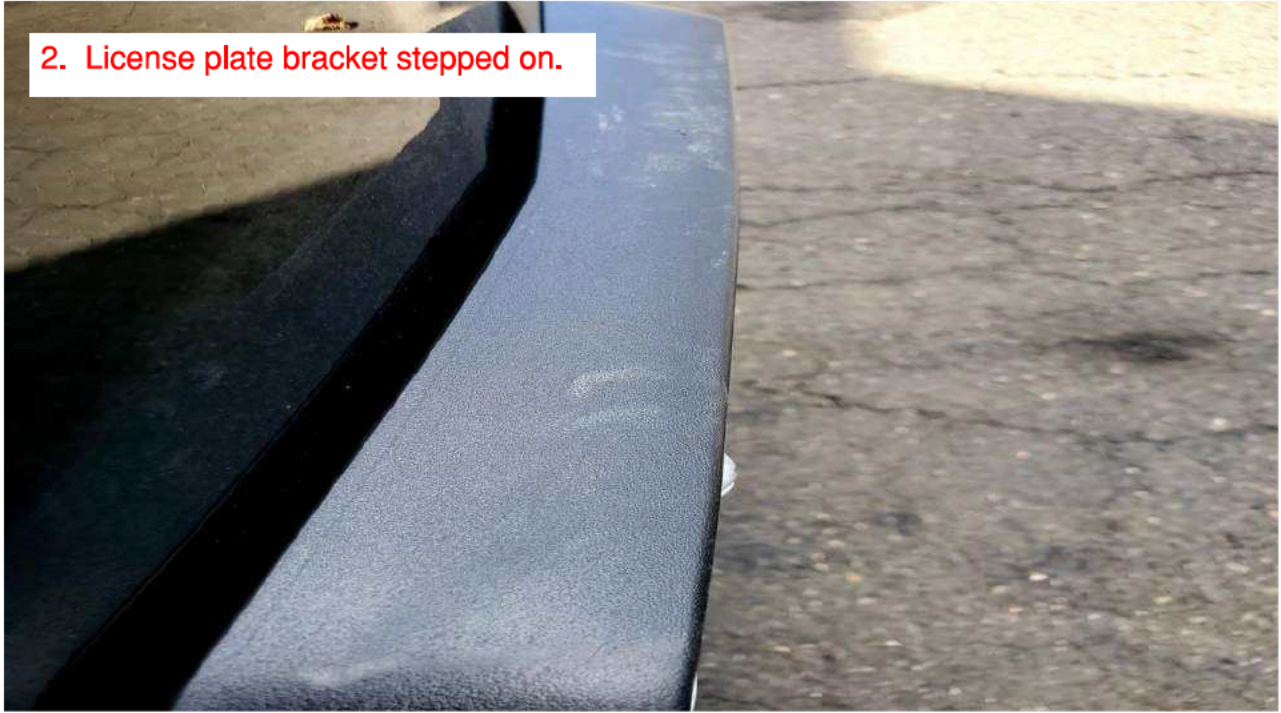
2. License plate bracket stepped on.

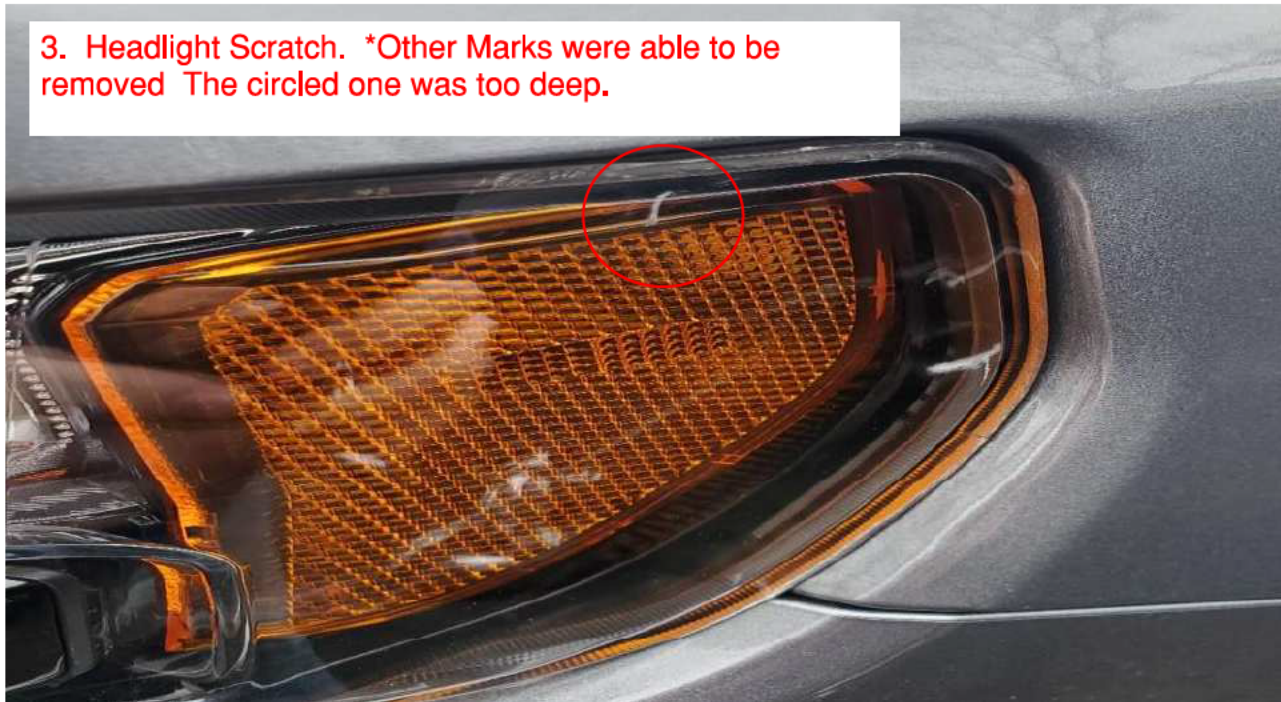
3. Headlight Scratch. \*Other Marks were able to be removed The circled one was too deep.

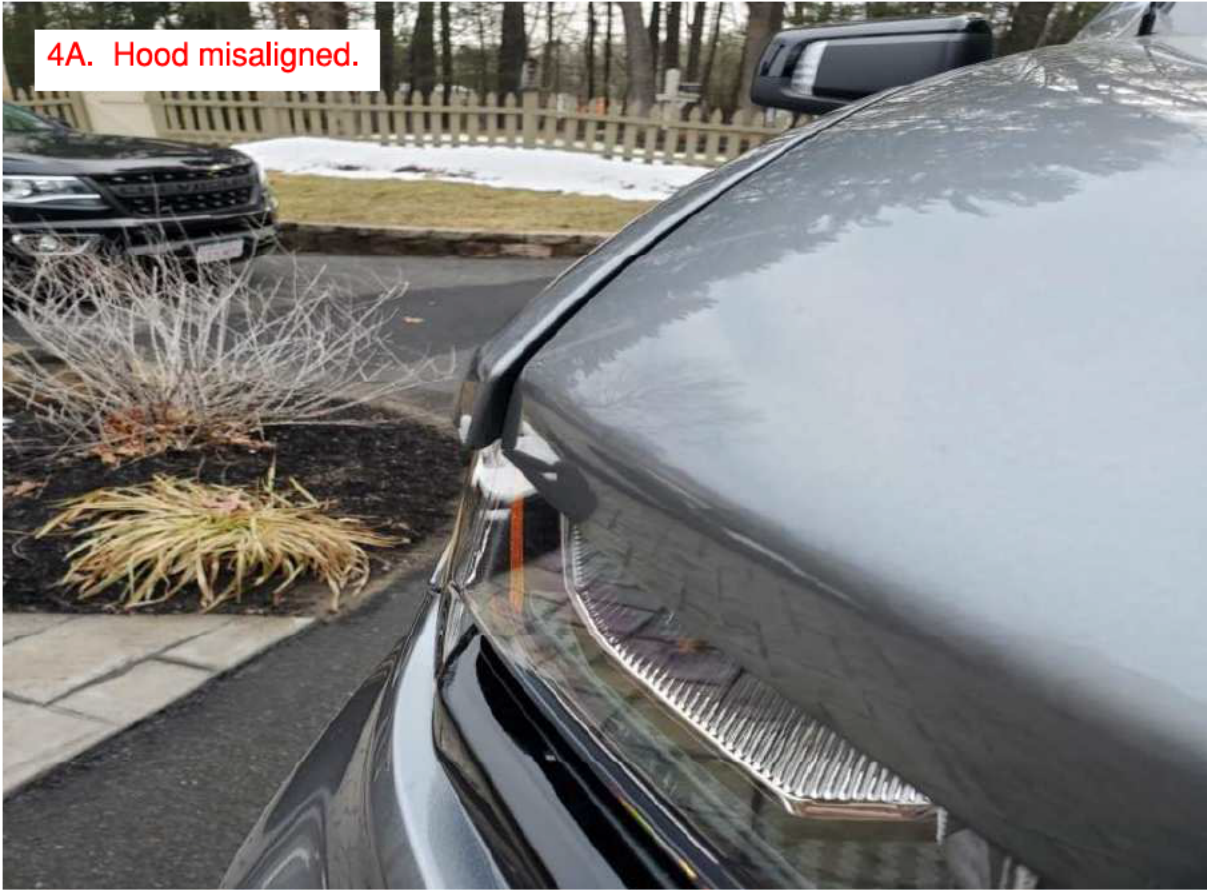
4A. Hood misaligned.

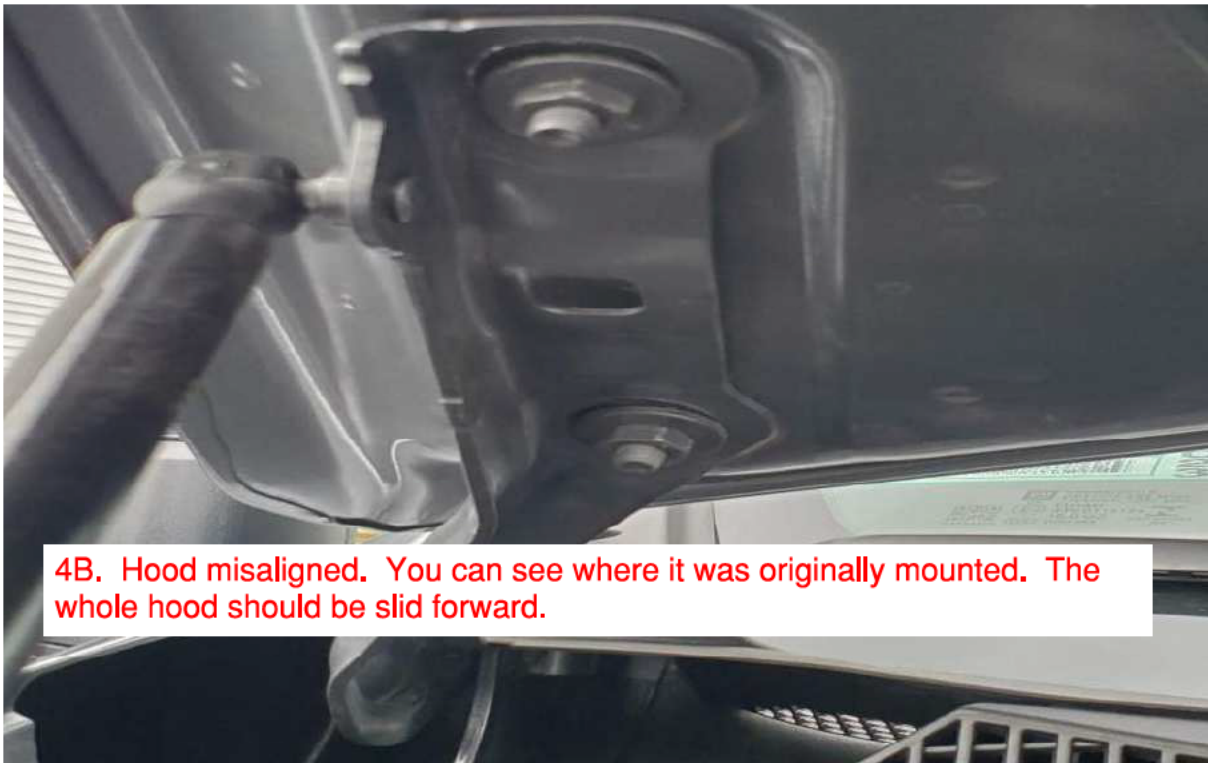
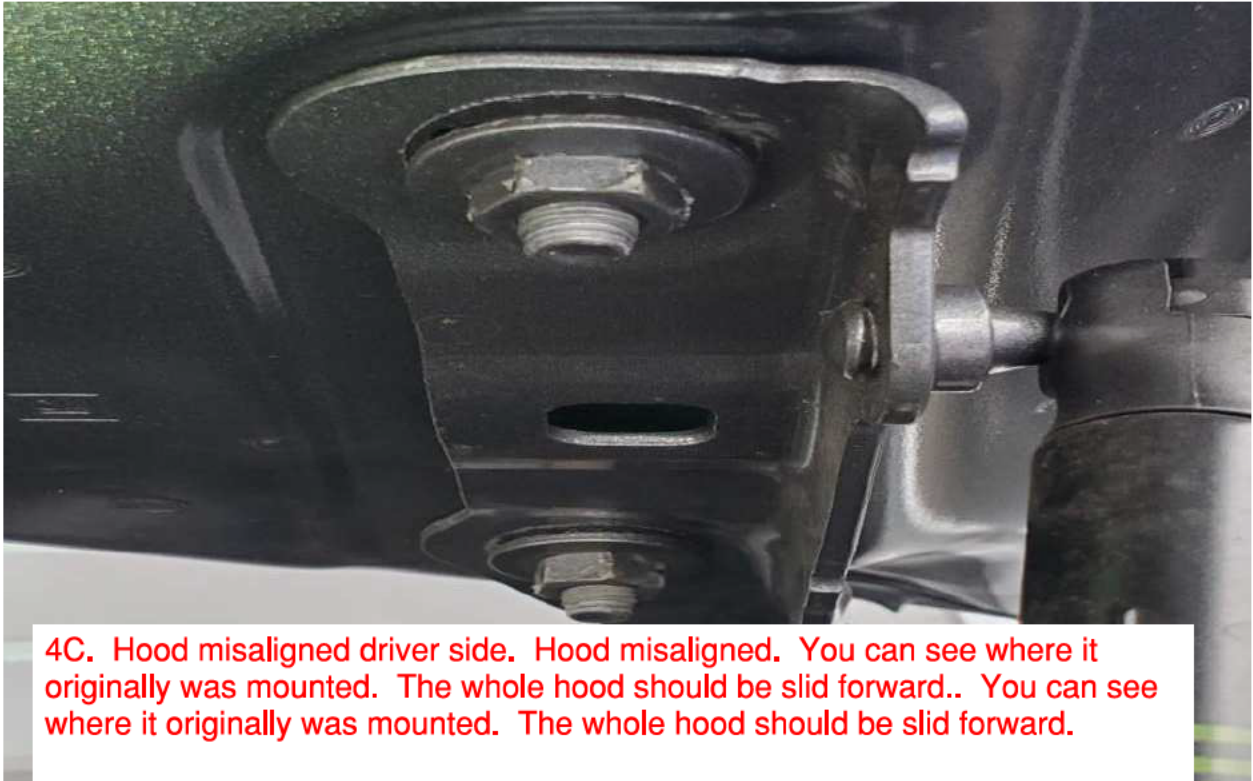
4B. Hood misaligned. You can see where it was originally mounted. The whole hood should be slid forward.

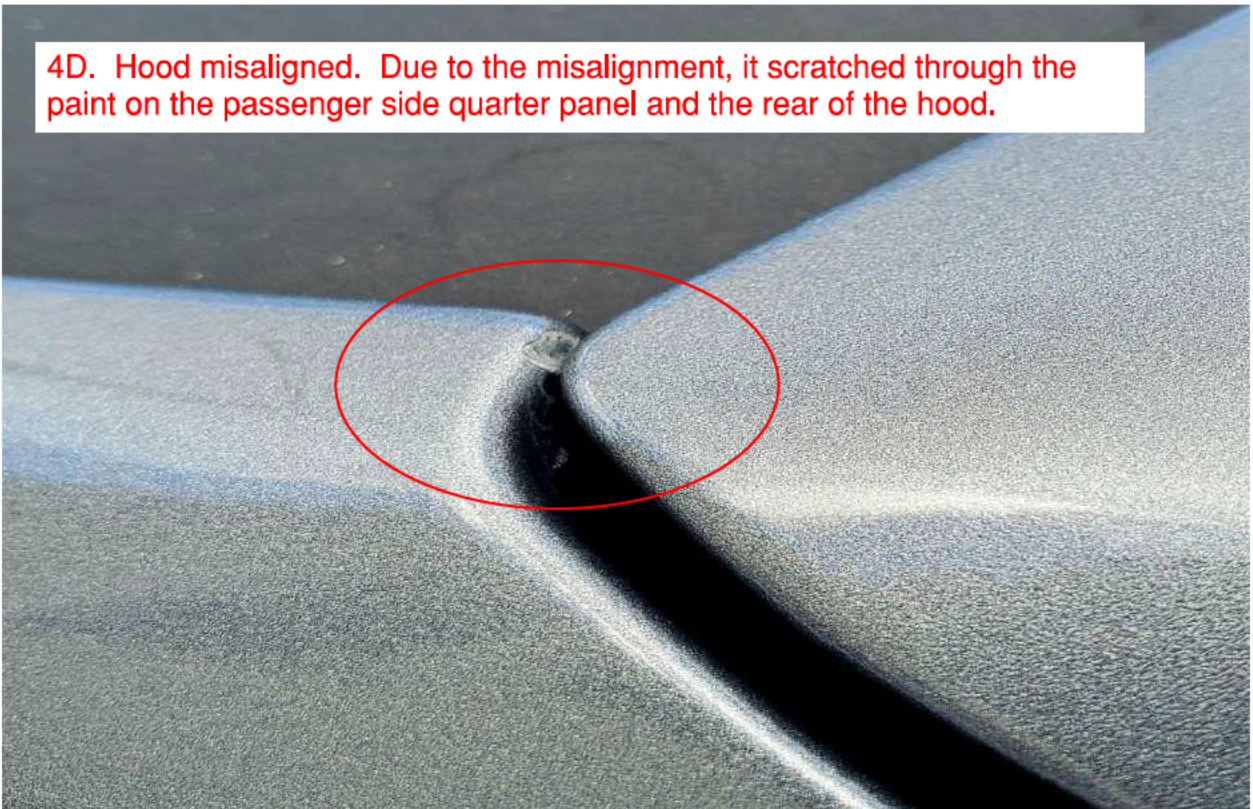
4C. Hood misaligned driver side. Hood misaligned. You can see where it originally was mounted. The whole hood should be slid forward.. You can see where it originally was mounted. The whole hood should be slid forward.

4D. Hood misaligned. Due to the misalignment, it scratched through the paint on the passenger side quarter panel and the rear of the hood.

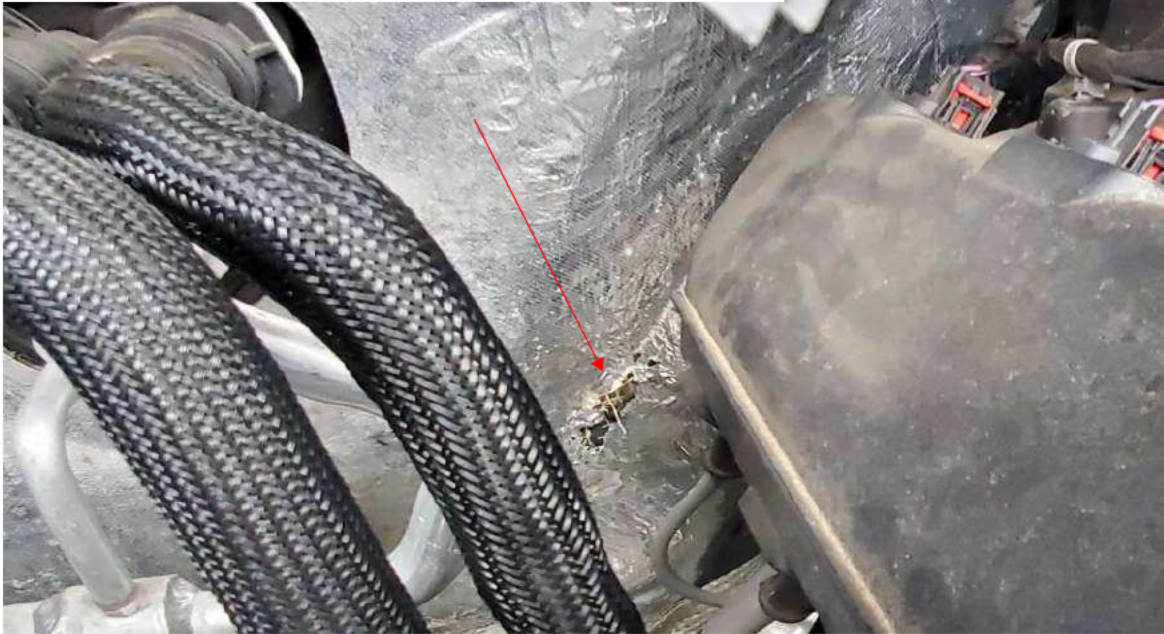
5A. Fire wall insulation damaged. Passenger side.

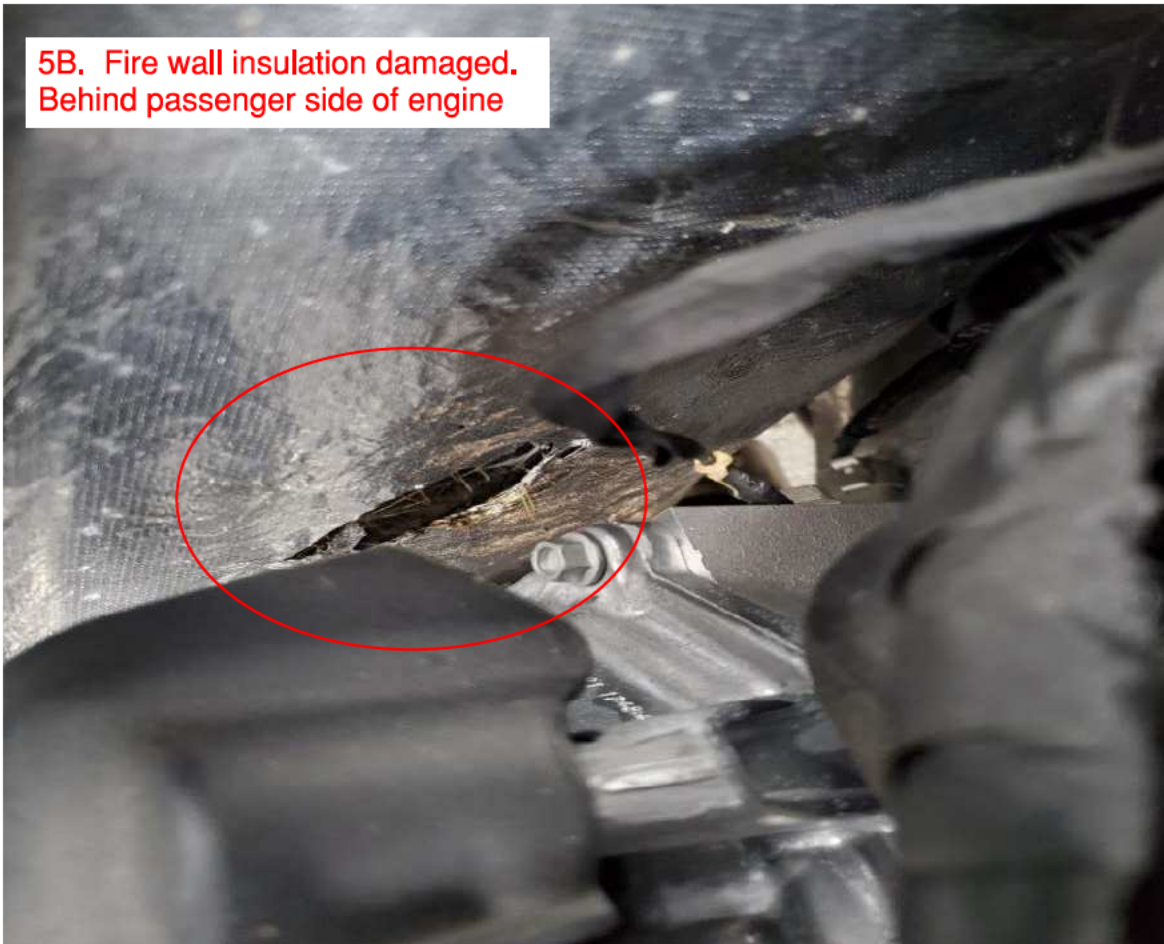
5B. Fire wall insulation damaged. Behind passenger side of engine

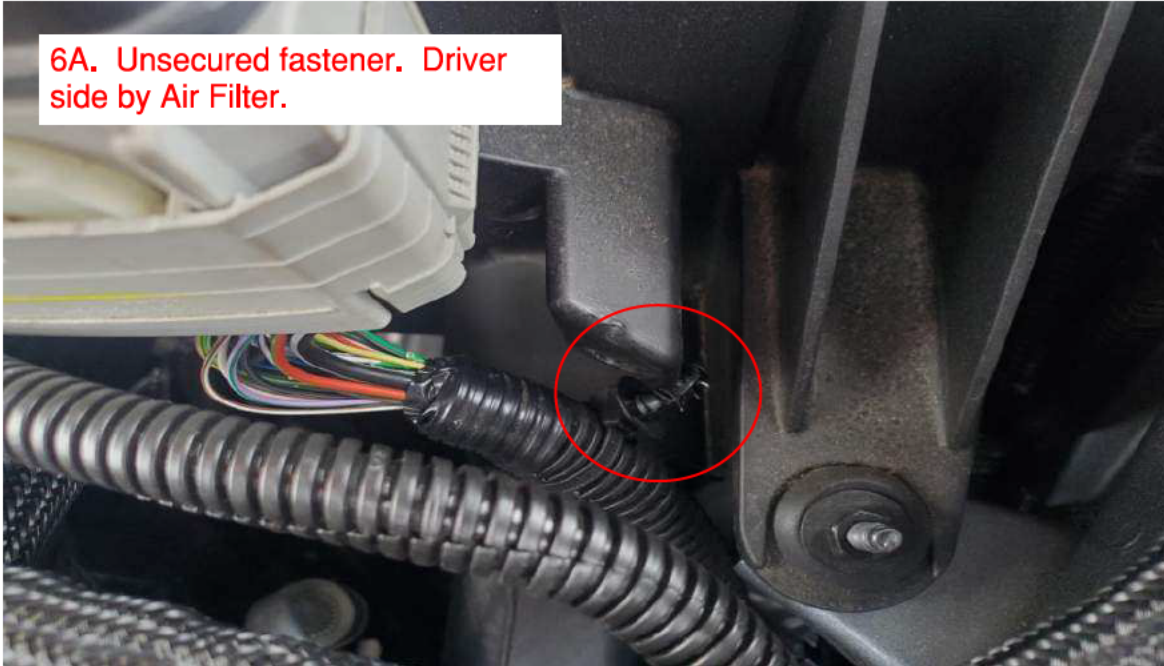
6A. Unsecured fastener. Driver side by Air Filter.

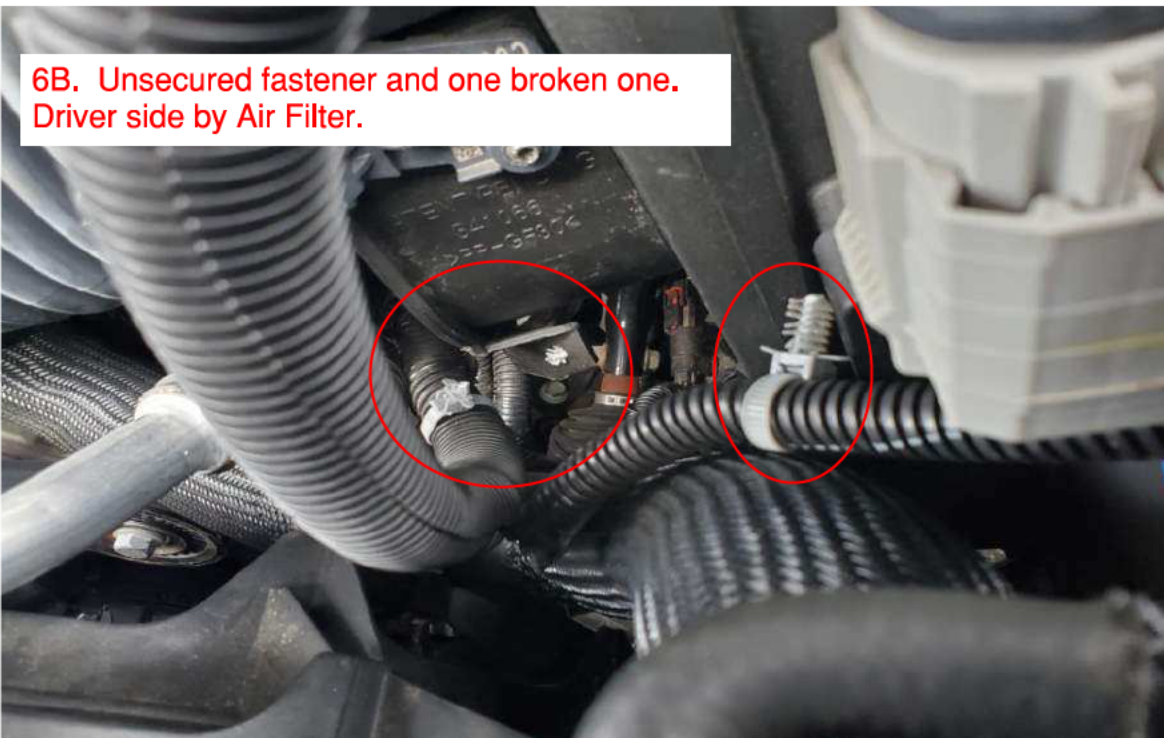
6B. Unsecured fastener and one broken one. Driver side by Air Filter.

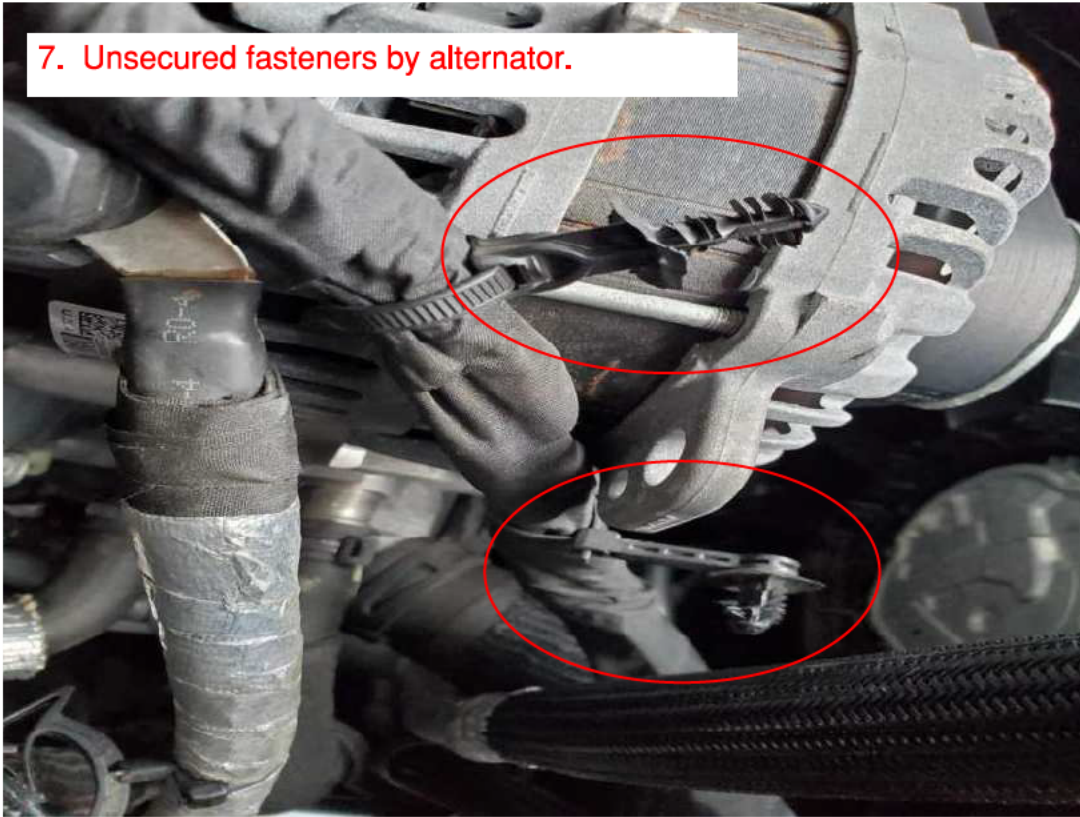
7. Unsecured fasteners by alternator.

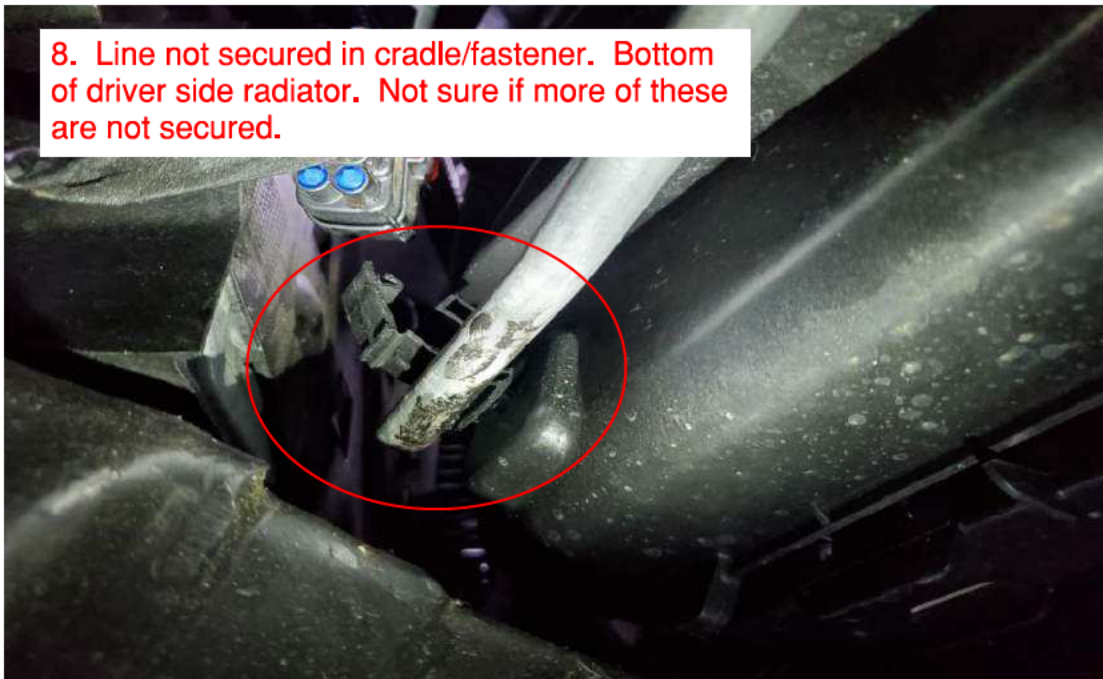
8. Line not secured in cradle/fastener. Bottom of driver side radiator. Not sure if more of these are not secured.

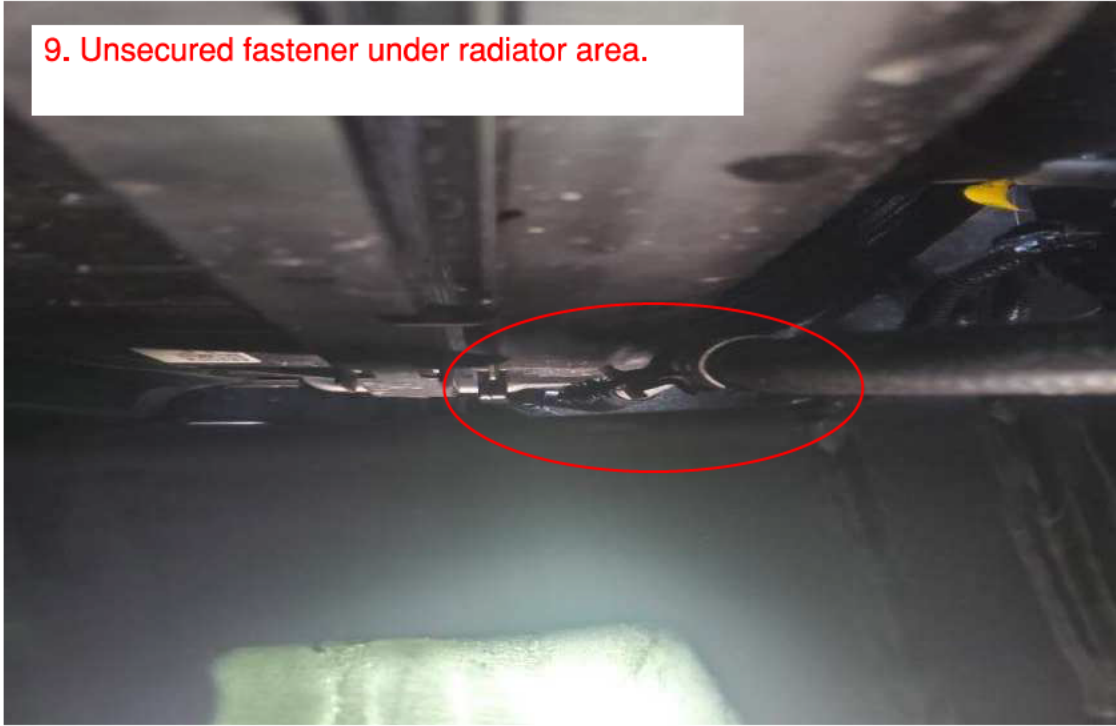
9. Unsecured fastener under radiator area.

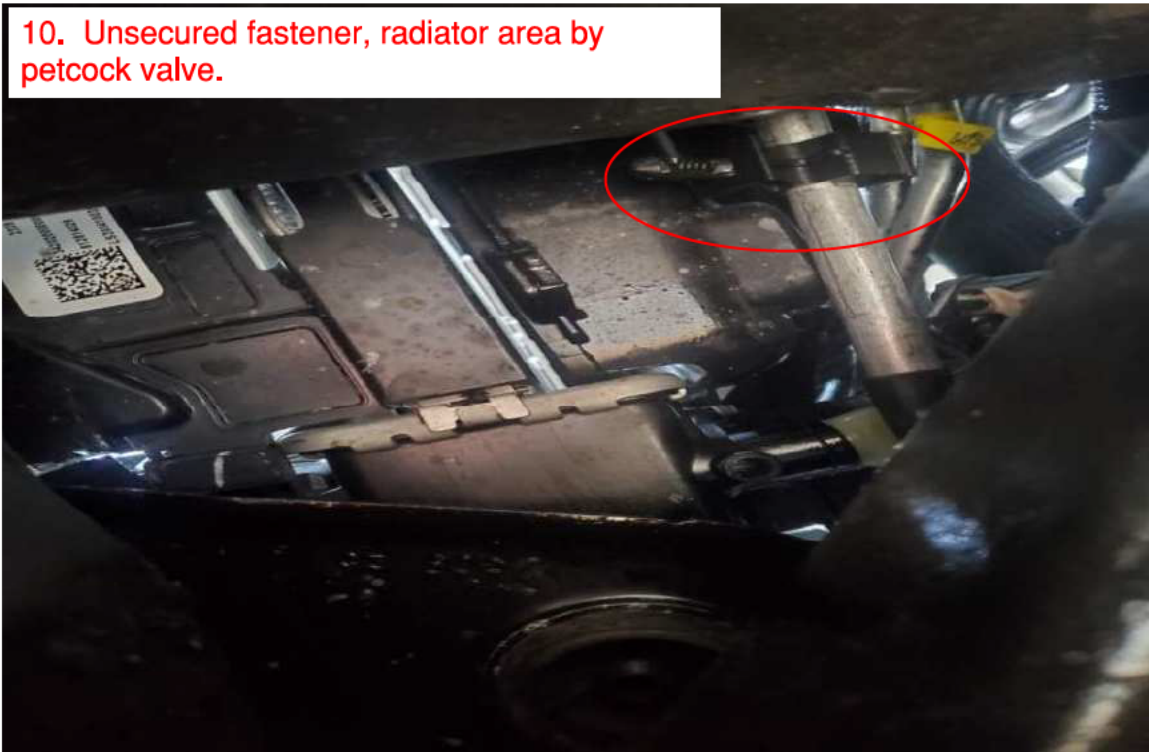
10. Unsecured fastener, radiator area by petcock valve.

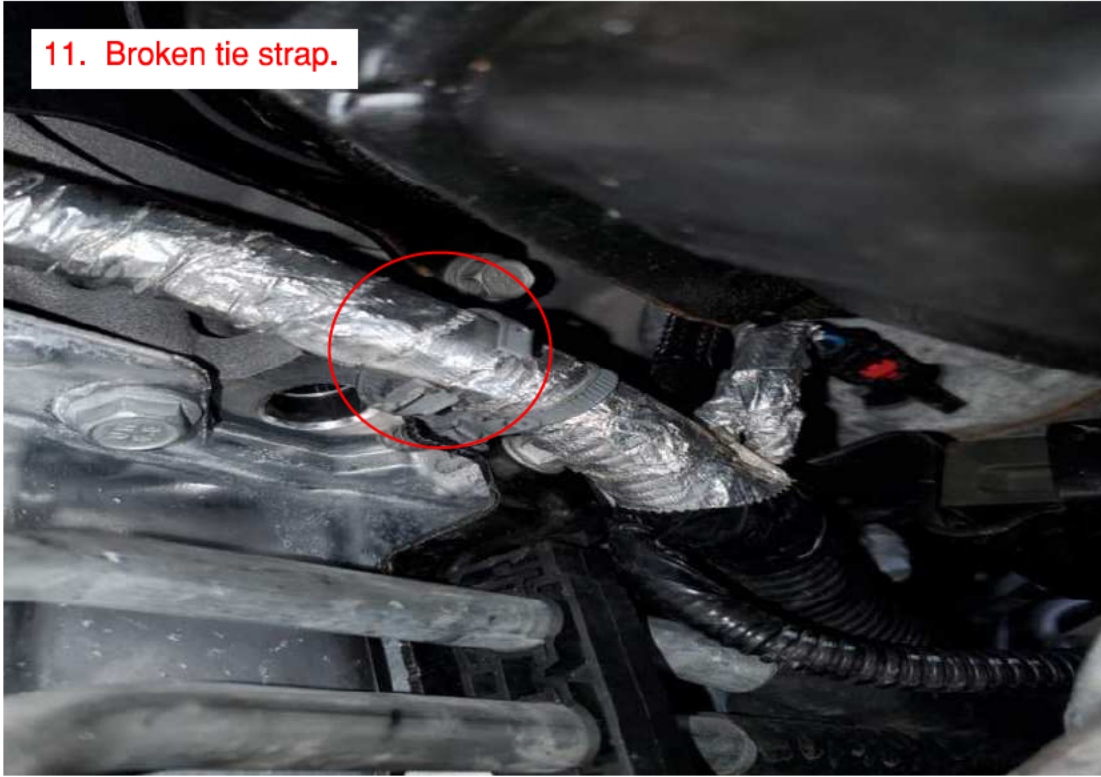
11. Broken tie strap.

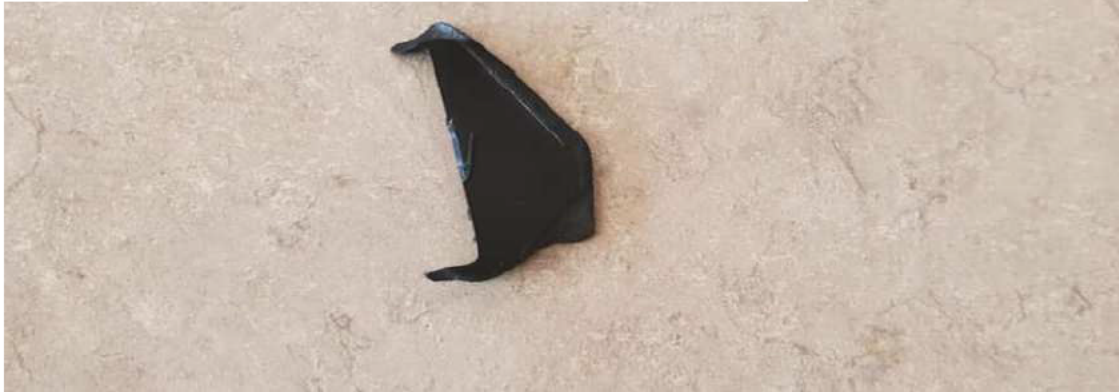
12. Broken plastic piece off of something. Found in the back of the truck. Was not there before.

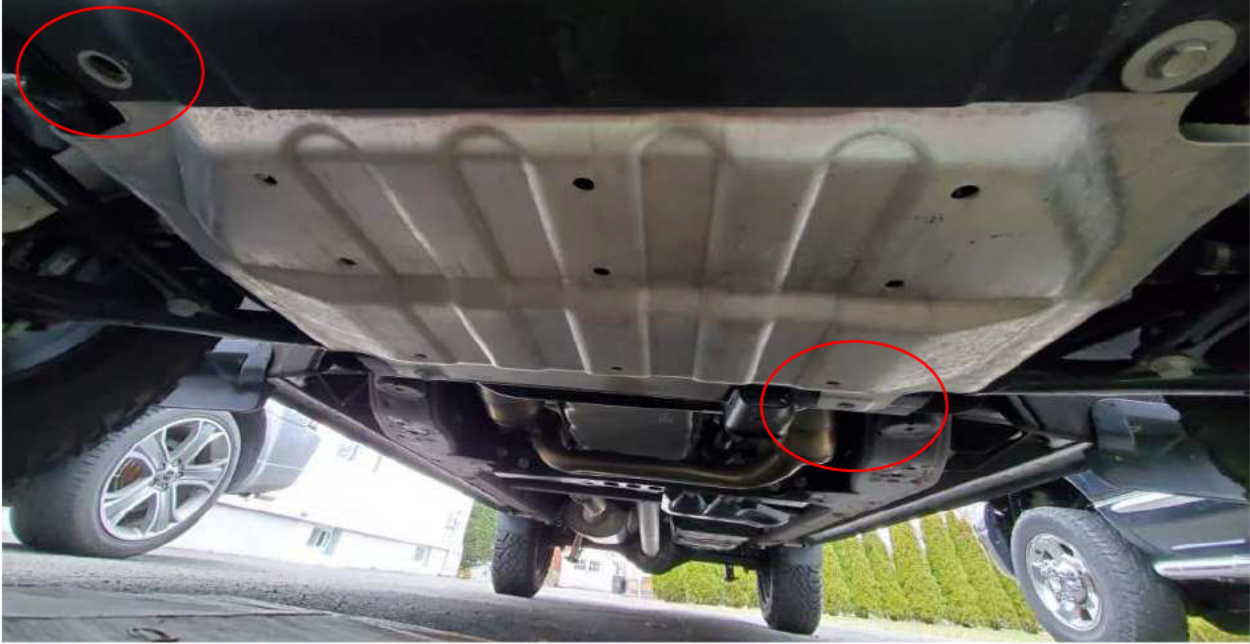
13A. Missing 2 bolts that hold the skid plate and splash guard on.

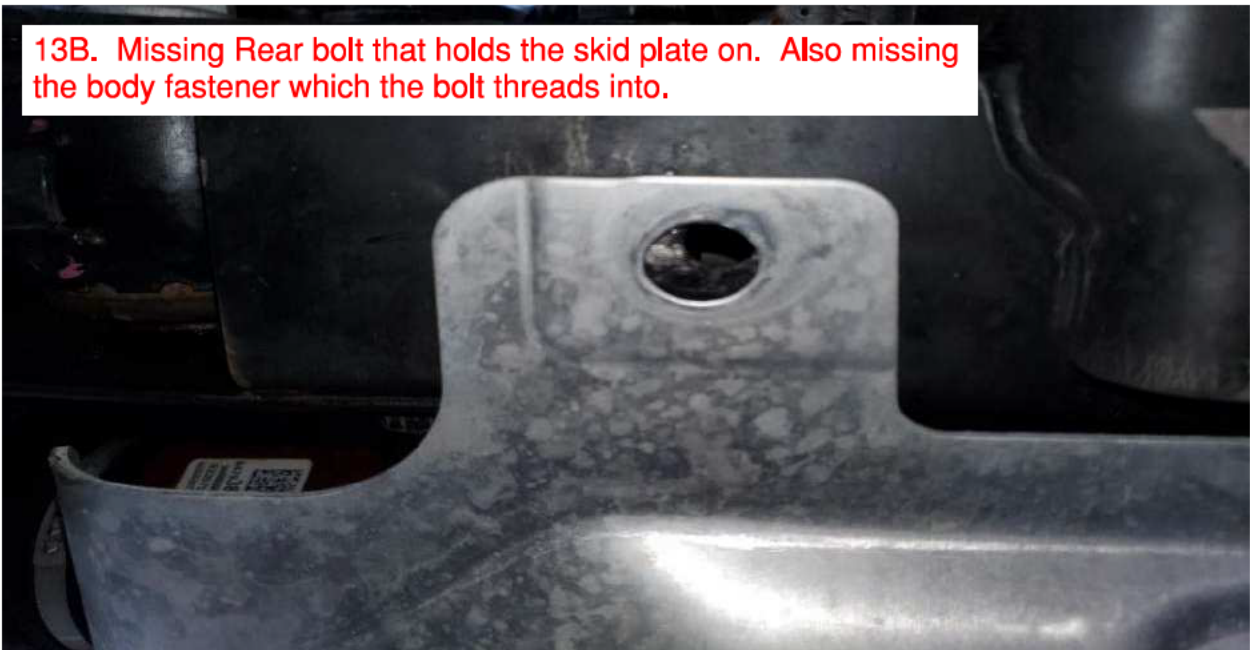
13B. Missing Rear bolt that holds the skid plate on. Also missing the body fastener which the bolt threads into.

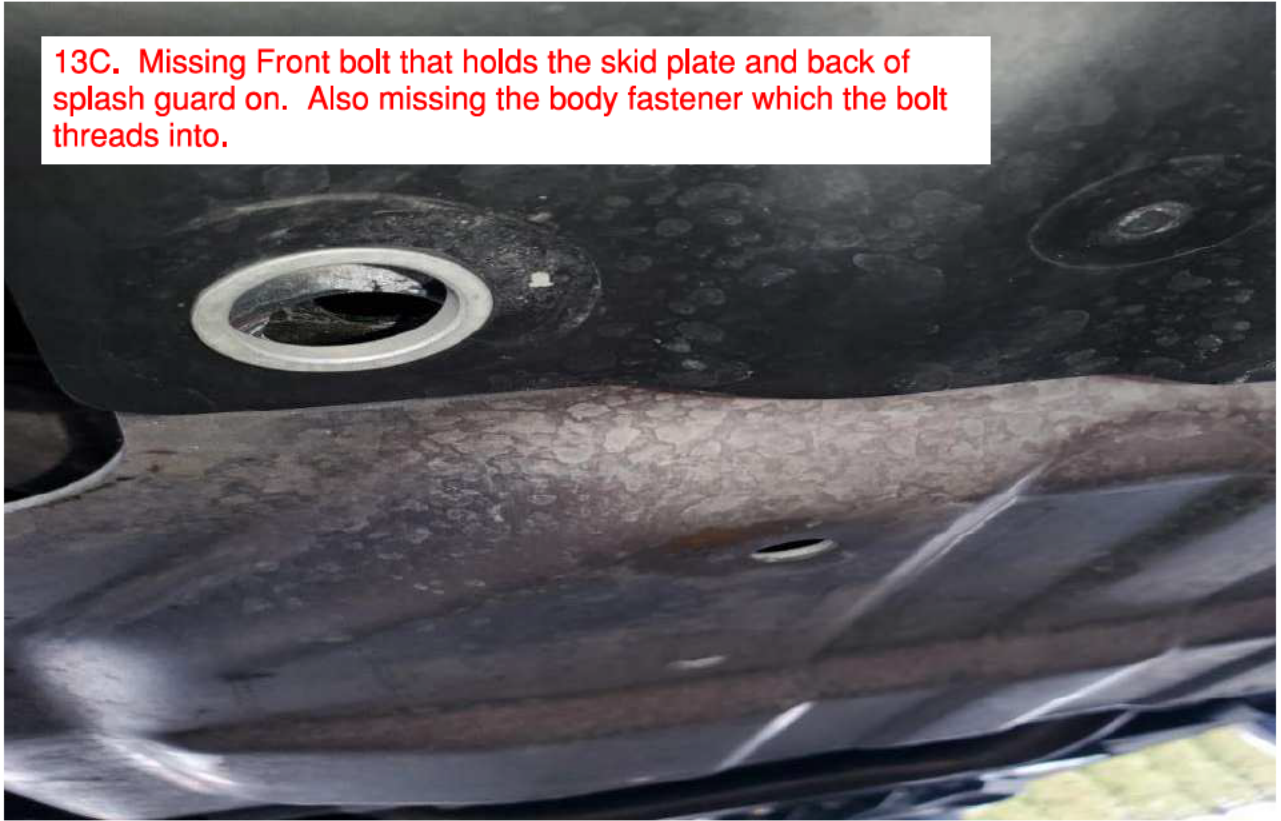
13C. Missing Front bolt that holds the skid plate and back of splash guard on. Also missing the body fastener which the bolt threads into.

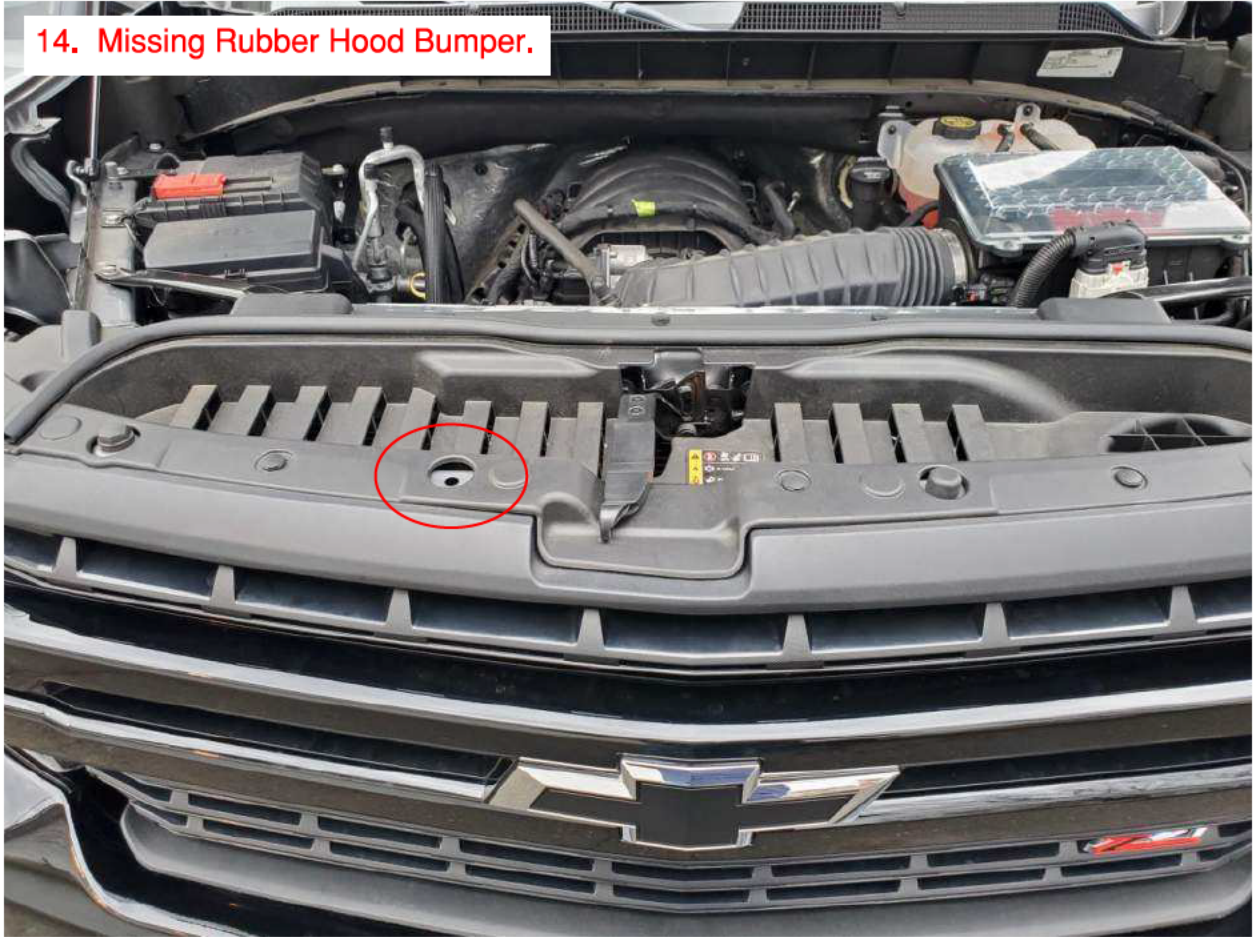
14. Missing Rubber Hood Bumper.

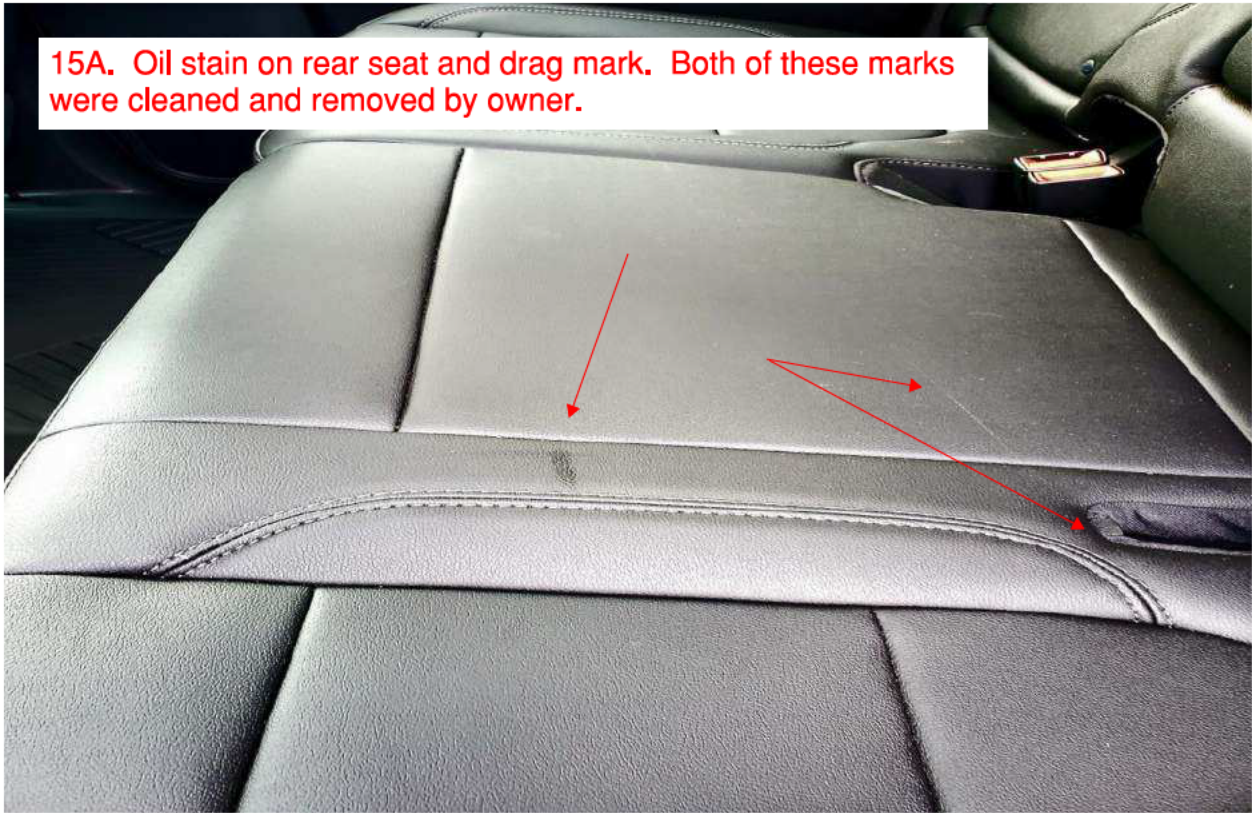
15A. Oil stain on rear seat and drag mark. Both of these marks were cleaned and removed by owner.

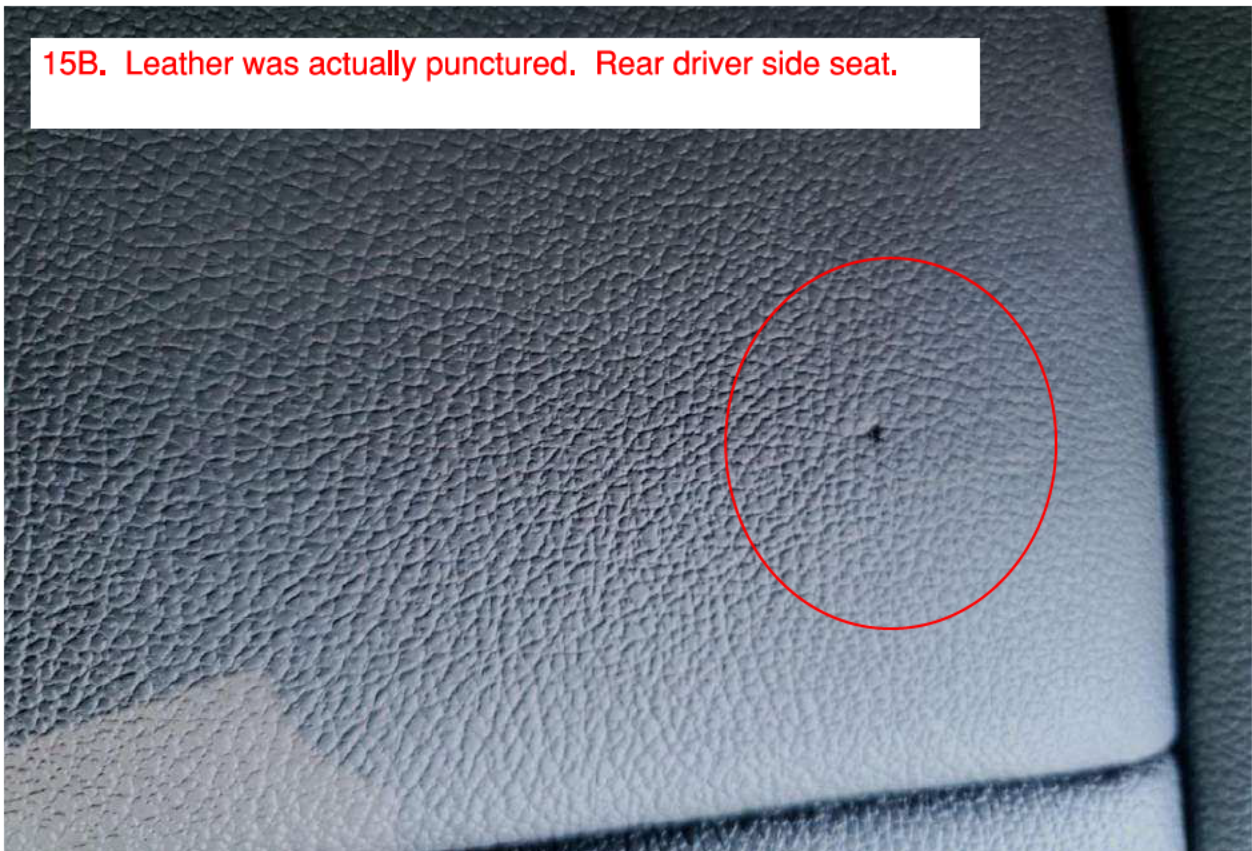
15B. Leather was actually punctured. Rear driver side seat.
