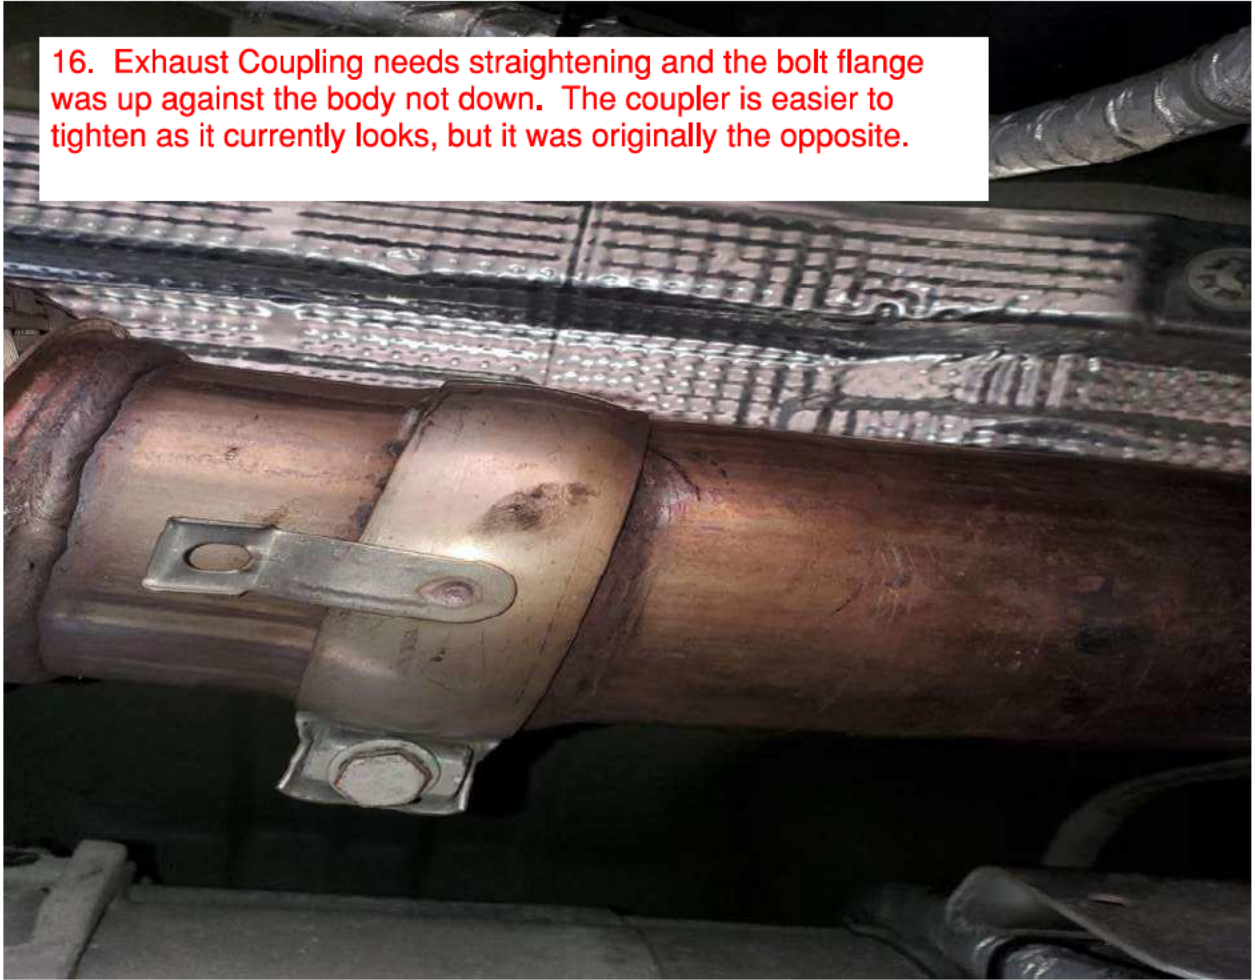
16. Exhaust Coupling needs straightening and the bolt flange was up against the body not down. The coupler is easier to tighten as it currently looks, but it was originally the opposite.

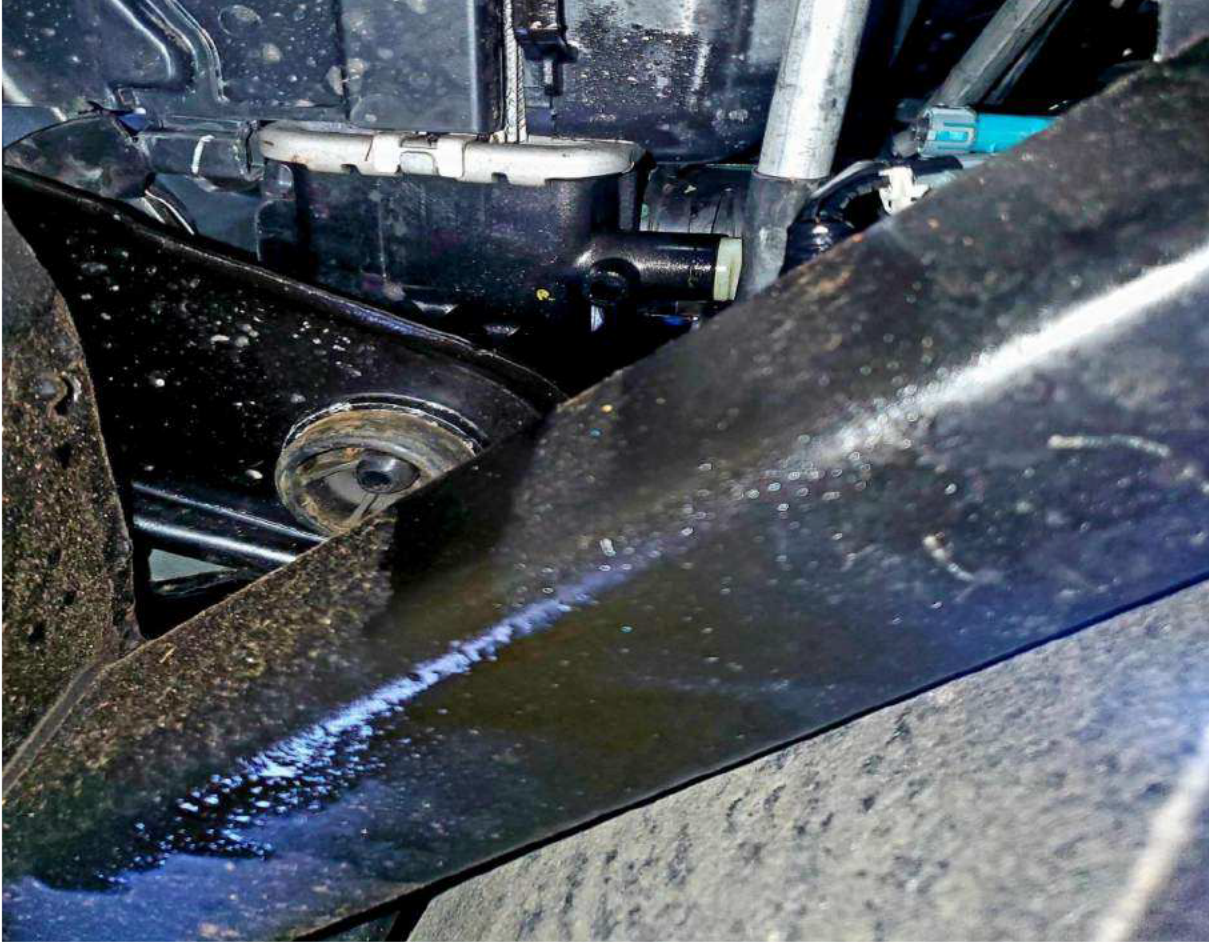
17. Decent amount of coolant and oil mixture below the coolant petcock valve and running down the frame rail. The entire engine bay had random residual coolant and oil spots and wasn't cleaned so it was hard to verify what are leaks or left over from the repair. This is how it looks on 3/21/2021, so this may be an issue.

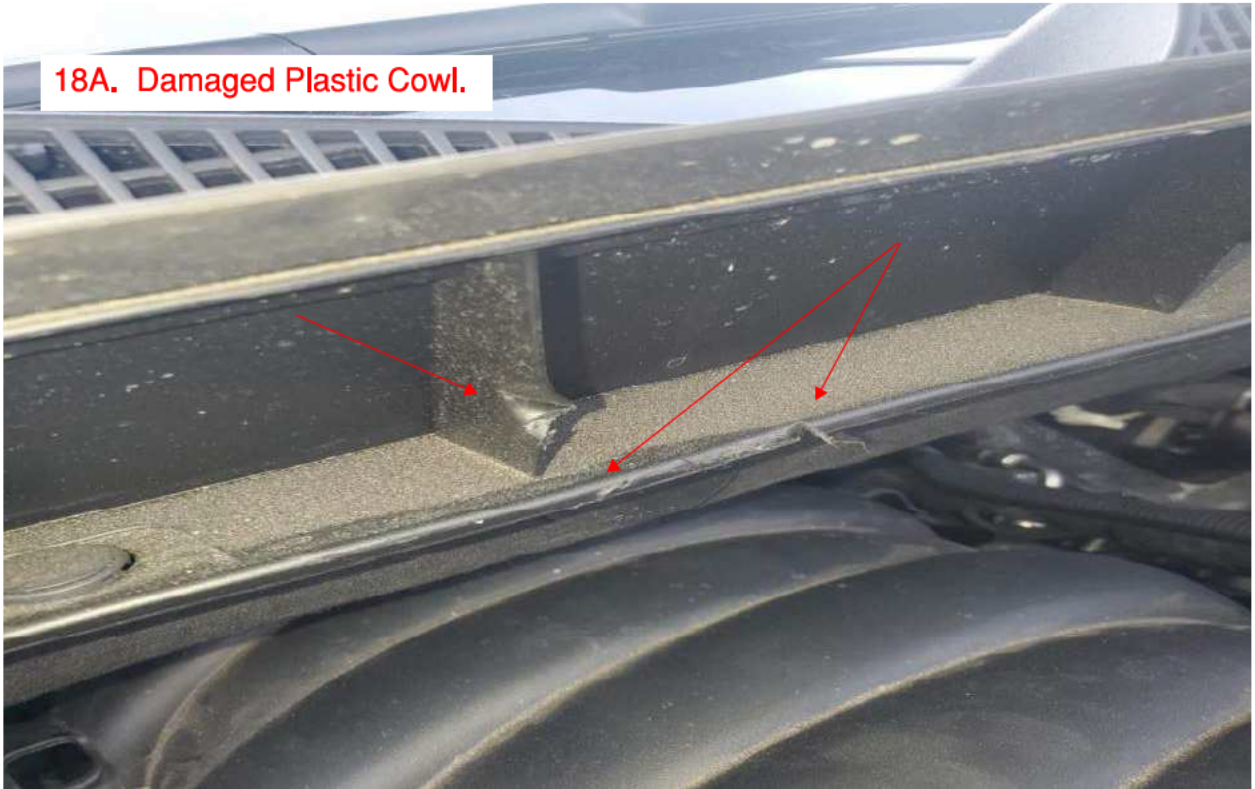
18A. Damaged Plastic Cowl.

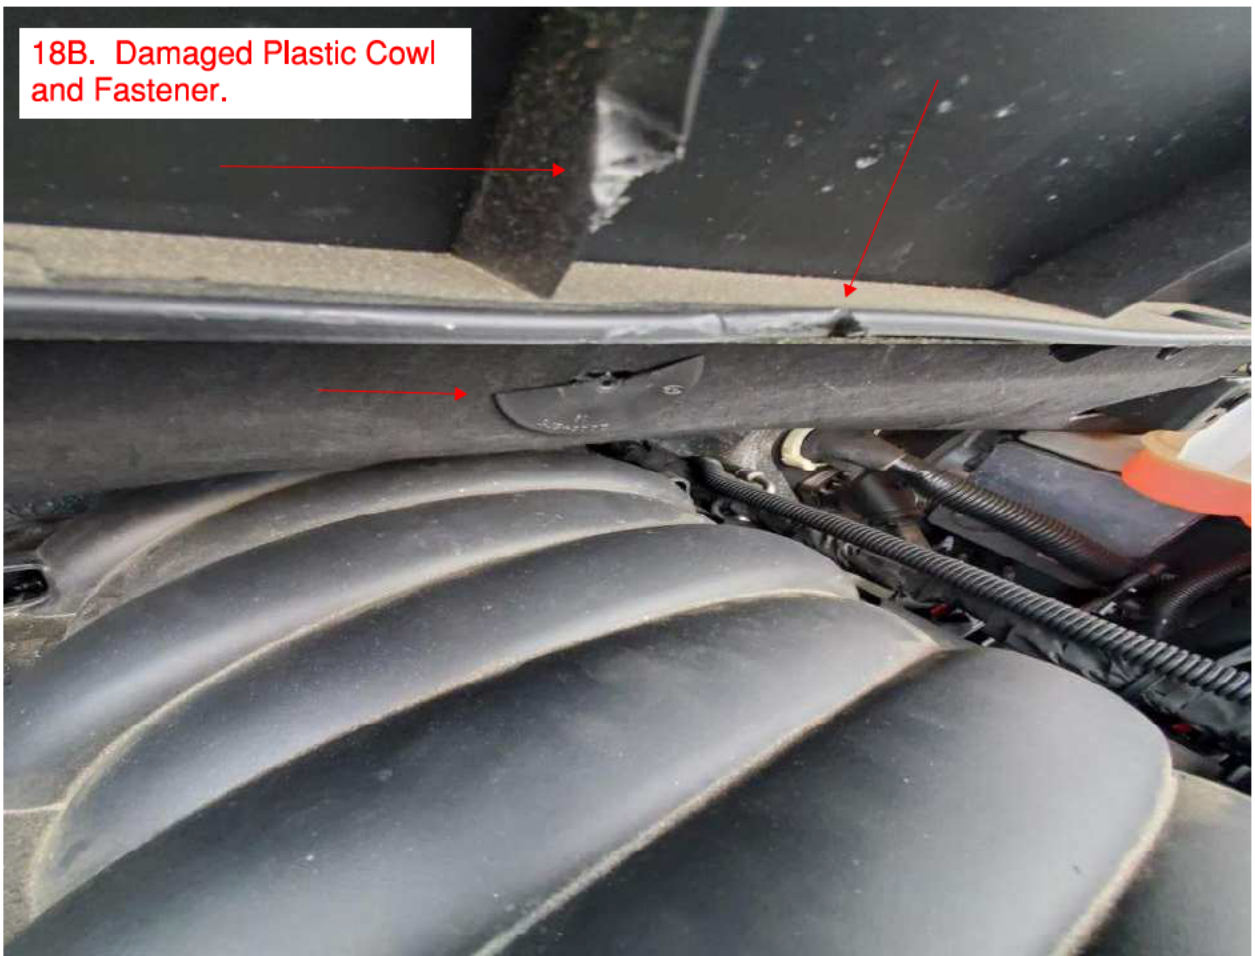
18B. Damaged Plastic Cowl and Fastener.

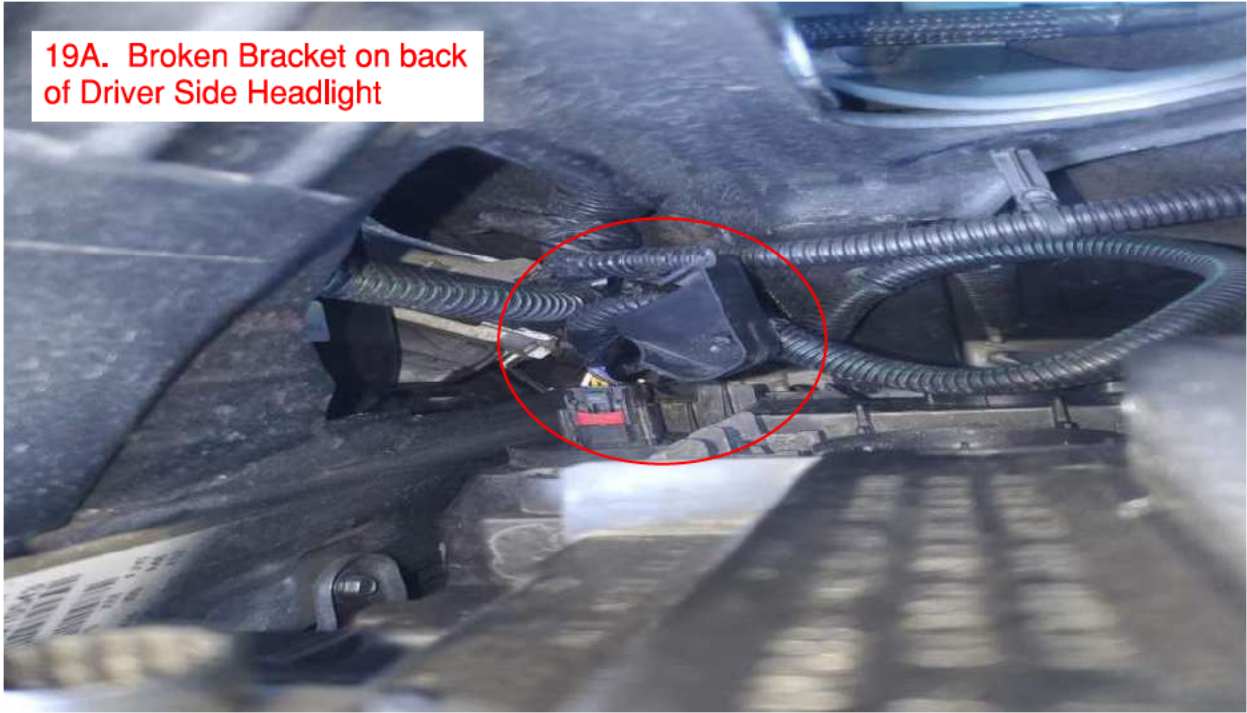
19A. Broken Bracket on back of Driver Side Headlight

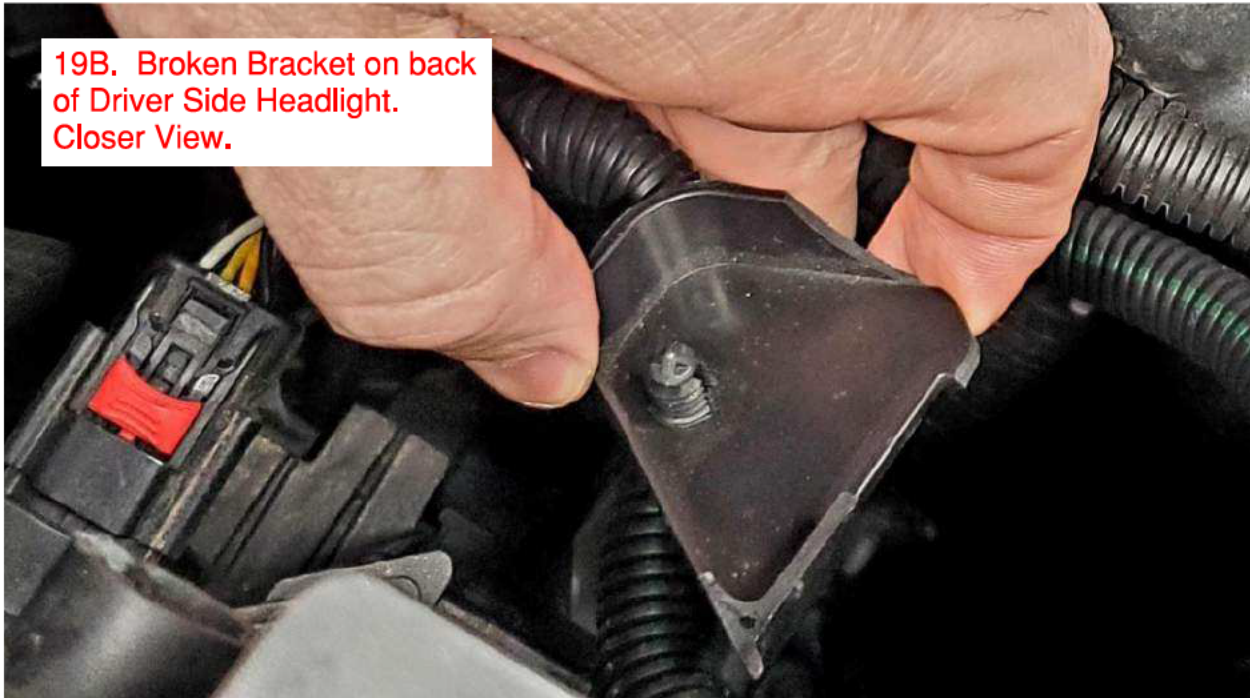
19B. Broken Bracket on back of Driver Side Headlight. Closer View.

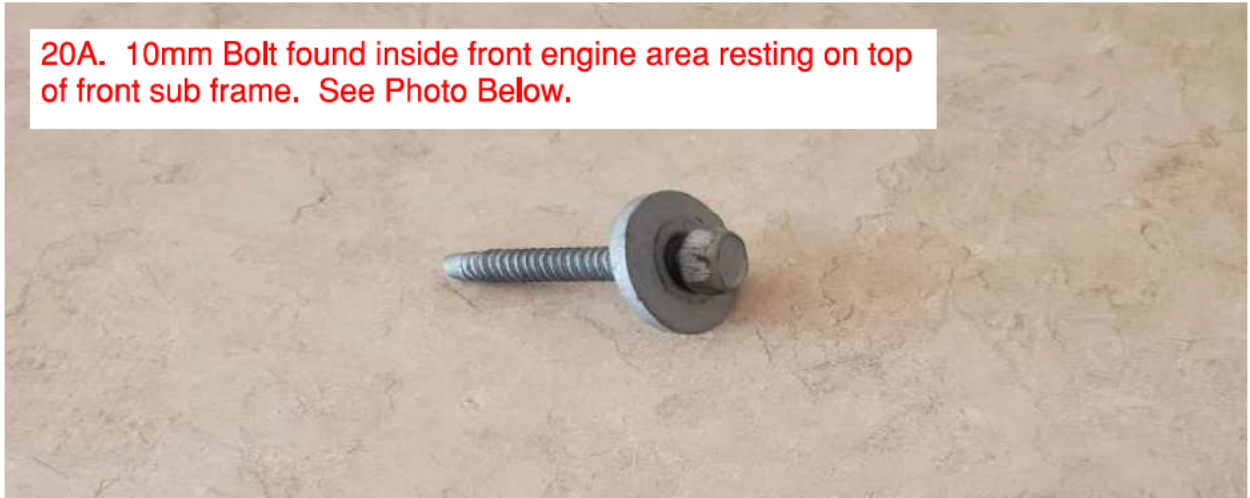
20A. 10mm Bolt found inside front engine area resting on top of front sub frame. See Photo Below.

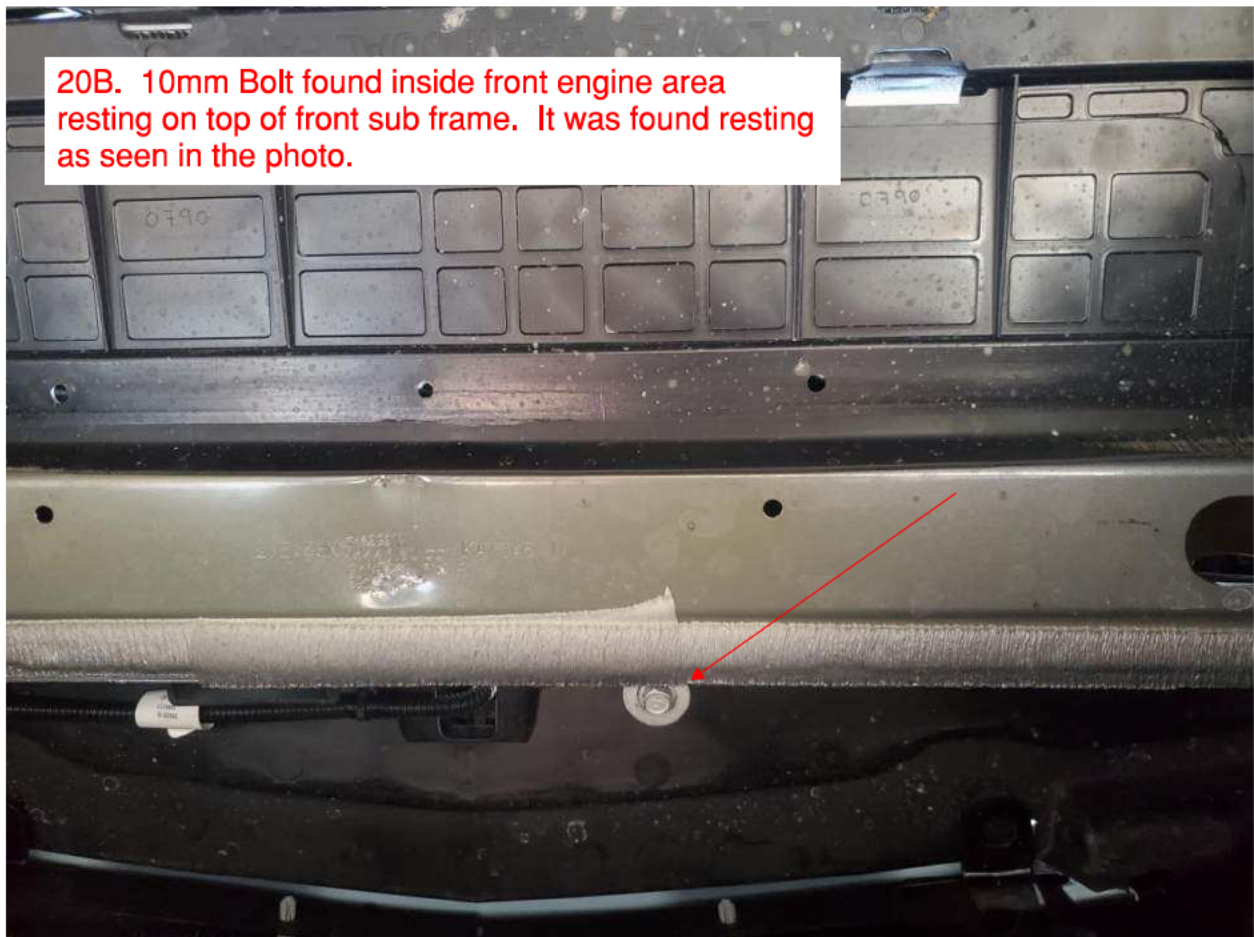
20B. 10mm Bolt found inside front engine area resting on top of front sub frame. It was found resting as seen in the photo.

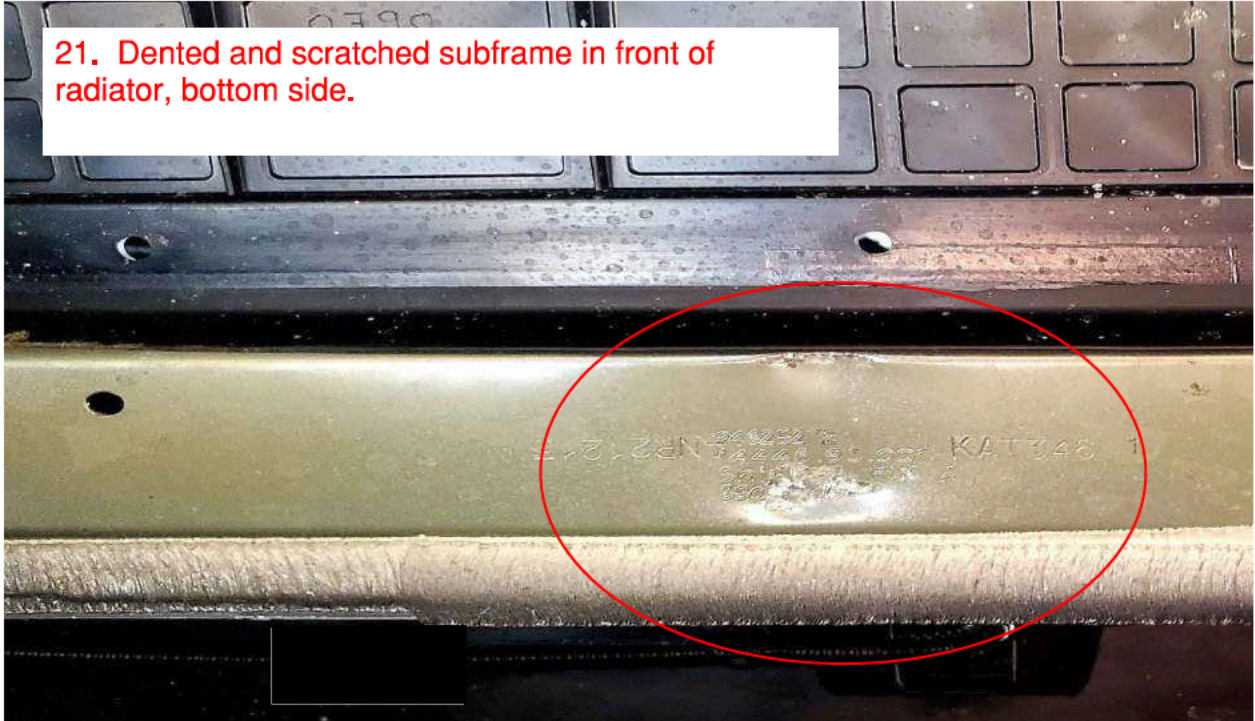
21. Dented and scratched subframe in front of radiator, bottom side.

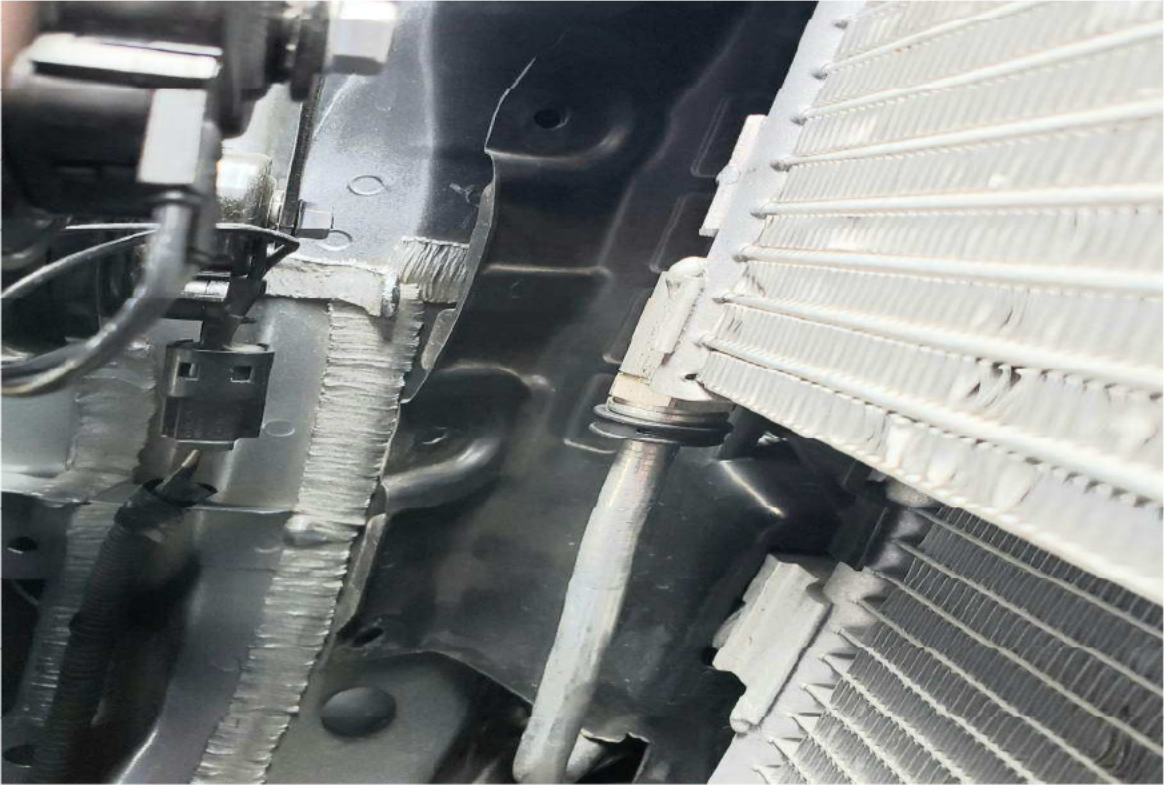
22A. Rubber flange on side of radiator not secured. This is the Passenger side.

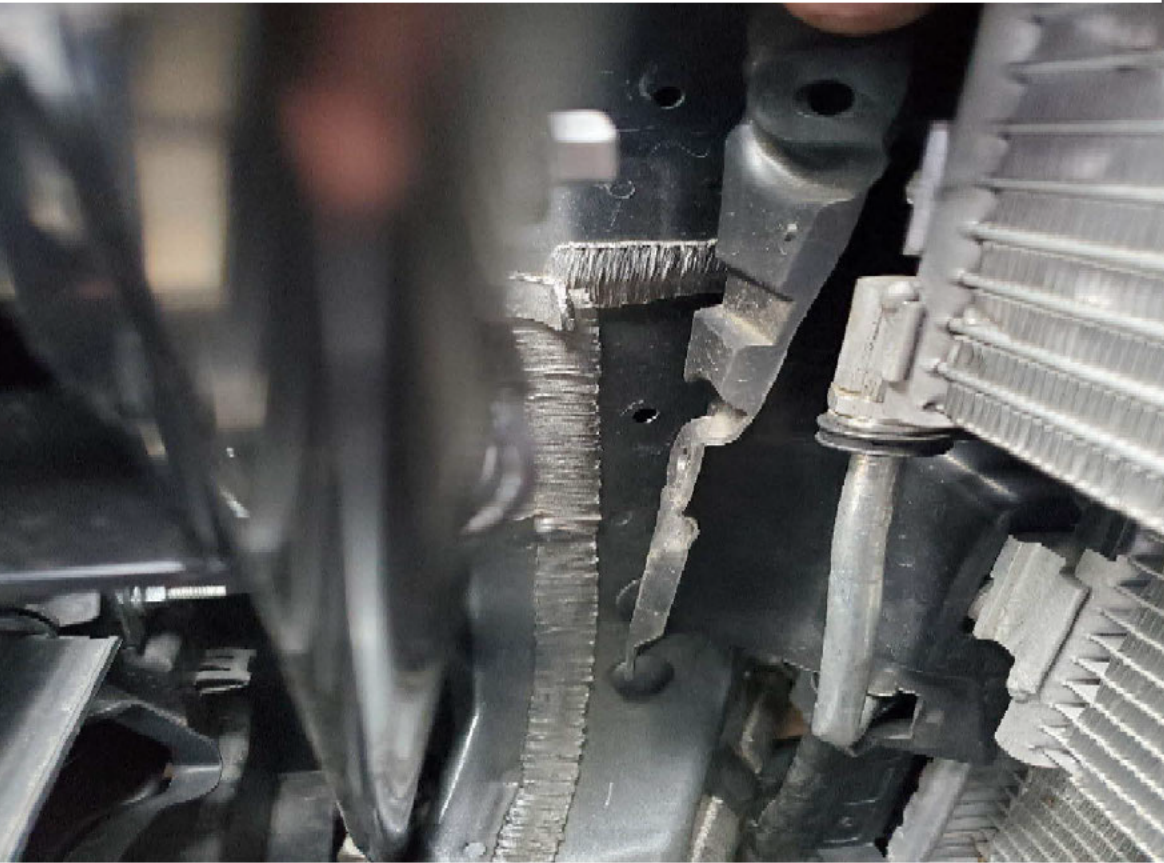
22B. Same rubber flange from above showing missing fasteners.

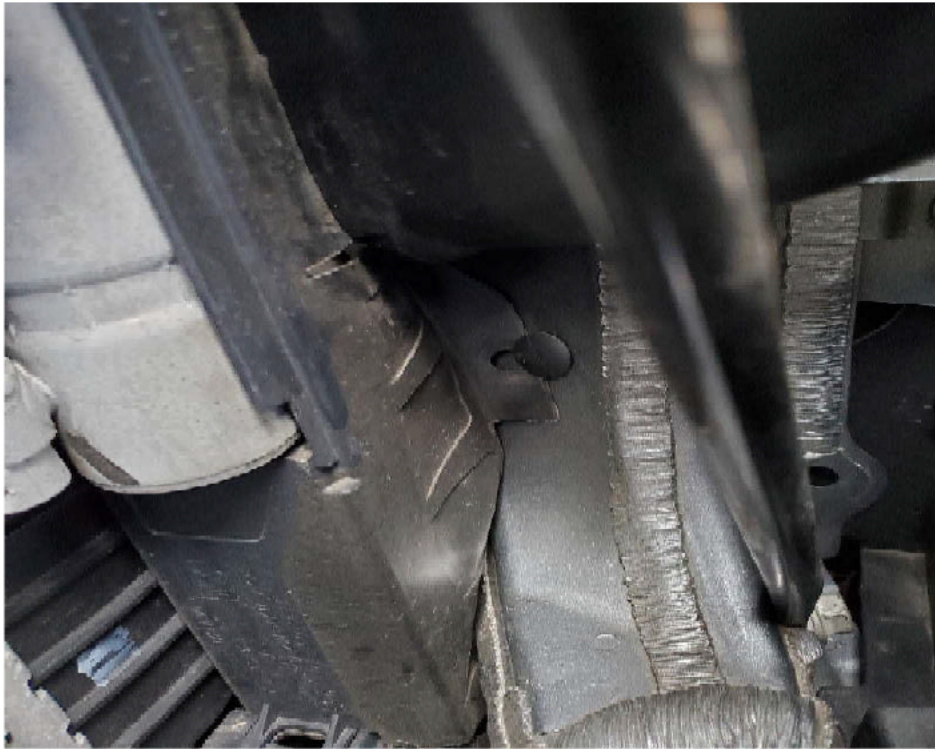
22C. Driver side flange partially fastened. Shows what the missing fasteners above were probably like.
