## #N192273510-02: Safety Recall - Loose Alternator Cable - (Feb 20, 2020)

**Subject: N192273510-02 – Loose Alternator Cable**

**Models: 2019 Chevrolet Silverado 1500 (New Model)  
2020 Chevrolet Silverado 1500  
2019 GMC Sierra 1500 (New Model)  
2020 GMC Sierra 1500**

**Revision:** 02

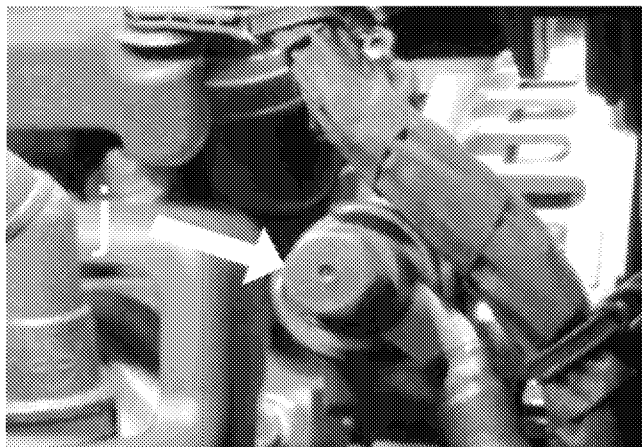
- Important: Use caution when dis-assembling so that damage to nut does not occur.**
3. Remove the positive starter solenoid cable fastening nut at the generator (1).

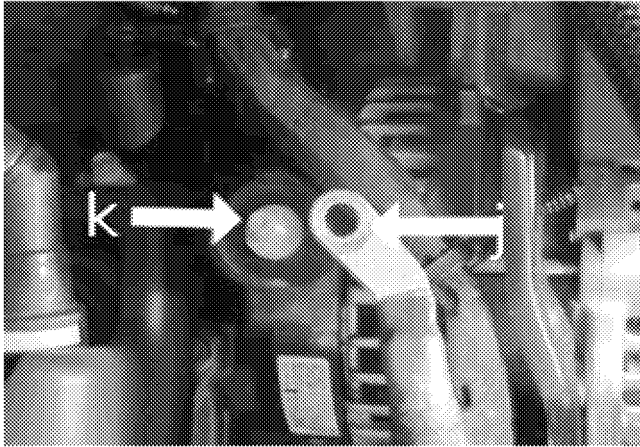
4. Inspect the cable terminal (1), cable terminal on the generator (2) and attachment nut for any signs of heat damage.

- If **NO HEAT DAMAGE** is found on the cable terminal, generator terminal or attachment nut, they can be inspected for glue contamination, cleaned and remain in the vehicle. Proceed to step # 5 for glue contamination inspection/removal.
- If **ANY HEAT DAMAGE IS INDICATED**, replace the Battery Positive Cable Nut, Generator and/or Starter Solenoid Cable as required. Refer to *Starter Solenoid Cable Replacement* and *Generator Replacement* in SI.

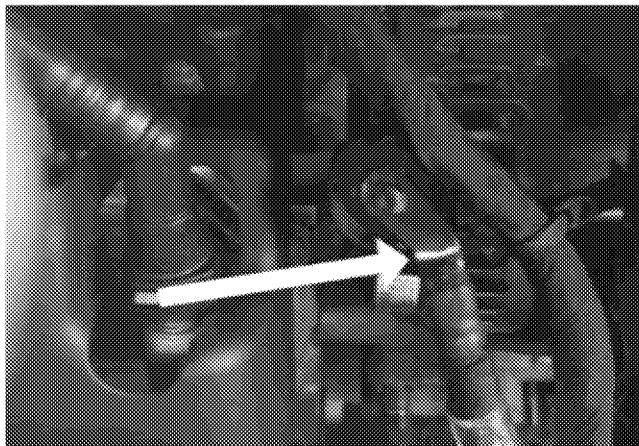
**Important: A small amount of glue is expected to be present around the shrink sleeve. The inspection procedure is for glue contamination on the cable terminal where it mounts to the terminal on the generator. This contamination prevents the fastener from tightening as designed and may loosen with heat and vibration.**

**Acceptable Glue Coverage Area (Black Light Image)**

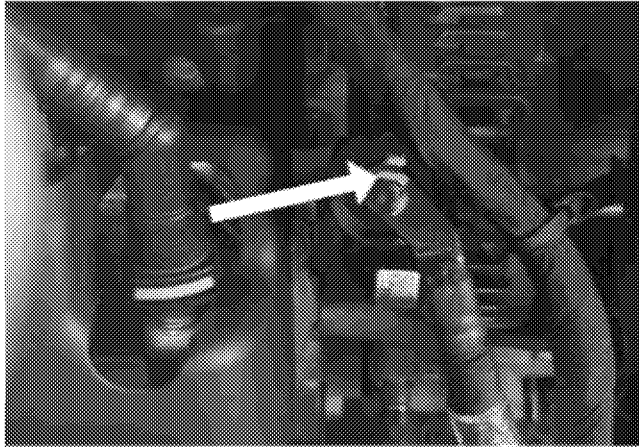
**Unacceptable Glue Contamination (Black Light Image)**

6. If any glue contamination is found, use a plastic scraper to remove the glue from the cable terminal, attachment nut and the cable terminal on the generator.

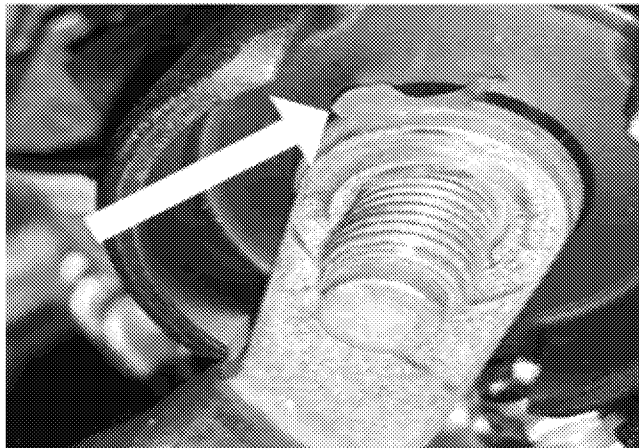
**Unacceptable Glue Contamination (Daylight Image)**

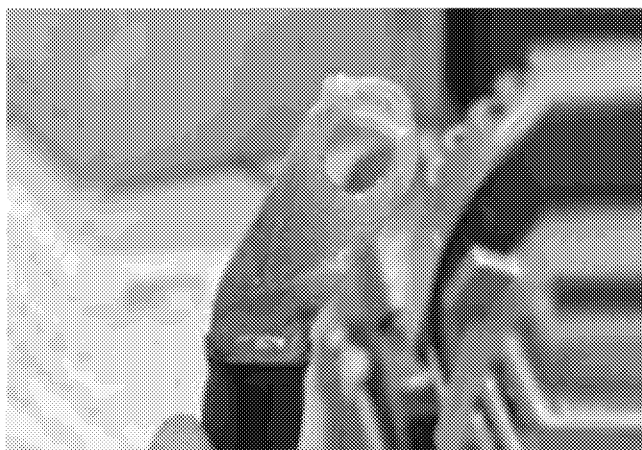
### Unacceptable Glue Contamination (Daylight Image)

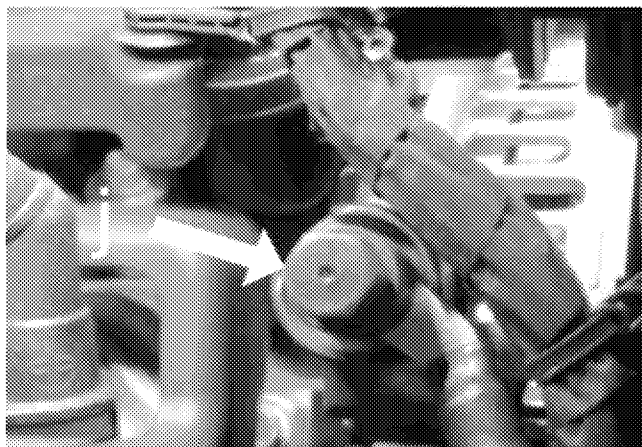
5. Remove the positive starter solenoid cable fastening nut at the generator (1).

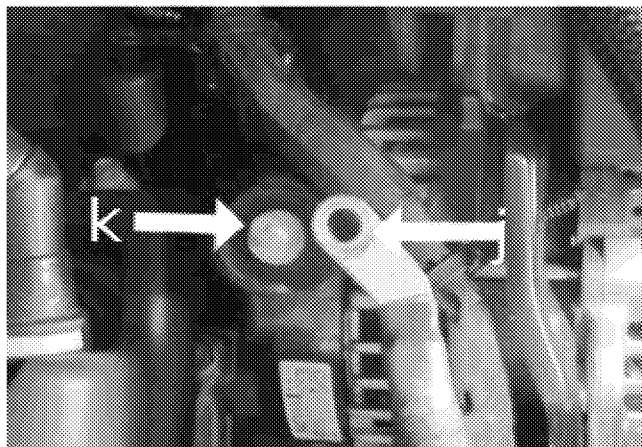
6. Inspect the cable terminal (1), cable terminal on the generator (2) and attachment nut for any signs of heat damage.
  - If **NO HEAT DAMAGE** is found on the cable terminal, generator terminal or attachment nut, they can be inspected glue contamination, cleaned and remain in the vehicle. Proceed to step #7 for glue contamination inspection/removal.

- If **ANY HEAT DAMAGE IS INDICATED**, replace the Battery Positive Cable Nut, Generator and/or Starter Solenoid Cable as required. Refer to *Starter Solenoid Cable Replacement* and *Generator Replacement* in SI.

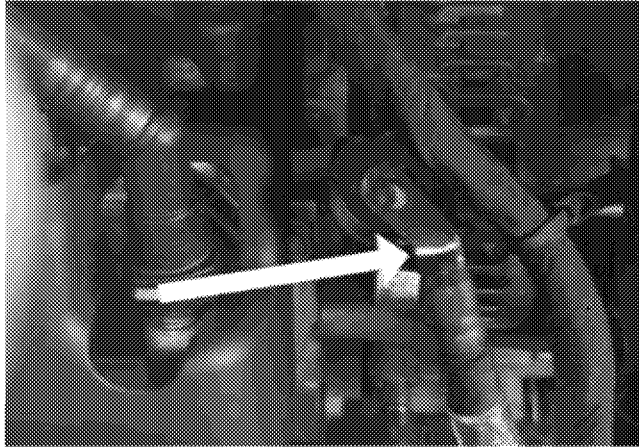
**Important:** A small amount of glue is expected to be present around the shrink sleeve. The inspection procedure is for glue contamination on the cable terminal where it mounts to the terminal on the generator. This contamination prevents the fastener from tightening as designed and may loosen with heat and vibration.

**Acceptable Glue Coverage Area (Black Light Image)**

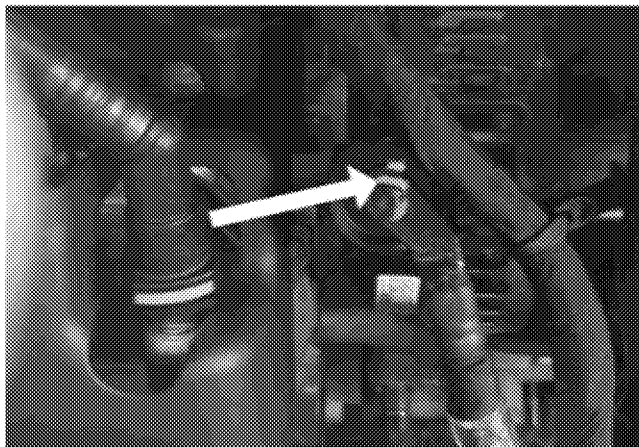
**Unacceptable Glue Contamination (Black Light Image)**

8. If any glue contamination is found, use a plastic scraper to remove the glue from the cable terminal, attachment nut and the cable terminal on the generator.

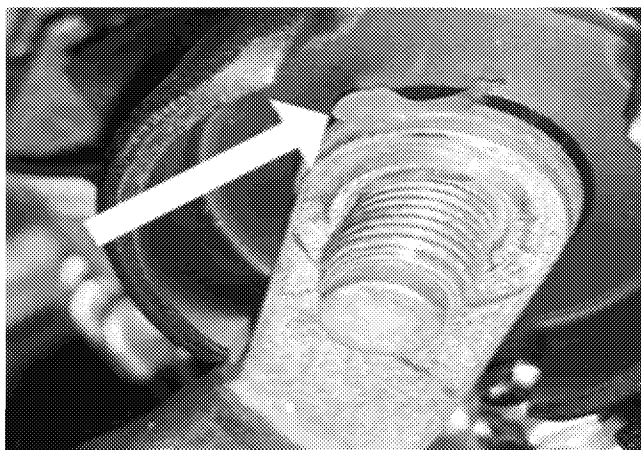
**Unacceptable Glue Contamination (Daylight Image)**

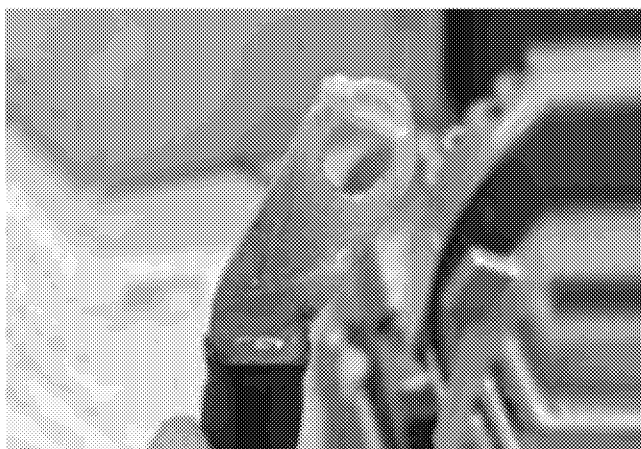
**Unacceptable Glue Contamination (Daylight Image)**
