#18-NA-073: Repair Guidelines for Engine Component Wear - (Jan 18, 2022)

Subject: Repair Guidelines for Engine Component Wear

Brand:	Model:	Model Year:		VIN:		Engine:	Transmission:
		from	to	from	to		
GM Passenger Cars and Trucks		2015	2022	All	All	All	—

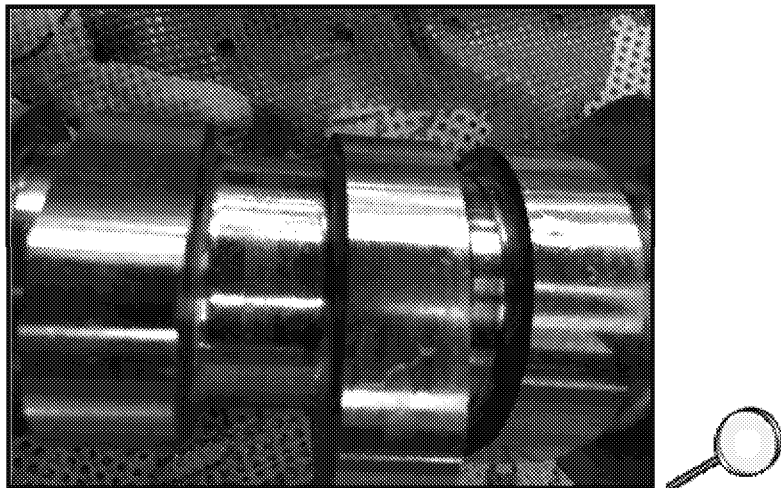
Camshaft

Example of minor scratching/scoring visible on camshaft lobes and/or camshaft bearing journals. In this example, the scored components can be replaced without need for engine assembly replacement.

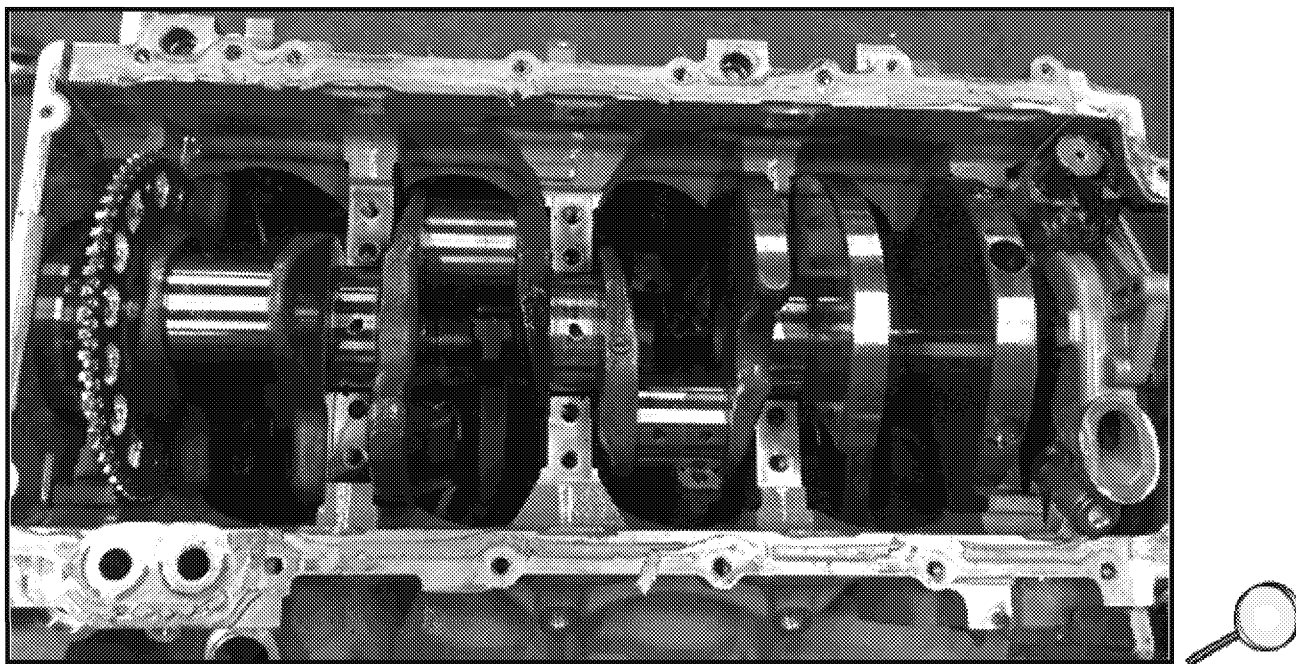
Crankshaft in Crankcase

Example of minor scratching/scoring visible on crankshaft. In this example, the scored components can be replaced without need for engine assembly replacement.

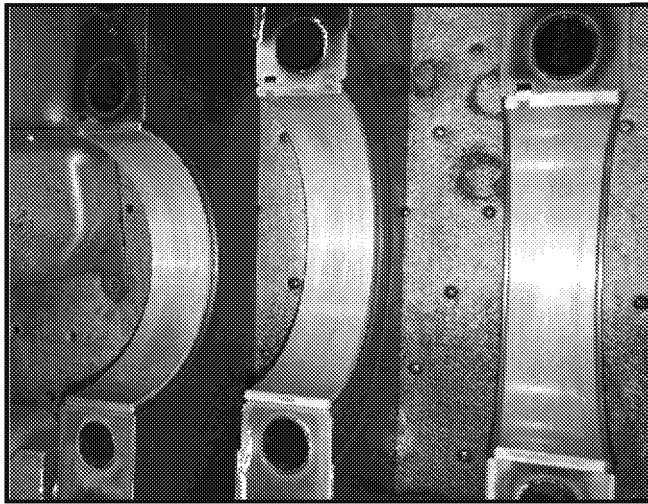
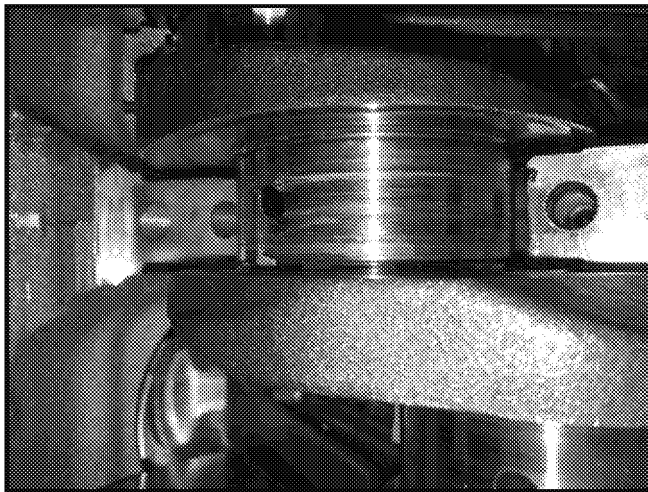
Crankshaft Main Bearings and Journal

Example of minor scratching/scoring visible on crankshaft. In this example, the scored components can be replaced without need for engine assembly replacement.

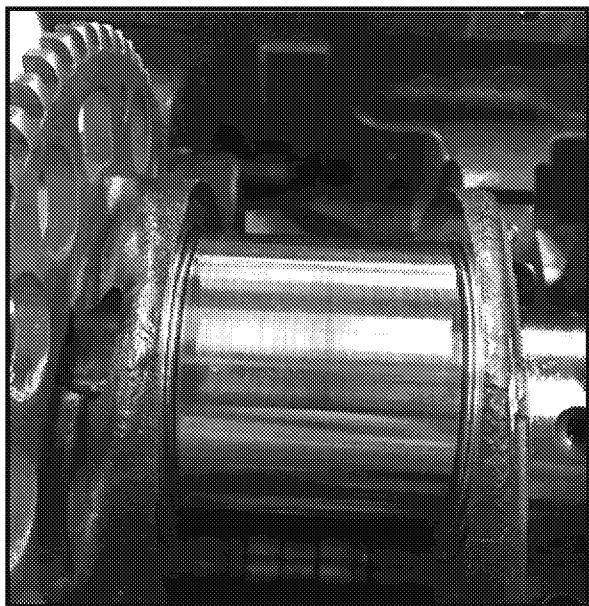
Crankshaft, Reluctor Ring and Journal

Example of minor scratching/scoring visible on crankshaft. In this example, the scored components can be replaced without need for engine assembly replacement.

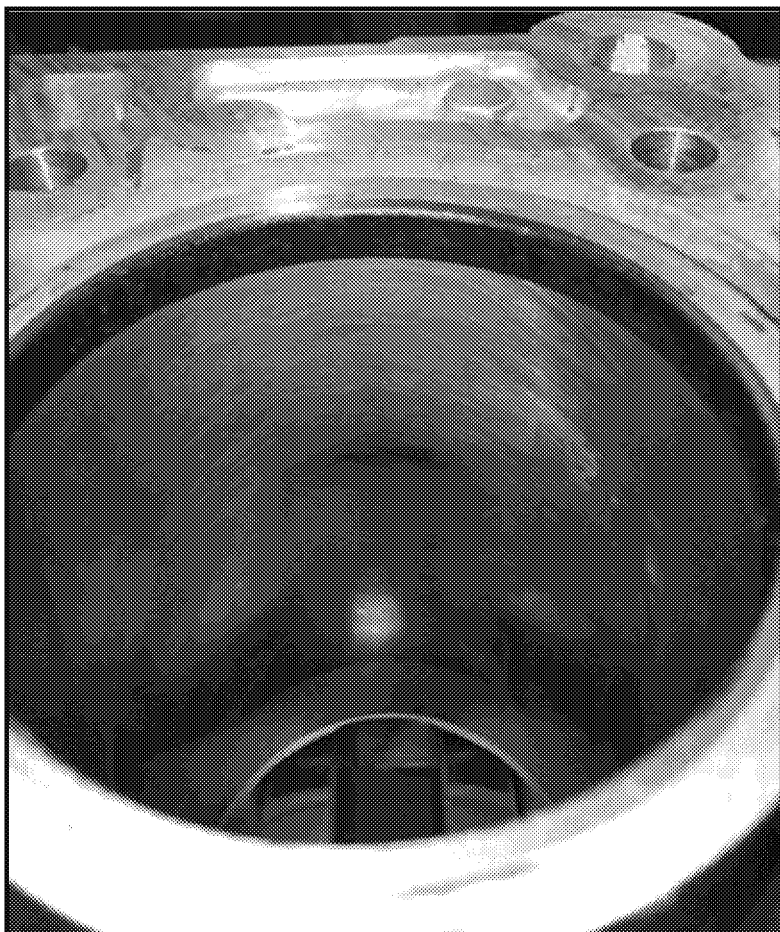
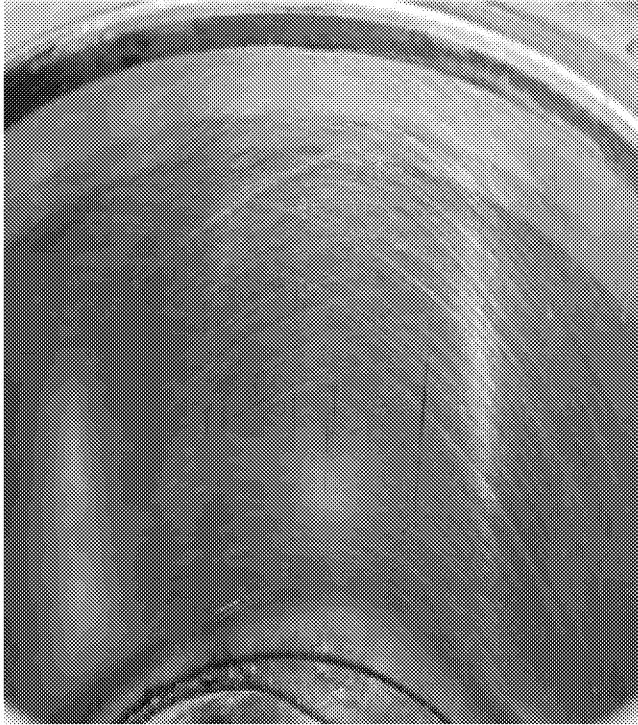
Cylinder Bore

Example of minor scratching/scoring visible on cylinder wall. In this example, if you cannot catch a pick or fingernail on the scratch, the cylinder bore/engine block does not require replacement. If the piston is slightly scored, the scored piston can be replaced without need for engine assembly replacement.

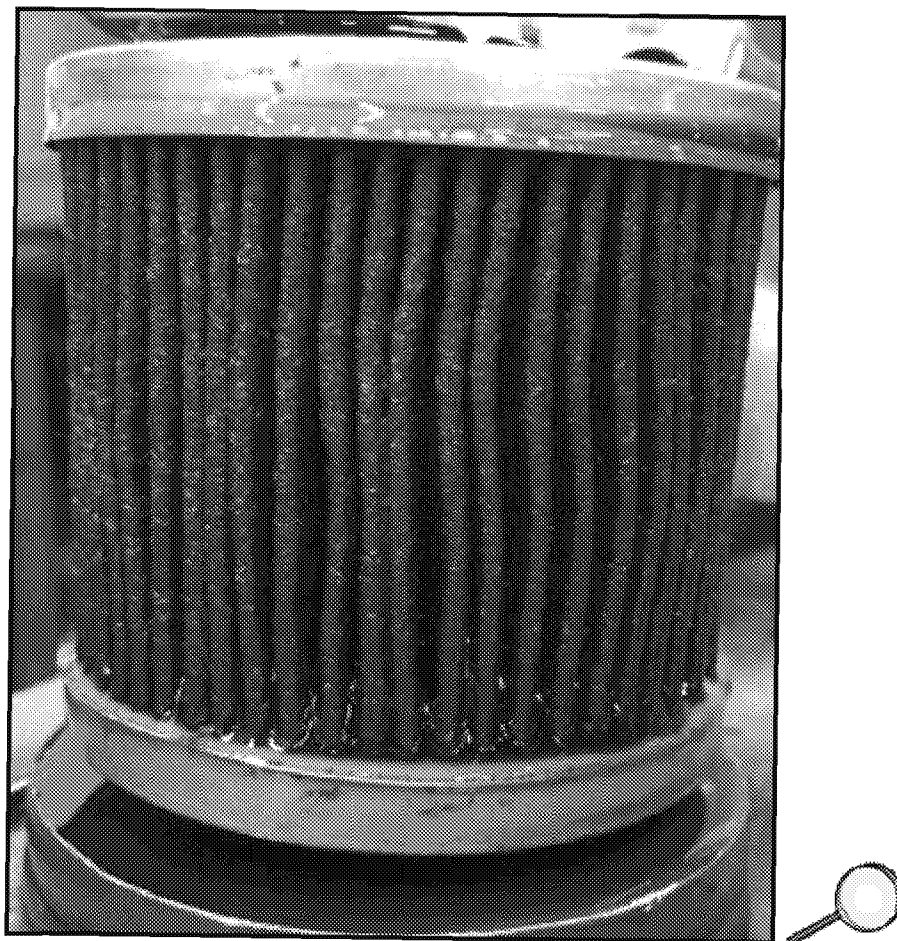
Oil Filter — Inspect for Excessive Debris

Shown are oil filter pleats with visible metal particles.

In this example, minimal amounts of metal particles are visible on oil filter pleats and should not pose a concern.

If excessive amounts of metal particles are observed, or if there is evidence of damaged oil filter pleats, then unfiltered oil with bearing debris may have been pumped into the oil lubrication galleries throughout the engine. This will require further inspection to confirm the degree of contamination and appropriate repair direction. Refer to Service Bulletin #19-NA-256 for HFV6 Gen 1 and Gen 2.
