#18-NA-073: Repair Guidelines for Engine Component Wear - (Jan 18, 2022)

Subject: Repair Guidelines for Engine Component Wear

Brand:	Model:	Model Year:		VIN:		Engine:	Transmission:
		from	to	from	to		
GM Passenger Cars and Trucks		2015	2022	All	All	All	—

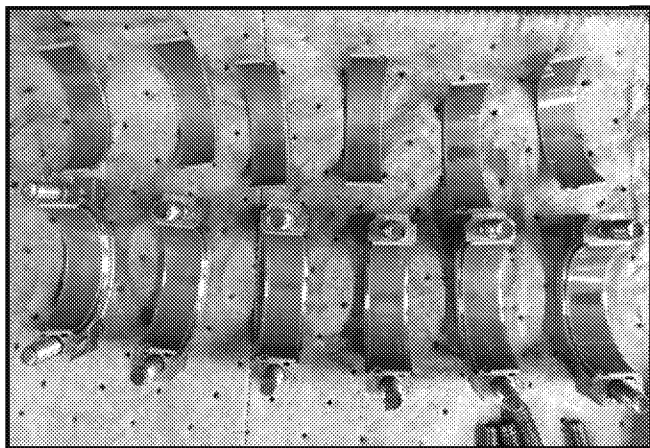
Connecting Rod End Caps and Bearings

Example of minor scratching/scoring visible on connecting rod bearings. In this example, the scored components can be replaced without need for engine assembly replacement.

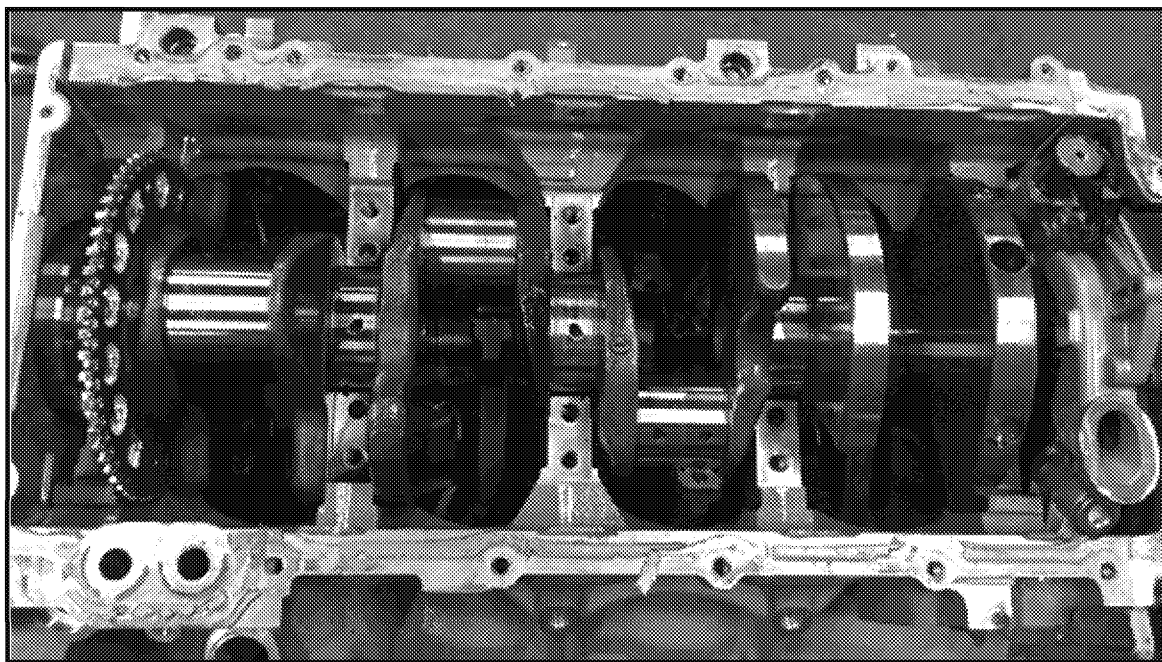
Crankshaft in Crankcase

Example of minor scratching/scoring visible on crankshaft. In this example, the scored components can be replaced without need for engine assembly replacement.

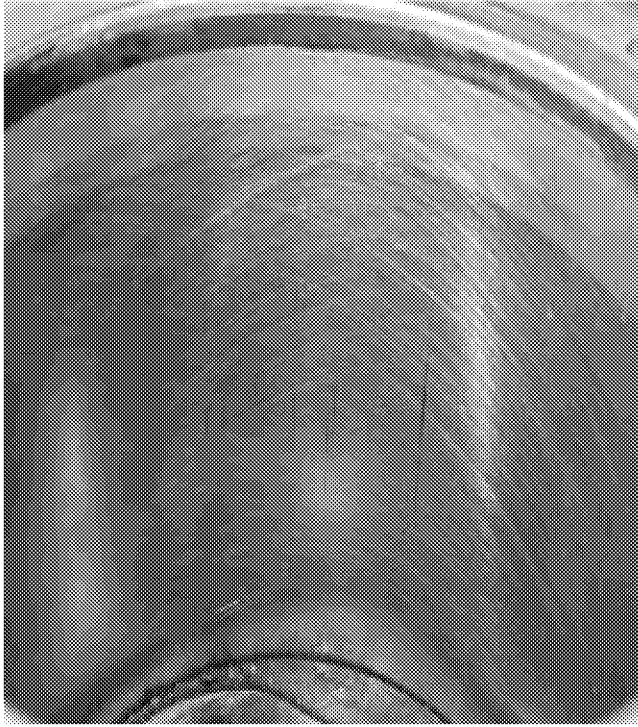
Cylinder Bore

Example of minor scratching/scoring visible on cylinder wall. In this example, if you cannot catch a pick or fingernail on the scratch, the cylinder bore/engine block does not require replacement. If the piston is slightly scored, the scored piston can be replaced without need for engine assembly replacement.
