<b>GROUP</b> <b>Safety Recall Campaign</b>	<b>MODEL</b> <b>2011-2014MY Optima (QF/TF)</b> <b>2012-2014MY Sorento (XMa)</b> <b>2011-2013MY Sportage (SL)</b>
	<b>NUMBER</b> <b>SC147 (Rev 1, 6/16/2017)</b>	<b>DATE</b> <b>June 2017</b>
<b>SAFETY RECALL CAMPAIGN</b>		
<b>SUBJECT: THETA II ENGINE INSPECTION AND/OR REPLACEMENT</b>

This bulletin provides the procedure to inspect, and if necessary, replace the engine long block assembly on the following vehicles:

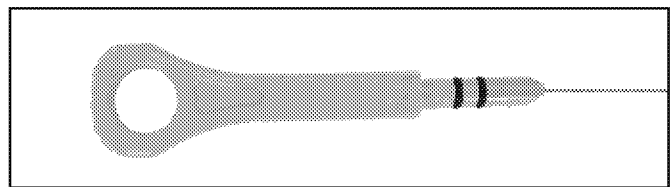
**Yellow Dipstick (P/N: 26611 2G020)**

22. For 2011-2013MY vehicles only: If the vehicle is equipped with a YELLOW dipstick, discard the dipstick and replace it with a new ORANGE one.

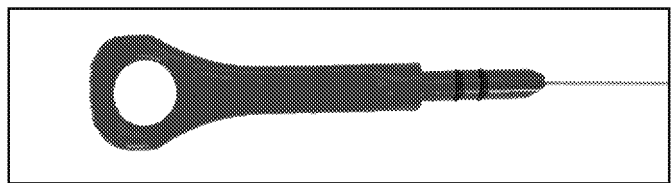
**Red Dipstick (P/N: 26611 2G040)  
 (NO REPLACEMENT REQUIRED)**

**\* NOTICE**  
 If the vehicle is equipped with a RED dipstick, replacement is not necessary.
