<b>GROUP</b> <b>Safety Recall Campaign</b>	<b>MODEL</b> <b>2011-2014MY Optima (QF/TF)</b> <b>2012-2014MY Sorento (XMa)</b> <b>2011-2013MY Sportage (SL)</b>
	<b>NUMBER</b> <b>SC147 (Rev 2, 6/29/2017)</b>	<b>DATE</b> <b>June 2017</b>
<b>SAFETY RECALL CAMPAIGN</b>		
<b>SUBJECT: THETA II ENGINE INSPECTION AND/OR REPLACEMENT</b>

This bulletin provides the procedure to inspect, and if necessary, replace the engine long block assembly on the following vehicles:

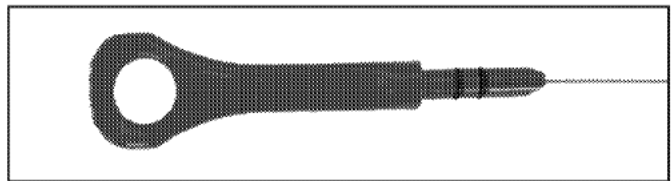
**Red Dipstick (P/N: 26611 2G040)  
(NO REPLACEMENT REQUIRED)**

If the vehicle is equipped with a **RED** dipstick, replacement is not necessary.
