GROUP Safety Recall Campaign	MODEL 2011-2014MY Optima (QF/TF) 2012-2014MY Sorento (XMa) 2011-2013MY Sportage (SL)
	NUMBER SC147 (Rev 4, 08/07/2017)	DATE June 2017
SAFETY RECALL CAMPAIGN		
SUBJECT: THETA II ENGINE INSPECTION AND/OR REPLACEMENT

This bulletin provides the procedure to inspect, and if necessary, replace the engine long block assembly on the following vehicles:

Metal debris may have been generated from factory machining operations of the engine crankshaft and may not have been completely removed from the crankshaft's oil passages during the cleaning process. It was also determined that the additional machining processes of the crankpins may have caused uneven surface roughness. These combined conditions can restrict oil flow to the bearings increasing the potential for premature bearing wear.

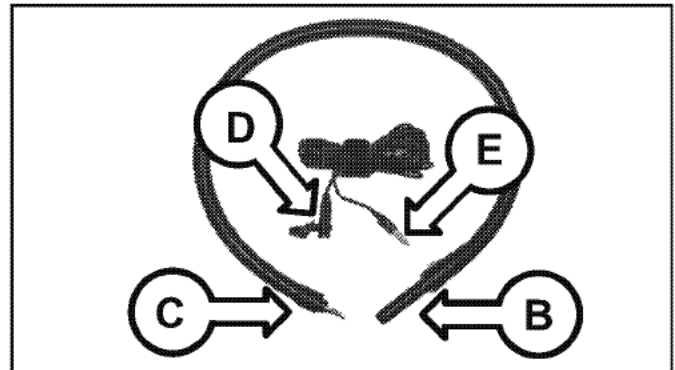
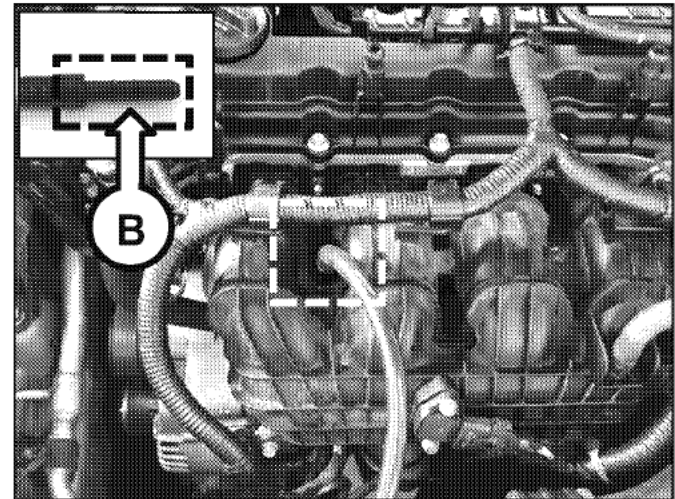
To avoid false readings, ensure the adapter (B) is properly inserted into the dipstick tube and that the tube is not in contact with the intake manifold.

If the dipstick tube is not centered and is close to or touching the manifold, carefully adjust (bend) and center the dipstick tube with a pry bar.

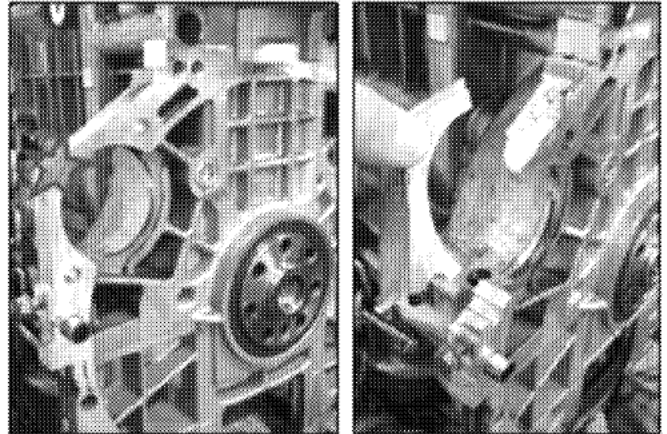
7. Prior to discarding the removed engine, disable it to prevent reuse by using a large mallet and striking firmly at the center of the starter mount tab on the removed engine to break off the tab.

Provide the removed starter mount tab to your dealership's Parts Department for campaign engine core charge reimbursement request processing.
