GROUP Safety Recall Campaign	MODEL 2011-2014MY Optima (QF/TF) 2012-2014MY Sorento (XMa) 2011-2013MY Sportage (SL)
	NUMBER SC147 (Rev 5, 09/01/2017)	DATE June 2017
SAFETY RECALL CAMPAIGN		
SUBJECT: THETA II ENGINE INSPECTION AND/OR REPLACEMENT

This bulletin provides the procedure to inspect, and if necessary, replace the engine long block assembly on the following vehicles:

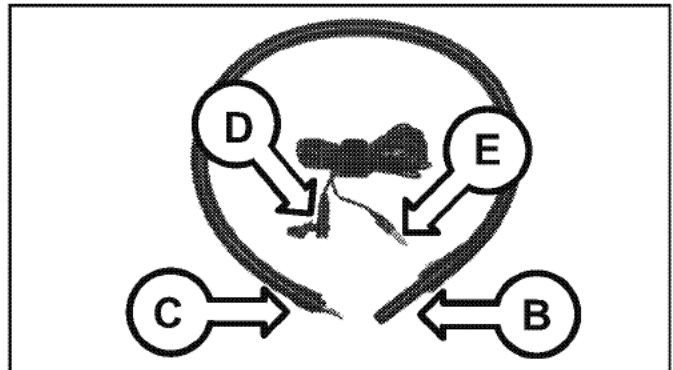
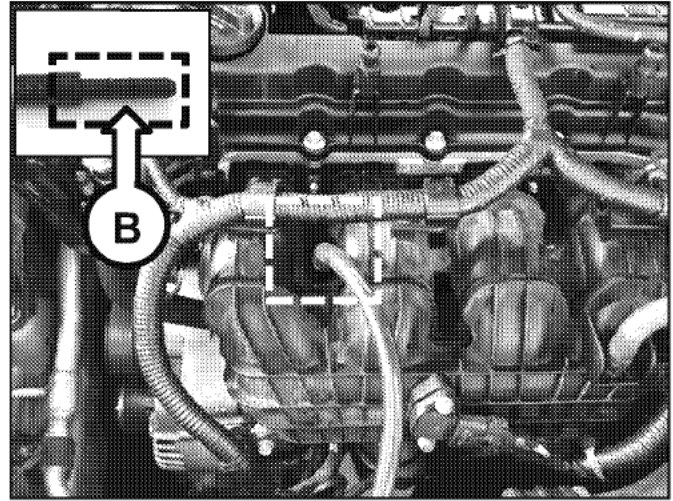
To avoid false readings, ensure the adapter (B) is properly inserted into the dipstick tube and that the tube is not in contact with the intake manifold.

If the dipstick tube is not centered and is close to or touching the manifold, carefully adjust (bend) and center the dipstick tube with a pry bar.

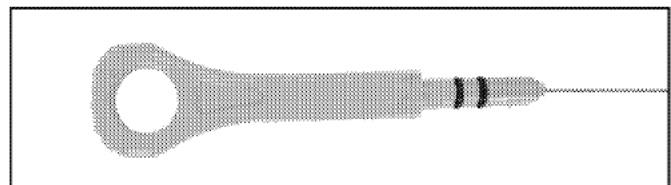
Yellow Dipstick (P/N: 26611 2G020)

21. Disconnect the engine noise tester from the KDS and carefully remove the adapter (B) from the dipstick tube by grasping the engine noise tester adapter.
22. For 2011-2013MY vehicles only: If the vehicle is equipped with a **YELLOW** dipstick, discard the dipstick and replace it with a new **ORANGE** one.

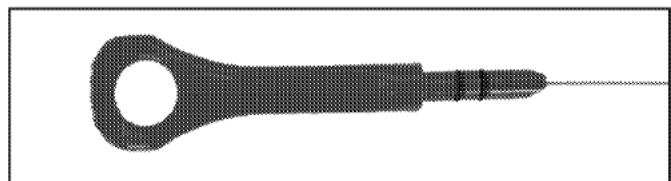
**Red Dipstick (P/N: 26611 2G040)
(NO REPLACEMENT REQUIRED)**

If the vehicle is equipped with a RED dipstick, replacement is not necessary.

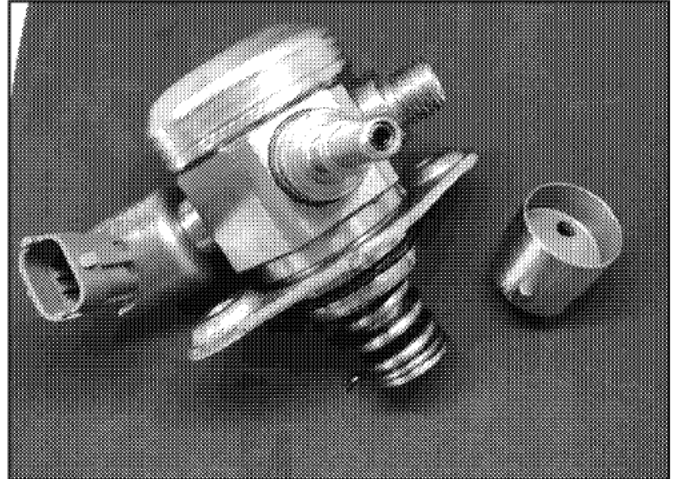
- Refer to TSB ENG083 for special attention and handling procedures of GDI-specific components.
- When installing the high pressure pump and roller tappet onto the new engine, apply engine oil to the roller tappet, and O-rings of the high pressure pump.

Tightening torques of pump bolts:
 9.4 – 10.9 lb.ft (12.8 – 14.7 N.m,
 1.3 – 1.5 kgf.m)

Tightening torques of pipe flare nut:
 19.5 – 23.9 lb.ft (26.5 – 32.4 N.m,
 2.7 – 3.3 kgf.m)

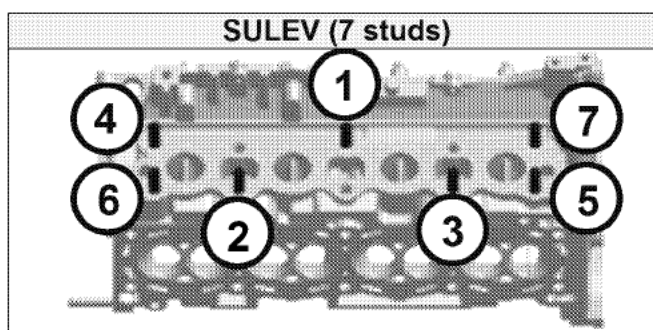
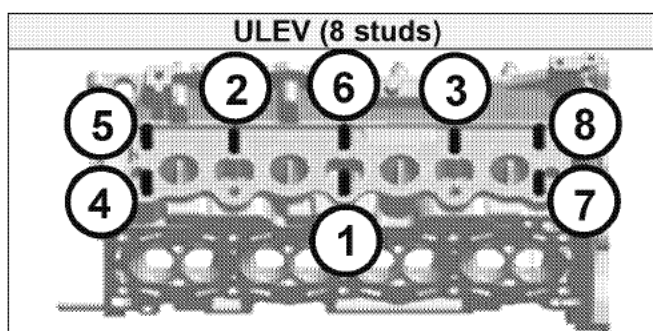
**Exhaust Manifold:**

- Refer to "Guidelines in case of Catastrophic Failure" on page 13.
- In a case of a catastrophic engine failure, use a bore/videoscope and inspect the exhaust manifold for any metallic debris and remove.
- All engines supplied under this campaign have the exhaust manifold studs configured for SULEV engines.
- Using the pictures to the right, check the exhaust manifold stud location and quantity. Relocate as required for ULEV engines and obtain one (1) extra from the removed engine.
- Prior to installation, replace the exhaust manifold gasket and front muffler gasket.
- Torque nuts in the sequence shown.

**36.2 – 39.7 lb.ft (49.0 – 53.9 N.m,
5.0 – 5.5 kgf.m)**

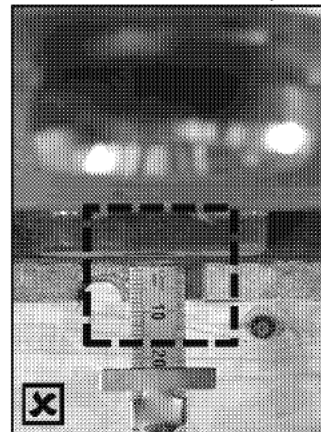
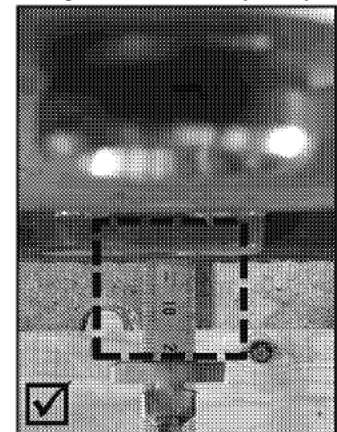
- If the torque converter has moved from the fully inserted position, carefully push inward while rotating the torque converter until it is recessed approximately 9/16 – 5/8" (14 – 16mm) (☑) into the transaxle case when reinstalling the automatic transaxle.

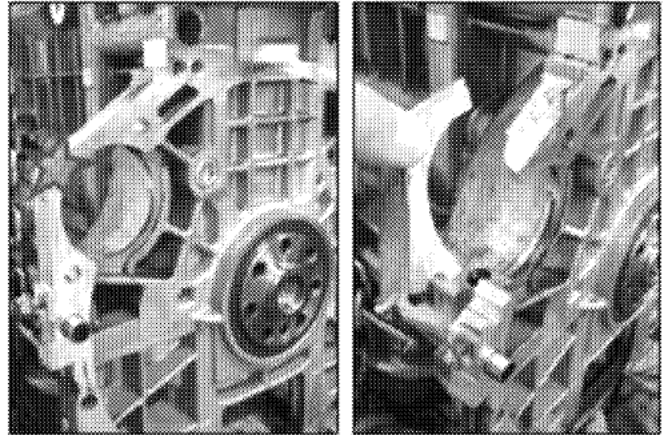
7. Prior to discarding the removed engine, disable it to prevent reuse by using a large mallet and striking firmly at the center of the starter mount tab on the removed engine to break off the tab.

Provide the removed starter mount tab to your dealership's Parts Department for campaign engine core charge reimbursement request processing.
